**INFLUENCE OF CORROSIVE INUNDATION ON THE
CORROSION RATES OF GALVANIZED TIE STRIPS IN
MECHANICALLY STABILIZED EARTH WALLS**

**Final Report, State Job No. 99700-3531-119
WPI 0510686**

**Prof. Alberto A. Sagüés, Ph.D., P.E.
Principal Investigator
February, 1998**

**College of Engineering
University of South Florida
Tampa Florida 33620**

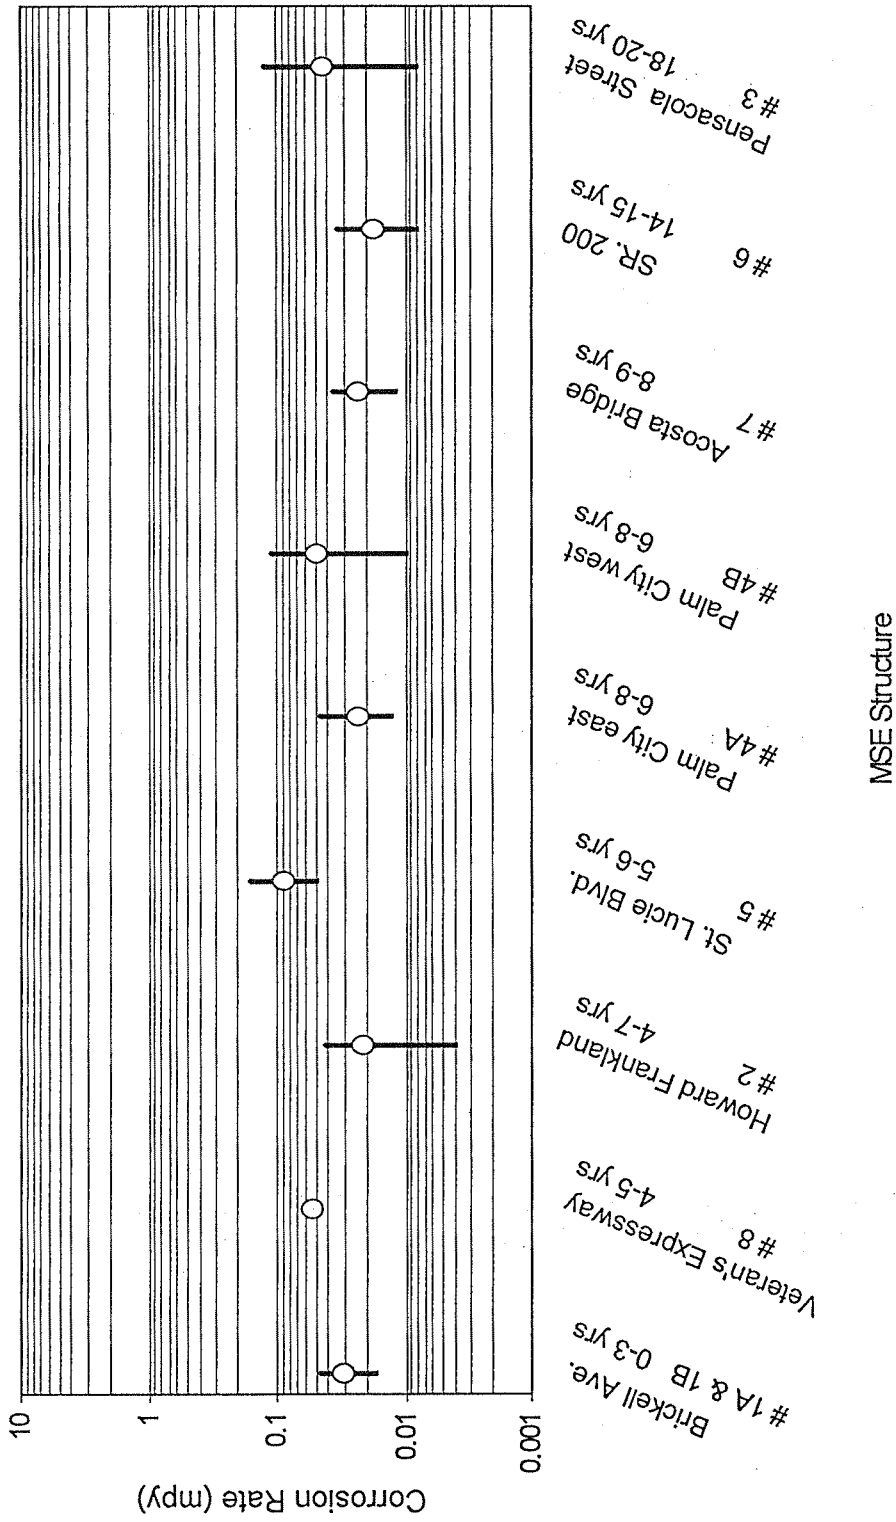
Figure 3-3. Average of galvanized Apparent Corrosion Rates (ACR) of all structures tested displayed in order of increasing structure age at the time of testing. The bars indicated the range of values obtained.
