**INFLUENCE OF CORROSIVE INUNDATION ON THE
CORROSION RATES OF GALVANIZED TIE STRIPS IN
MECHANICALLY STABILIZED EARTH WALLS**

**Final Report, State Job No. 99700-3531-119
WPI 0510686**

**Prof. Alberto A. Sagüés, Ph.D., P.E.
Principal Investigator
February, 1998**

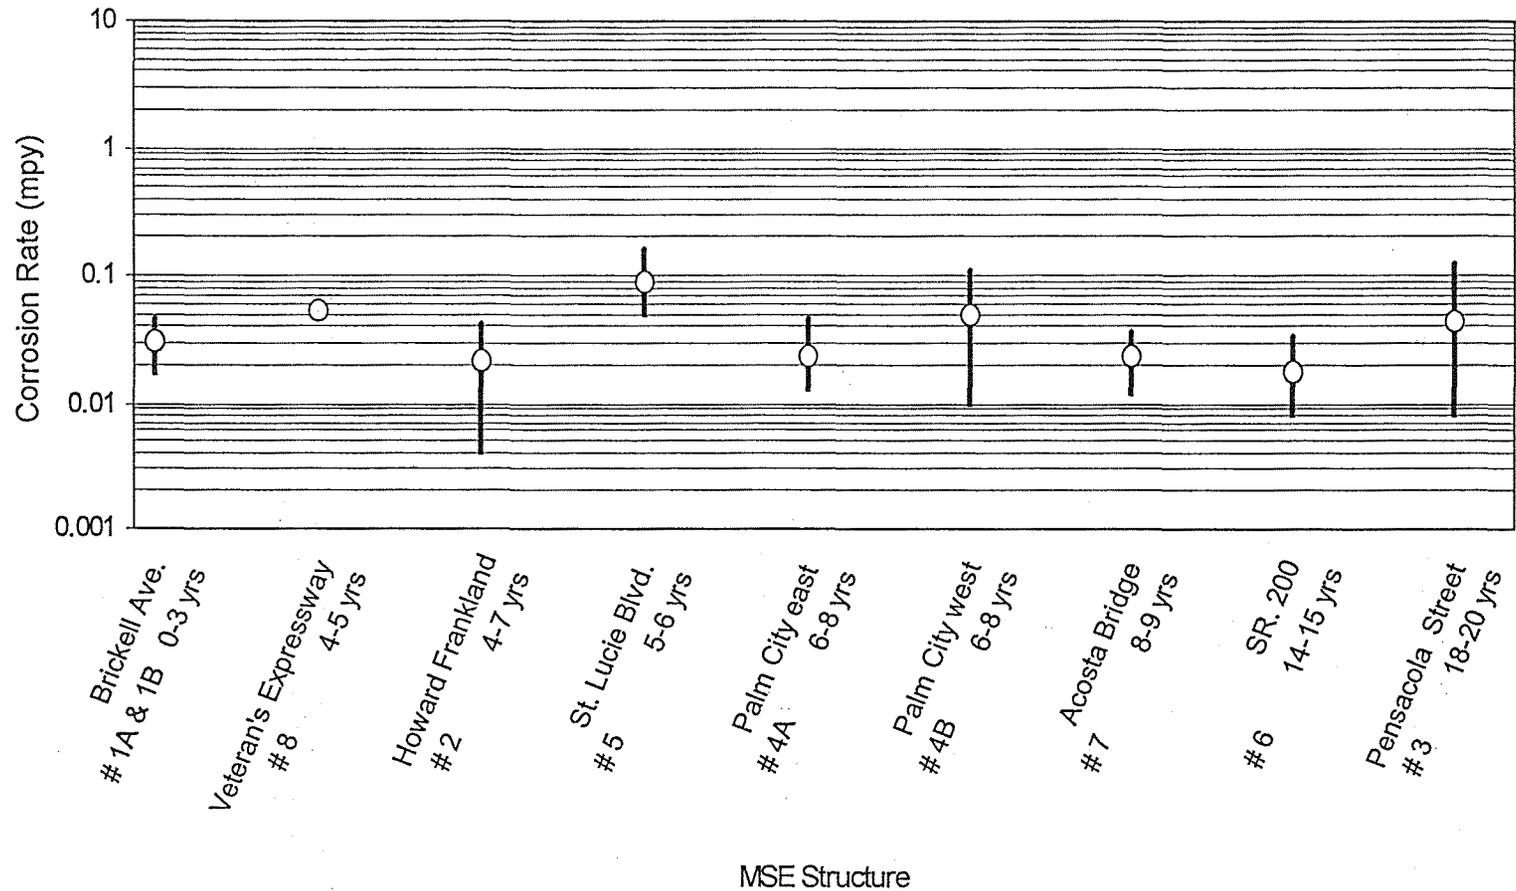
Field measurements of Apparent Corrosion Rates (ACR) of galvanized reinforcement showed typically very low values, with an average of $\approx 1 \mu\text{m/y}$ ($\approx 0.04 \text{ mpy}$). The ACR of galvanized reinforcement did not vary significantly with age of the structure tested. The ACR of recently introduced plain steel rods had an average of $\approx 12 \mu\text{m/y}$ ($\approx 0.5 \text{ mpy}$). There was little correlation observed between the ACR of either material and the electrochemical properties of the soil in the low aggressivity range explored and there was little correlation between the corrosion

Figure 3-3. Average of galvanized Apparent Corrosion Rates (ACR) of all structures tested displayed in order of increasing structure age at the time of testing. The bars indicated the range of values obtained.

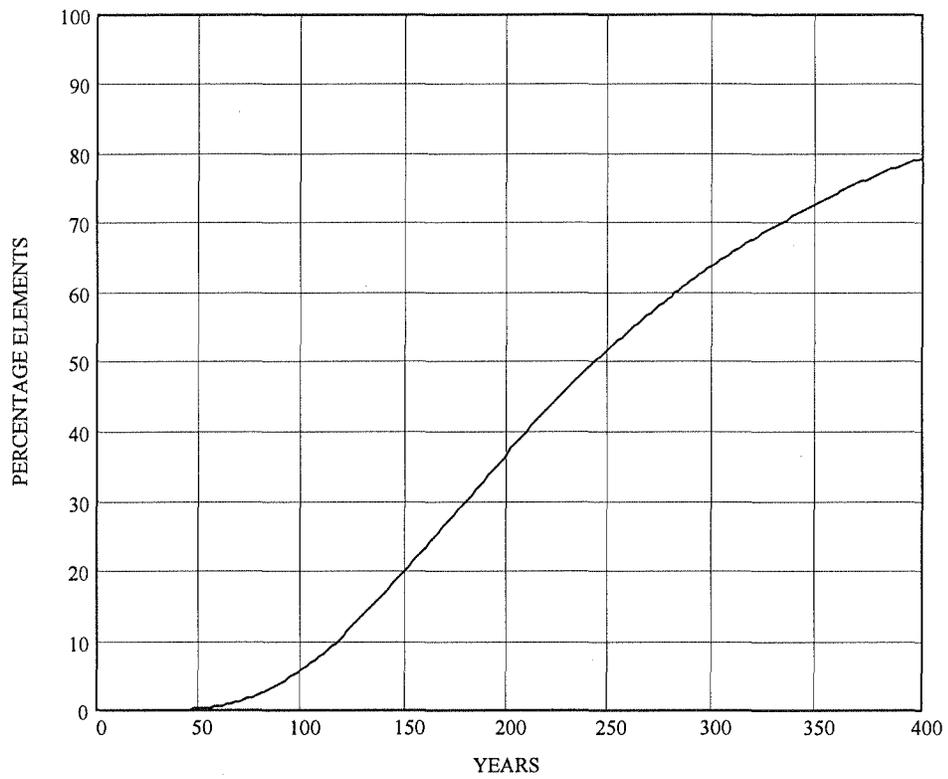
A conservative durability model was formulated to project the percentage of elements that reach the end of their service life after a given service time of a generic MSE wall. The model input incorporated conservatively all the field evidence representative of Florida conditions obtained in this investigation. For walls not subject to episodic saltwater flooding the model projects a period of ≈ 50 years with negligible reinforcement failure, and $\approx 5\%$ failure after 100 years. For a wall with a saltwater flood at year zero, the model projects failure development 10 times earlier.

Figure 4-1. Projection of the percentage of elements that reached the end of service life as a function of time of service for the generic MSE wall not subject to episodic chloride contamination.

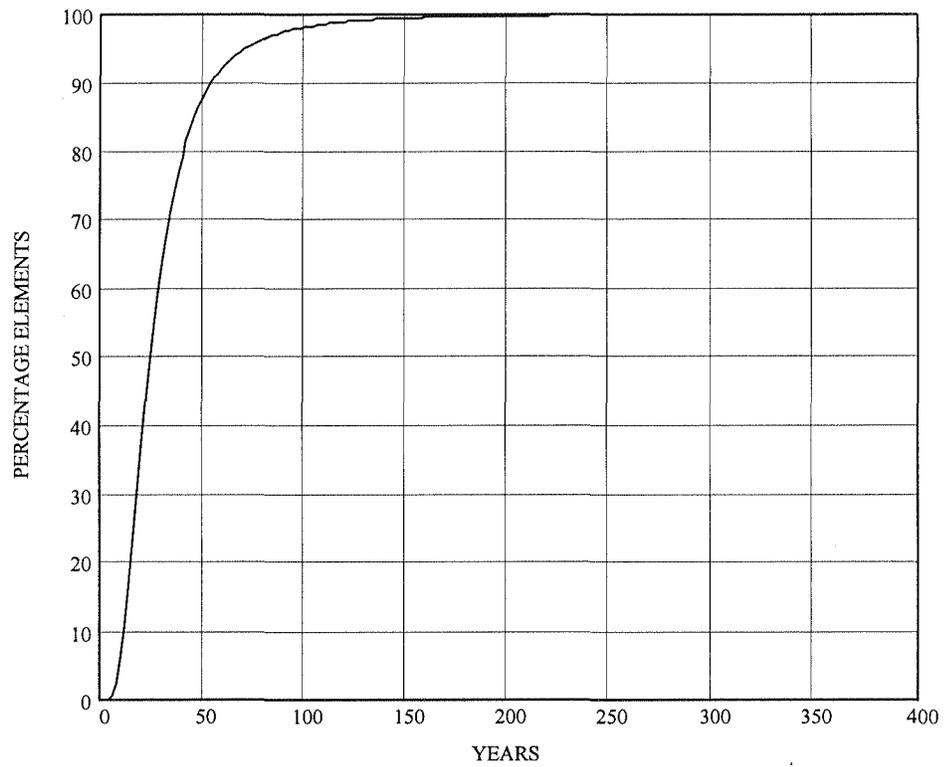
Figure 4-2. Projection of the percentage of elements that reached the end of service life as a function of time of service for the generic MSE wall subject to corrosive inundation at year zero.
