## **Corrosion of the Strand-Anchorage System in Post-Tensioned Grouted Assemblies**

Hongbin Wang\*, Alberto A. Sagues\*, and Rodney Powers<sup>+</sup>

### **ABSTRACT**

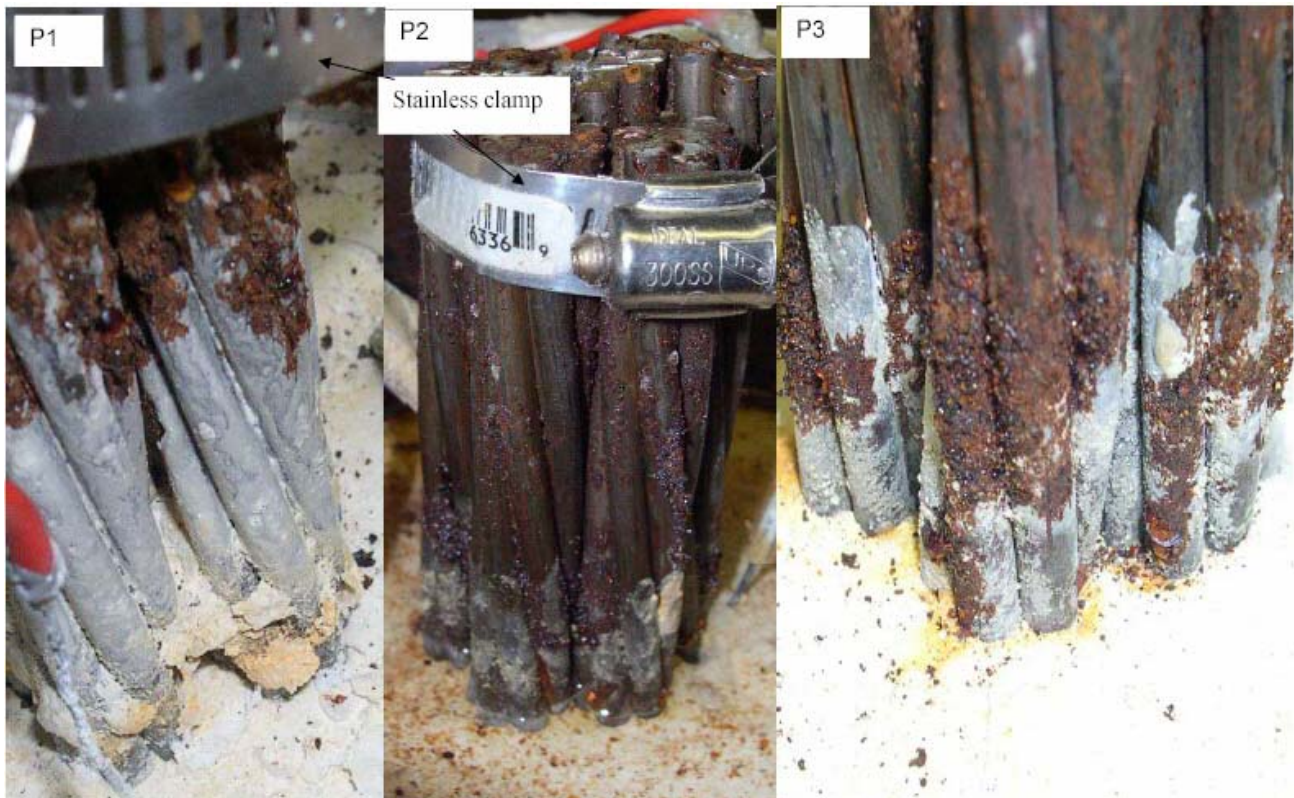
**Figure 4. Rusting On Strands In P Series Assemblies At Day 308 (After Three Water Recharge Events)** Severe air space corrosion on all three bundles. Slight grout/void interface rusting in P3. White grout residues left by bleed water.

Figure 4 illustrates the surface condition of the strand bundles in the P assemblies (plain cement) after 308 days when the P1 assembly had only one fresh water recharge and P2 and P3 had one fresh water recharge and two 0.01N NaCl recharges. There was significant variability (days to months) from assembly to assembly in the length of time recharge water was retained at the surface after a recharge event, partly reflecting differences in the gaps in the anchor body-grout interface. P3 had the greatest downward leakage there; in contrast P2 retained 1-2 mm of water at the surface long after the 3<sup>rd</sup> recharge event as shown in the picture. The picture shows also variability in the amount of grout residue (from bleed water) at the steel surface. Corrosion was severe in the air space of all three strand bundles, while little attack was present at the grout/void interface even though P2 and P3 had already chloride solution additions. Little air space corrosion was noticed in the areas covered by residual grout. For the strands bundle in P1 assembly, there was no rust from air space corrosion attack on relative thicker grout-covered area.

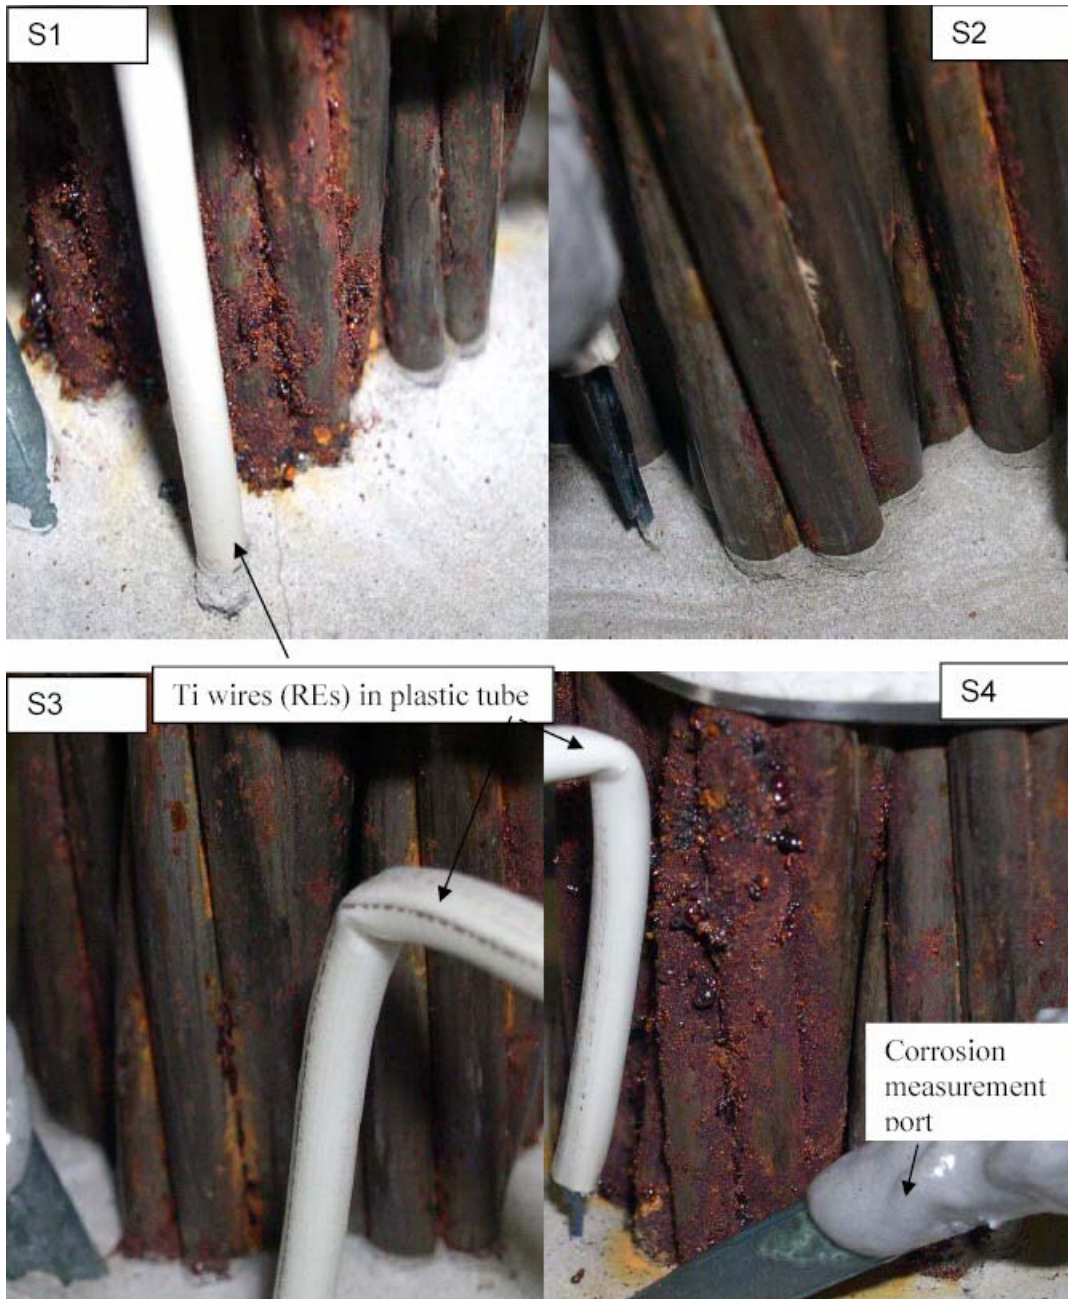
**Figure 5. Corrosion On PT Strands In S Series Assemblies (Day 272)**

Figure 5 shows the surface condition of strands in S assemblies at day 272. These (except for S2 which was a control with no recharge events) were exposed to fresh water events only. There was nevertheless severe air space corrosion at some spots, as well as corrosion attack at the grout/void interface, although not as severe as in the P assemblies. Control assembly S2 showed no signs of corrosion.

(S1, S3, and S4 showed corrosion attack at the grout/void interface;  
S2 showed almost no corrosion attack.)

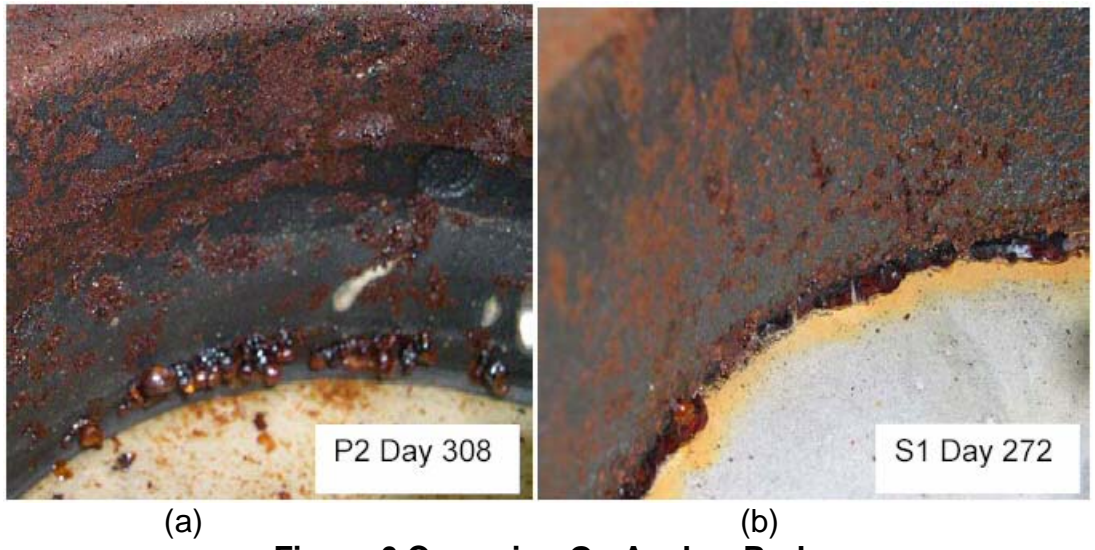
**Figure 6 Corrosion On Anchor Body**

Figure 6 illustrates the surface condition of the anchor body ductile iron in P2 and S1 after respective water recharges, showing severe water line corrosion in both. There was some air space corrosion in the P assembly but much less in the S assembly. This may reflect the combined effect of a wider grout-anchor interstice in the S assembly, allowing for faster water drainage, and to lower internal relative humidity (~80%) from self-desiccation of the S grout (RH results to be published elsewhere).

a: severe water line corrosion in P assembly after 0.01N NaCl recharge,  
 b: water line corrosion attack in S assembly after fresh water recharge.

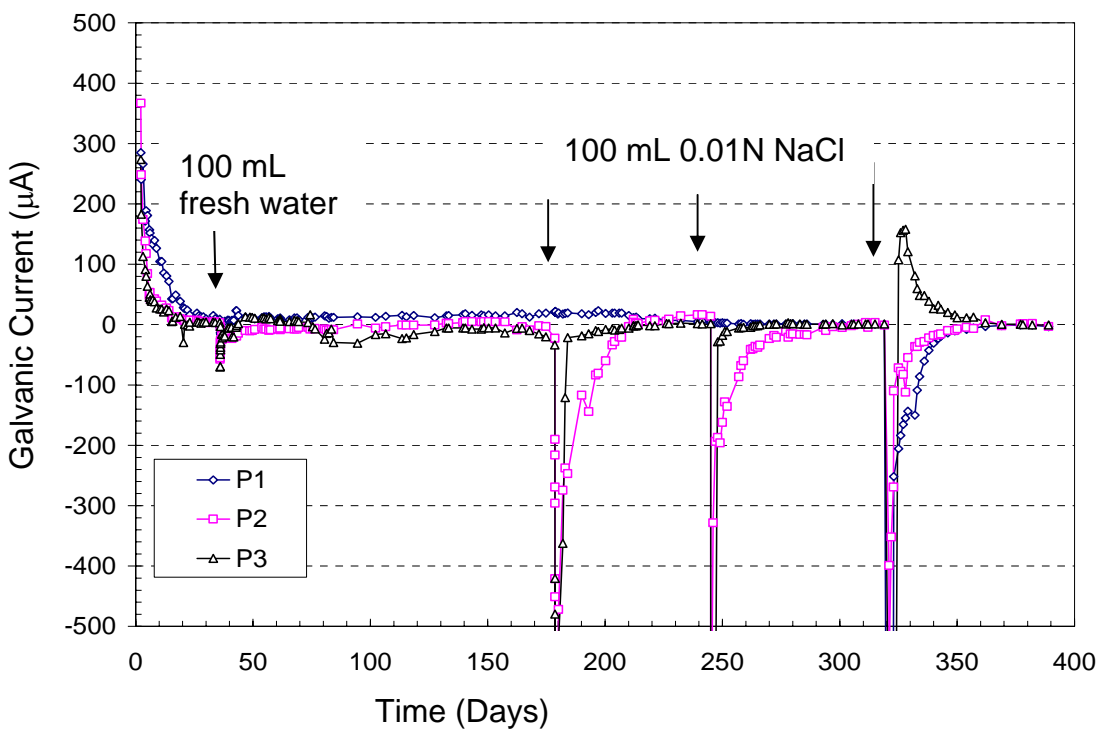
**Figure 7 Galvanic Current Between Anchor And Strands In P Series Assemblies**  
 (arrows present the water recharge events listed in the test matrix; negative current sign indicates that strands serve as the cathodes)

Figure 7 shows the anchor/strands galvanic current in the P series assemblies. The arrows indicate water recharge events per Table 3. Positive values denote net anode character for the strands. These were initially strongly anodic (current ~ 500  $\mu$ A) immediately following initial interconnection, but the current dropped to <10  $\mu$ A after a few days-weeks likely reflecting maturing passivity of the assembly in the alkaline grout environment.

The first recharge (fresh water, all three P assemblies) caused only small transient changes in galvanic current. Visual inspection shortly afterwards showed no rust on the strands at the grout/void interface. Galvanic current was small in the following 4-month waiting period. Addition of NaCl-spiked recharge water into P2 and P3 at days 179 and 245 caused sharp transient increases (to 1000  $\mu\text{A}$ ) in macrocell current, but with the strands acting as net cathodes. However, in the next salt water recharge event (day 320, all three assemblies) the strands in P3 became anodic and slight yellow or brown rusting was noticed on those strands at the grout/void interface. Visual inspection showed that a tiny water pool existed there as late as 4 days after the event, possibly contributing to the observed corrosion of those strands. It should be noted however that the pH of recharge water (whether fresh or salty) temporarily remaining on top of the grout after wetting events was  $\sim 13$ . The strand-anchorage body conductance evolution in the P assemblies is shown in Figure 8. Each water recharge event was accompanied by an increase in conductance which dissipated after some time, roughly paralleling the length of time recharge water remained visible on the grout surface (see Table 3).

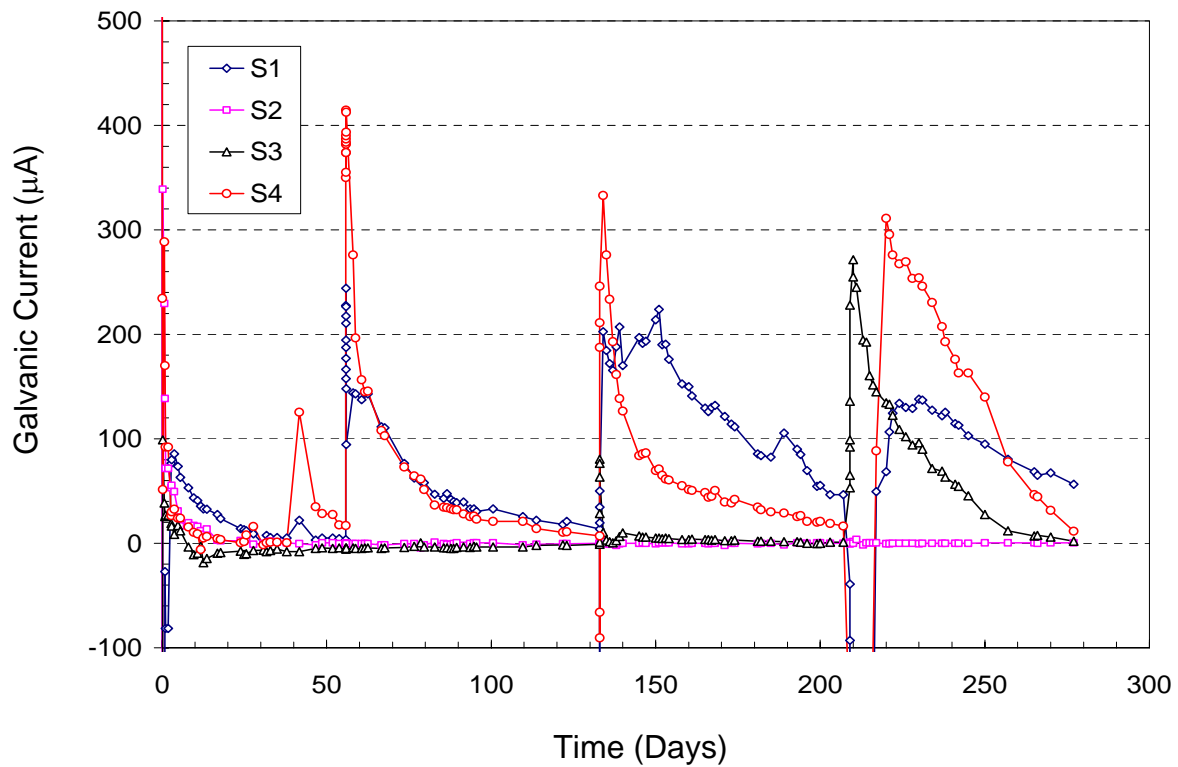
**Figure 9 Galvanic Current Between Anchor And Strands In S Series Assemblies**  
(arrows present the water recharge events listed in the test matrix; Positive current sign indicates that strands serve as the anodes)

Figure 9 shows the galvanic current trends in the S series assemblies. Unlike in the P assemblies, fresh water in the S assemblies triggered strong macrocell action (in agreement with the visual observations), and the strands behaved consistently as net anodes. This difference is partly explained by the greater chloride content in the S grout (500 ppm, Table 1) compared that in the P grout (80 ppm). Despite the relatively high native chloride content, recharge water was still needed to support corrosion at the grout/void interface, as evidenced by the rust free condition of that zone in Assembly S2 which was kept without external water contamination. On the other hand, even a small amount of fresh water (e.g. 10 ml in S3 at day 209) was enough to support significant strand corrosion. Conductance trends in the S assemblies (Figure 10) resembled those in the P assemblies, but with typical conductance values about one order of magnitude lower.

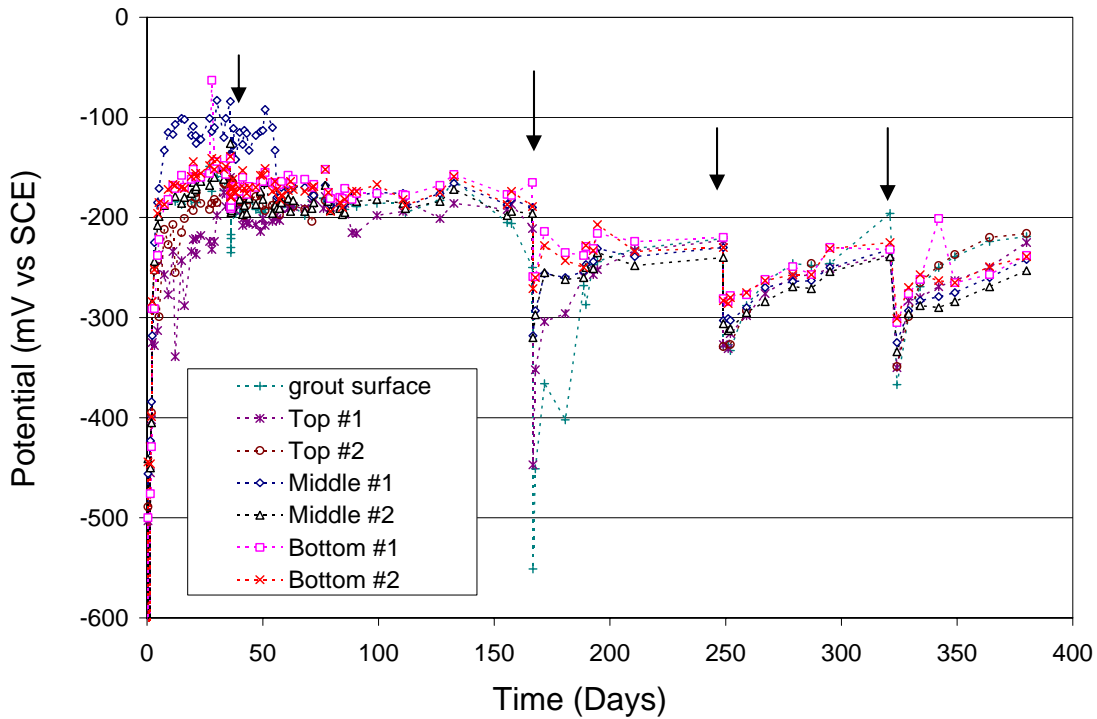
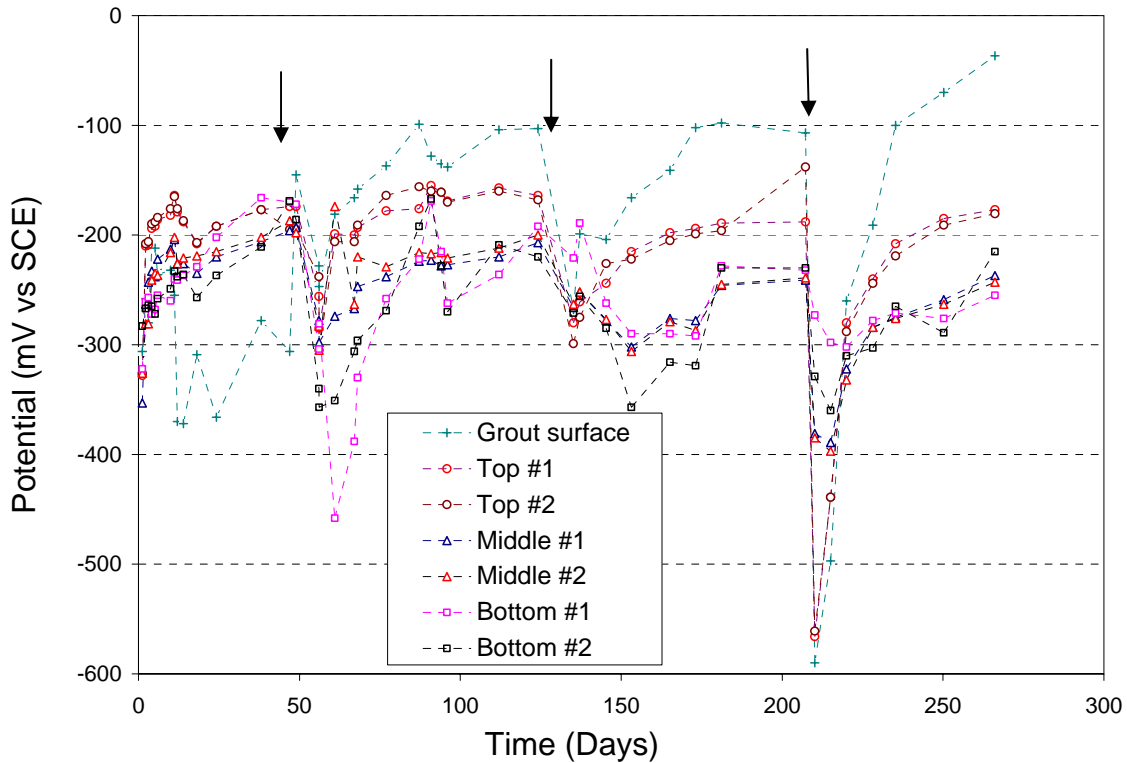
Figures 11 and 12 show representative potential trends of the interconnected strands-anchor system, using assemblies P2 and S1 as examples. Comparable trends were observed in the replicate assemblies. The potential trends correlate well with those of the galvanic currents and suggest the presence of activation-passivation cycles linked to each recharge event. Spatial resolution is provided by measurements at ports at the various levels (Figure 1). Figure 11 shows that the first fresh water addition to P2 caused no large change on potentials (all remaining at  $\sim -200$  mV vs SCE) at either the top, middle, and bottom locations. This is indicative of passive behavior at all levels, unaffected by the fresh water addition, and in agreement with the macrocell current behavior noted above. However, recharge with the salty solution caused instantaneous excursions to much more negative potentials, indicative of depassivation and consistent with the macrocell current increase. The potential excursions at the upper levels (by the grout-void interface) were larger, in agreement with the externally observed locus of corrosion. Comparable trends are seen in Figure 12 for assembly S1. However, in this case the potentials at the top and grout surface locations gradually increased to above  $-200$  mV as repassivation followed a recharge event, but the potential readings at the middle and bottom locations did not completely recover to about  $-200$  mV before next water recharge event. This suggests that some corrosion might extend to regions far below the main grout/void interface.

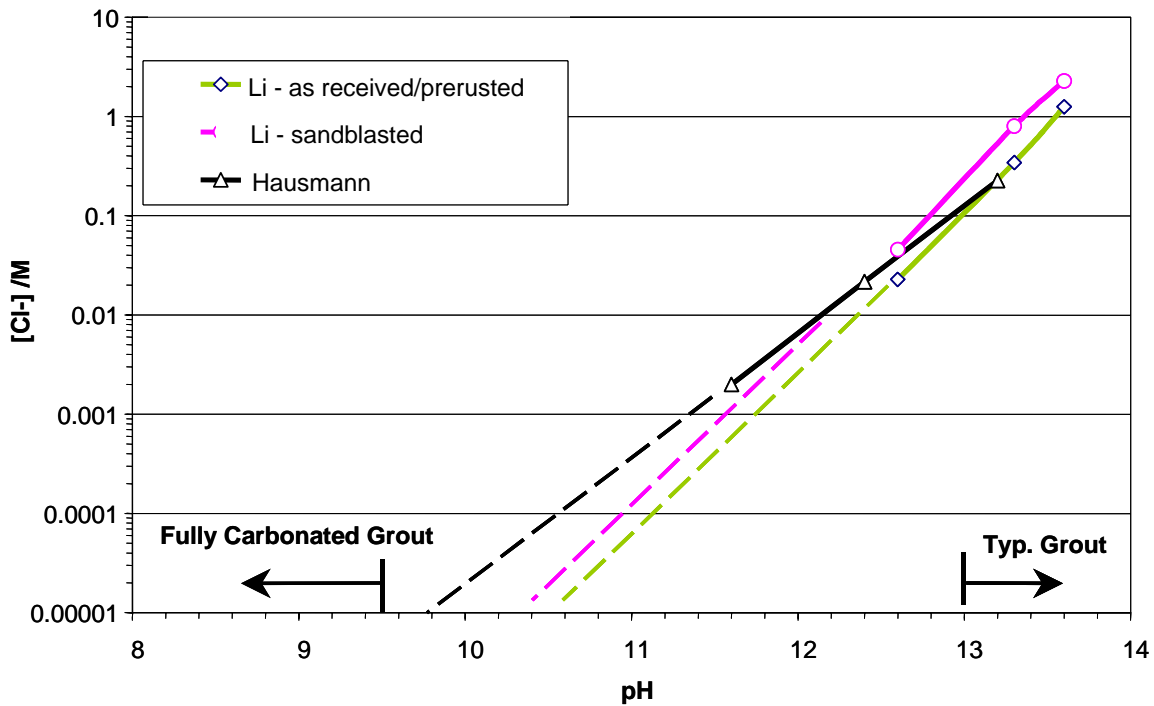
**Figure 13. Chloride Concentration Threshold to Initiate Corrosion as Function of pH for Rebar Steel** (data from references 14, 15)

The response to recharge events may be considered in the light of Figure 13, which summarizes results<sup>[14,15]</sup> on the chloride content needed to initiate corrosion of plain steel as function of solution pH. Values of pH expected for the pore solution of a typical grout (not carbonated) and in a fully carbonated condition<sup>[16]</sup> are shown as well. For a given hydrated grout saturated with external fresh water, the chloride content of the pore water depends on factors that include the native chloride content and the porosity  $\epsilon$  of the hydrated grout, and the chloride binding isotherm of the system<sup>[14]</sup>. Those factors can vary greatly, but for discussion representative values of  $\epsilon=0.2$ , concrete density  $2 \text{ g/cm}^3$ , and roughly linear binding (on account of the low native chloride levels considered here) with a bound/free chloride ratio of 10:1<sup>[14]</sup> may be assumed. In such case the 80 ppm and 500 ppm native chloride levels would correspond to pore water concentrations in the order of  $\sim 0.0015 \text{ N}$  and  $\sim 0.01 \text{ N}$  respectively. Thus, a pore water pH of  $\sim 13$  (as observed in the surface water) would still suffice to retain passivity in either case. However, if at some spots the pH were to fall by just  $\sim 1/2$  unit (e.g. by localized carbonation) or if modest chloride evaporative concentration would occur, corrosion initiation could easily take place in the 500 ppm case. Conditions would have to be proportionally more severe to initiate corrosion by fresh water contact in the 80 ppm case. These scenarios are consistent with the observation of corrosion upon fresh water addition in the S but not in the P grout, as well as the onset of corrosion in the P grout upon addition of 0.01 N NaCl recharge water. It may be concluded that conditions are dangerously close to steel depassivation in voided anchorages if openings to the exterior allow for even modest carbonation of the grout and periodic intrusion of even fresh water, if sufficient native chloride is present in the grout. The responsible native chloride does not need to be very high, since 500 ppm in the hydrated grout corresponds to only  $\sim 600 \text{ ppm}$  (0.06%) in the initial bagged product. Such content is below common current product specifications [0.08% per FDOT Specification 938] which may merit revision to lower levels in view of these findings.

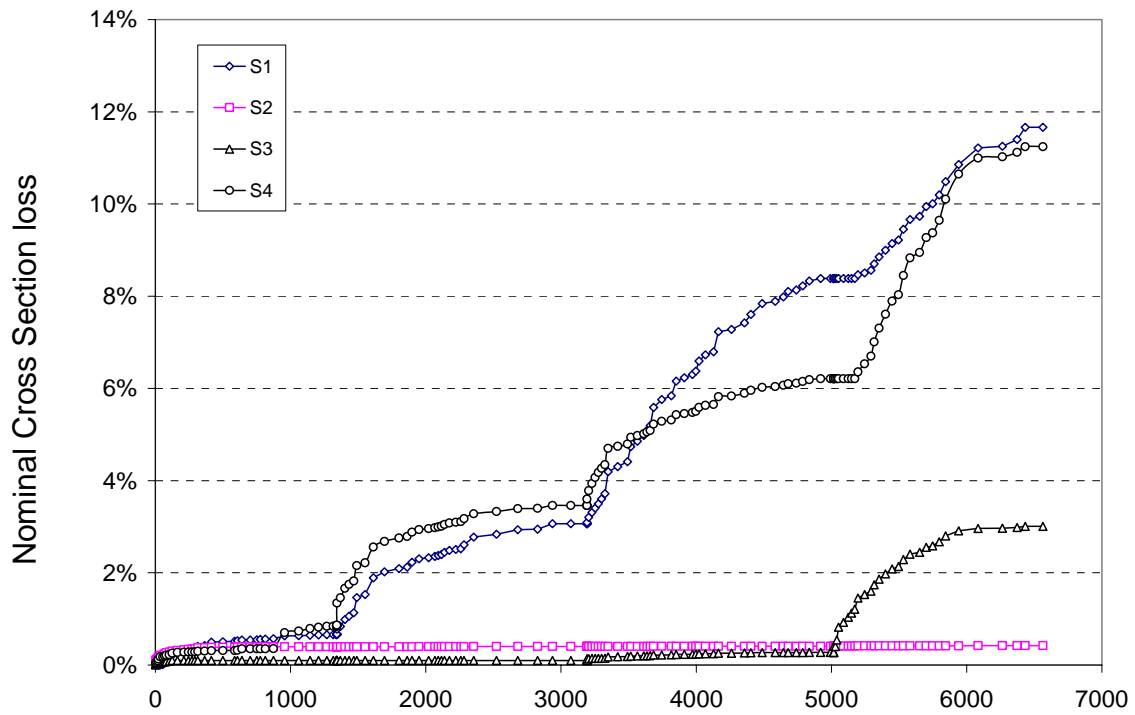
**Figure 14 Nominal Cross Section Loss of A Single Strand**  
 (Assume that all metal loss is in a 1 mm high band around the strand bundle at air/grout interface and anodic galvanic current in Figure 9 equals to corrosion current)

Attempts at corrosion rate measurements using polarization methods will be reported elsewhere. At present however, a working assumption was made that the total strand corrosion current is in the order of the anodic galvanic current measured. This assumption is not necessarily conservative, as local cell action is ignored, but preliminary experiments<sup>[4]</sup> suggest that it may be sufficient to obtain a rough indication of the expected damage. Since the grout-void interface corrosion appeared to be limited to a small zone, it was further assumed that the corroded zone affected a 1 mm high band around the strand bundle perimeter (surface  $\sim 2.5 \text{ cm}^2$ ). The metal loss was considered to affect equally each of the six strands in the perimeter, and the loss of any given strand was calculated as a simple percentage of its total 7-wire cross sectional area ( $\sim 1.4 \text{ cm}^2$ ); detailed distribution among wires was not addressed. The results of this analysis are given in Figure 14 using the S assemblies as an example. The calculations project between  $\sim 0.4\%$  and  $\sim 12\%$  strand cross section loss after a period of 9 months with a few recharge events. As a normally stressed strand could easily fail after 30% cross section loss by pit-like corrosion<sup>[4]</sup>, fractures could take place after as little as  $\sim 2$  years under these conditions (Table 3). These projections, albeit based only on rough assumptions, are consistent with other preliminary work<sup>1,4</sup> and with the observation of tendon failures in the field as early as after 7 years of service.
