Corrosion of the Strand-Anchorage System in Post-Tensioned Grouted Assemblies

Hongbin Wang*, Alberto A. Sagues*, and Rodney Powers⁺

ABSTRACT

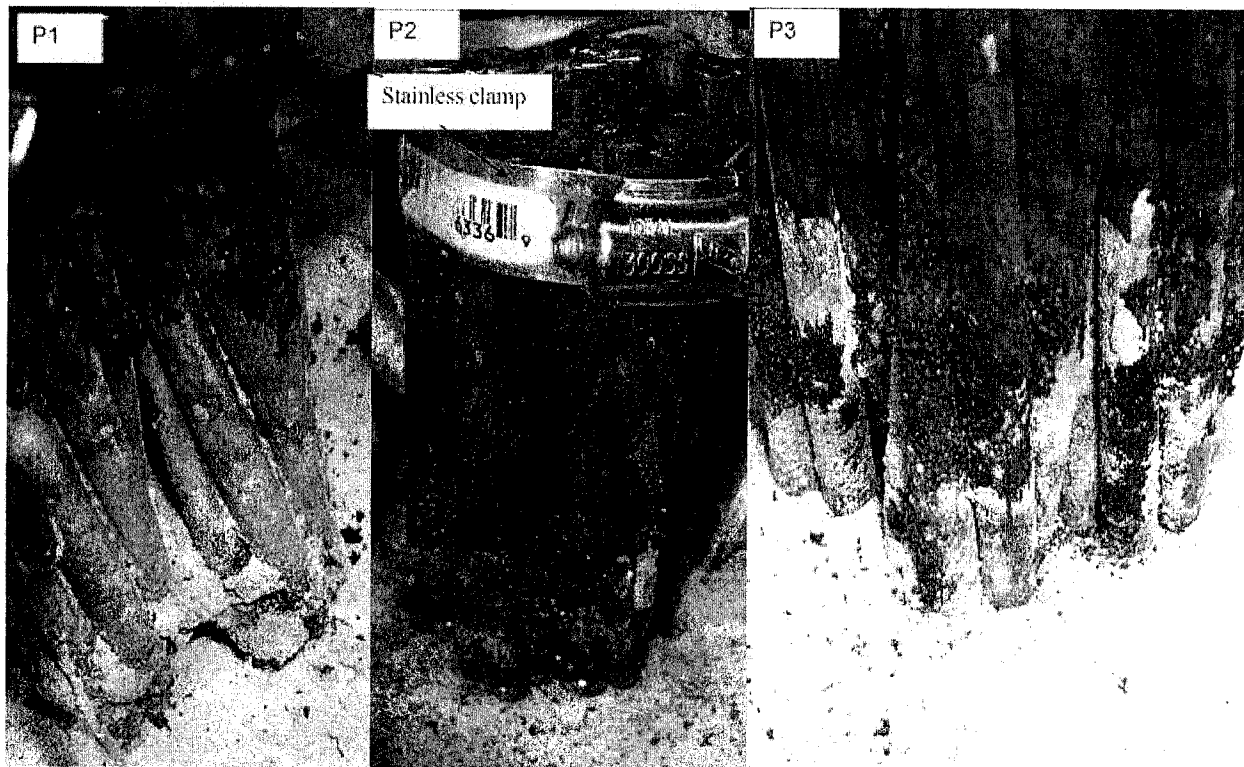
Figure 4 illustrates the surface condition of the strand bundles in the P assemblies (plain cement) after 308 days when the P1 assembly had only one fresh water recharge and P2 and P3 had one fresh water recharge and two 0.01N NaCl recharges. There was significant variability (days to months) from assembly to assembly in the length of time recharge water was retained at the surface after a recharge event, partly reflecting differences in the gaps in the anchor body-grout interface. P3 had the greatest downward leakage there; in contrast P2 retained 1-2 mm of water at the surface long after the 3rd recharge event as shown in the picture. The picture shows also variability in the amount of grout residue (from bleed water) at the steel surface. Corrosion was severe in the air space of all three strand bundles, while little attack was present at the grout/void interface even though P2 and P3 had already chloride solution additions. Little air space corrosion was noticed in the areas covered by residual grout. For the strands bundle in P1 assembly, there was no rust from air space corrosion attack on relative thicker grout-covered area.

Figure 4. Rusting On Strands In P Series Assemblies At Day 308 (After Three Water Recharge Events) Severe air space corrosion on all three bundles. Slight grout/void interface rusting in P3. White grout residues left by bleed water.

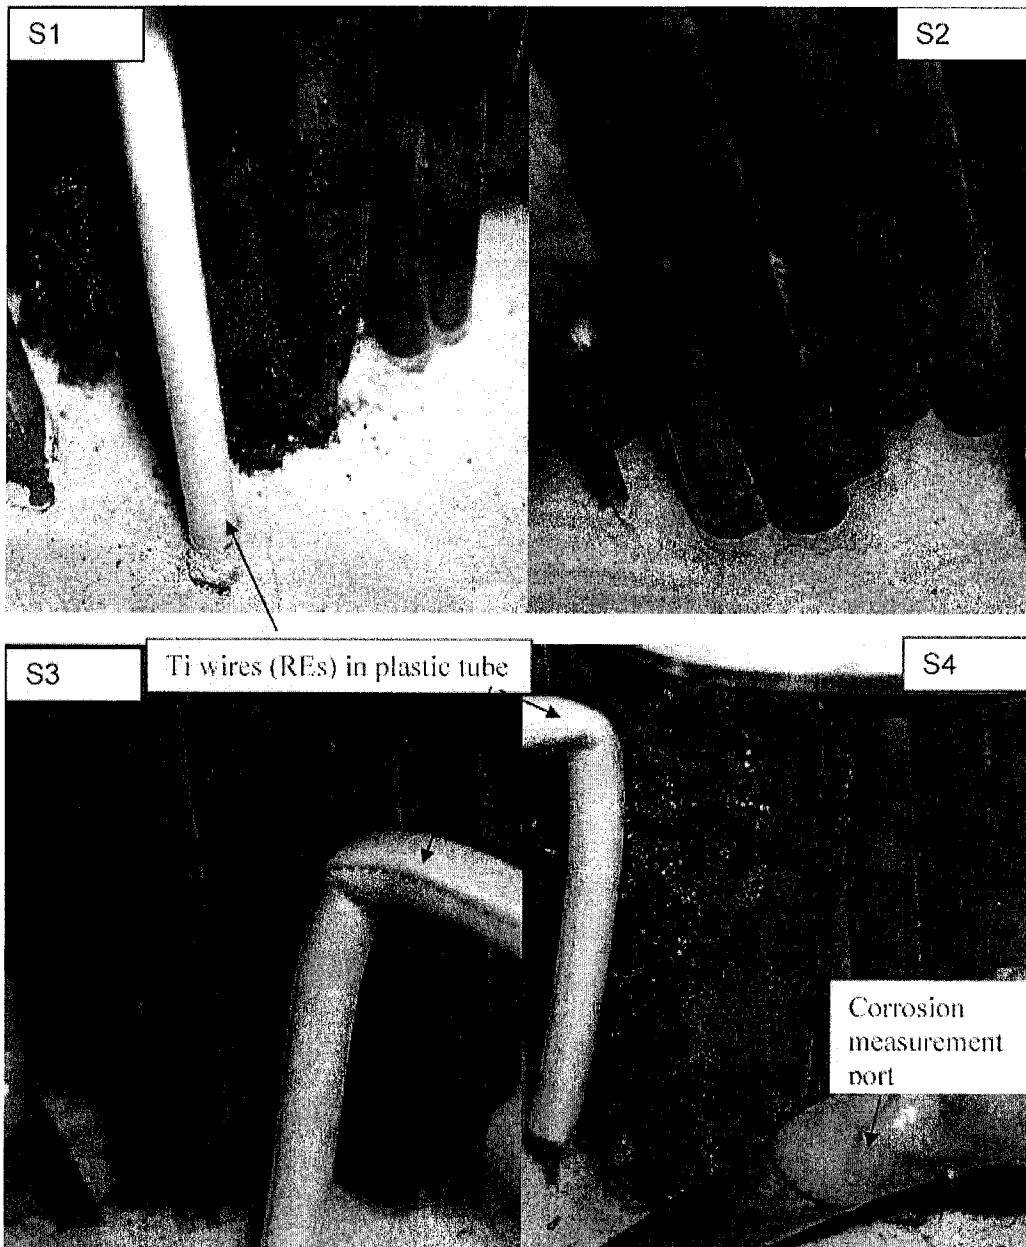
Figure 5. Corrosion On PT Strands In S Series Assemblies (Day 272)

Figure 5 shows the surface condition of strands in S assemblies at day 272. These (except for S2 which was a control with no recharge events) were exposed to fresh water events only. There was nevertheless severe air space corrosion at some spots, as well as corrosion attack at the grout/void interface, although not as severe as in the P assemblies. Control assembly S2 showed no signs of corrosion.

(S1, S3, and S4 showed corrosion attack at the grout/void interface;
S2 showed almost no corrosion attack.)

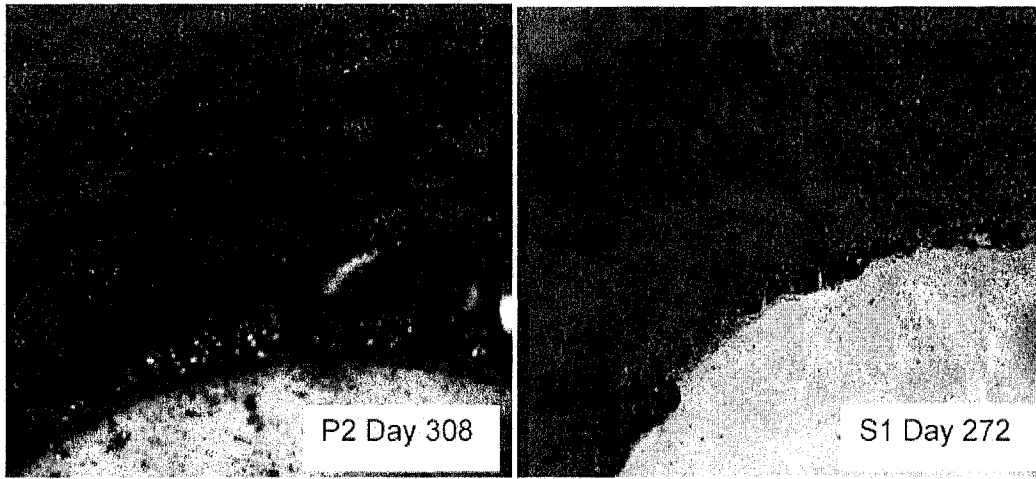
Figure 6 Corrosion On Anchor Body

Figure 6 illustrates the surface condition of the anchor body ductile iron in P2 and S1 after respective water recharges, showing severe water line corrosion in both. There was some air space corrosion in the P assembly but much less in the S assembly. This may reflect the combined effect of a wider grout-anchor interstice in the S assembly, allowing for faster water drainage, and to lower internal relative humidity (~80%) from self-desiccation of the S grout (RH results to be published elsewhere).

a: severe water line corrosion in P assembly after 0.01N NaCl recharge,
 b: water line corrosion attack in S assembly after fresh water recharge.

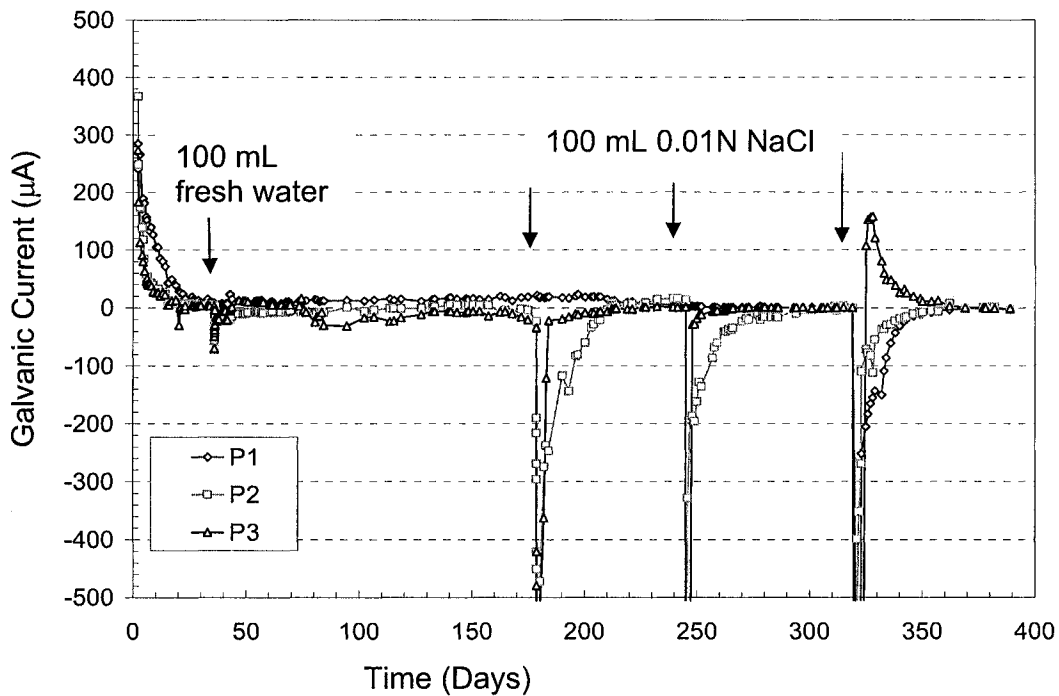
Figure 7 Galvanic Current Between Anchor And Strands In P Series Assemblies

Figure 7 shows the anchor/strands galvanic current in the P series assemblies. The arrows indicate water recharge events per Table 3. Positive values denote net anode character for the strands. These were initially strongly anodic (current ~ 500 μ A) immediately following initial interconnection, but the current dropped to <10 μ A after a few days-weeks likely reflecting maturing passivity of the assembly in the alkaline grout environment.

The first recharge (fresh water, all three P assemblies) caused only small transient changes in galvanic current. Visual inspection shortly afterwards showed no rust on the strands at the grout/void interface. Galvanic current was small in the following 4-month waiting period. Addition of NaCl-spiked recharge water into P2 and P3 at days 179 and 245 caused sharp transient increases (to 1000 μA) in macrocell current, but with the strands acting as net cathodes. However, in the next salt water recharge event (day 320, all three assemblies) the strands in P3 became anodic and slight yellow or brown rusting was noticed on those strands at the grout/void interface. Visual inspection showed that a tiny water pool existed there as late as 4 days after the event, possibly contributing to the observed corrosion of those strands. It should be noted however that the pH of recharge water (whether fresh or salty) temporarily remaining on top of the grout after wetting events was ~ 13 . The strand-anchorage body conductance evolution in the P assemblies is shown in Figure 8. Each water recharge event was accompanied by an increase in conductance which dissipated after some time, roughly paralleling the length of time recharge water remained visible on the grout surface (see Table 3).

(arrows present the water recharge events listed in the test matrix; negative current sign indicates that strands serve as the cathodes)

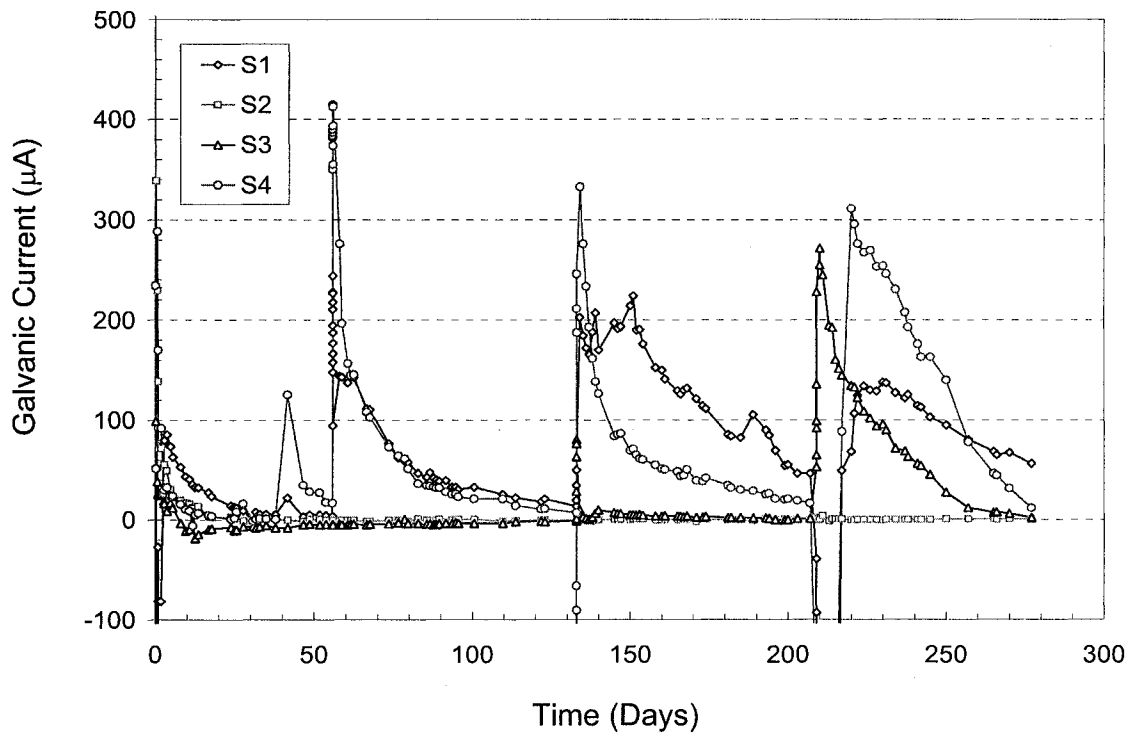
Figure 9 Galvanic Current Between Anchor And Strands In S Series Assemblies
 (arrows present the water recharge events listed in the test matrix; Positive current sign indicates that strands serve as the anodes)

Figure 9 shows the galvanic current trends in the S series assemblies. Unlike in the P assemblies, fresh water in the S assemblies triggered strong macrocell action (in agreement with the visual observations), and the strands behaved consistently as net anodes. This difference is partly explained by the greater chloride content in the S grout (500 ppm, Table 1) compared that in the P grout (80 ppm). Despite the relatively high native chloride content, recharge water was still needed to support corrosion at the grout/void interface, as evidenced by the rust free condition of that zone in Assembly S2 which was kept without external water contamination. On the other hand, even a small amount of fresh water (e.g. 10 ml in S3 at day 209) was enough to support significant strand corrosion. Conductance trends in the S assemblies (Figure 10) resembled those in the P assemblies, but with typical conductance values about one order of magnitude lower.

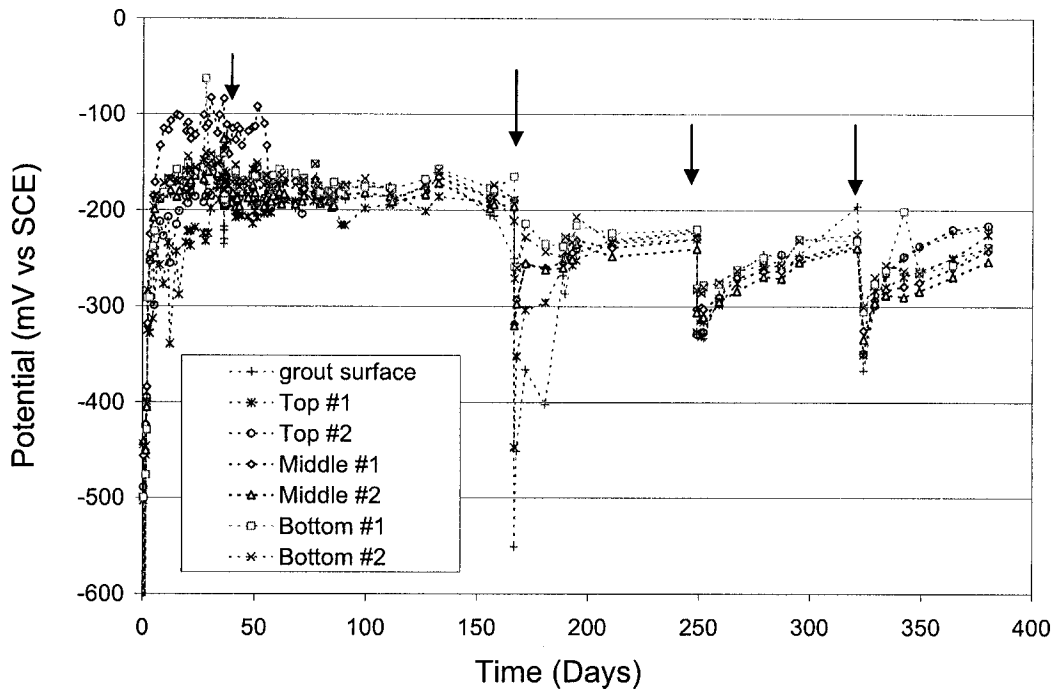
Figure 11 Potential Change Of The Anchor-Strands System With Time For P2 Assembly (arrows present the water recharge events listed in the test matrix; locations for potential readings measured at top, middle and bottom was listed as 5-1,2,3 in Figure 1)

Figures 11 and 12 show representative potential trends of the interconnected strands-anchor system, using assemblies P2 and S1 as examples. Comparable trends were observed in the replicate assemblies. The potential trends correlate well with those of the galvanic currents and suggest the presence of activation-passivation cycles linked to each recharge event. Spatial resolution is provided by measurements at ports at the various levels (Figure 1). Figure 11 shows that the first fresh water addition to P2 caused no large change on potentials (all remaining at ~ -200 mV vs SCE) at either the top, middle, and bottom locations. This is indicative of passive behavior at all levels, unaffected by the fresh water addition, and in agreement with the macrocell current behavior noted above. However, recharge with the salty solution caused instantaneous excursions to much more negative potentials, indicative of depassivation and consistent with the macrocell current increase. The potential excursions at the upper levels (by the grout-void interface) were larger, in agreement with the externally observed locus of corrosion. Comparable trends are seen in Figure 12 for assembly S1. However, in this case the potentials at the top and grout surface locations gradually increased to above -200 mV as repassivation followed a recharge event, but the potential readings at the middle and bottom locations did not completely recover to about -200 mV before next water recharge event. This suggests that some corrosion might extend to regions far below the main grout/void interface.

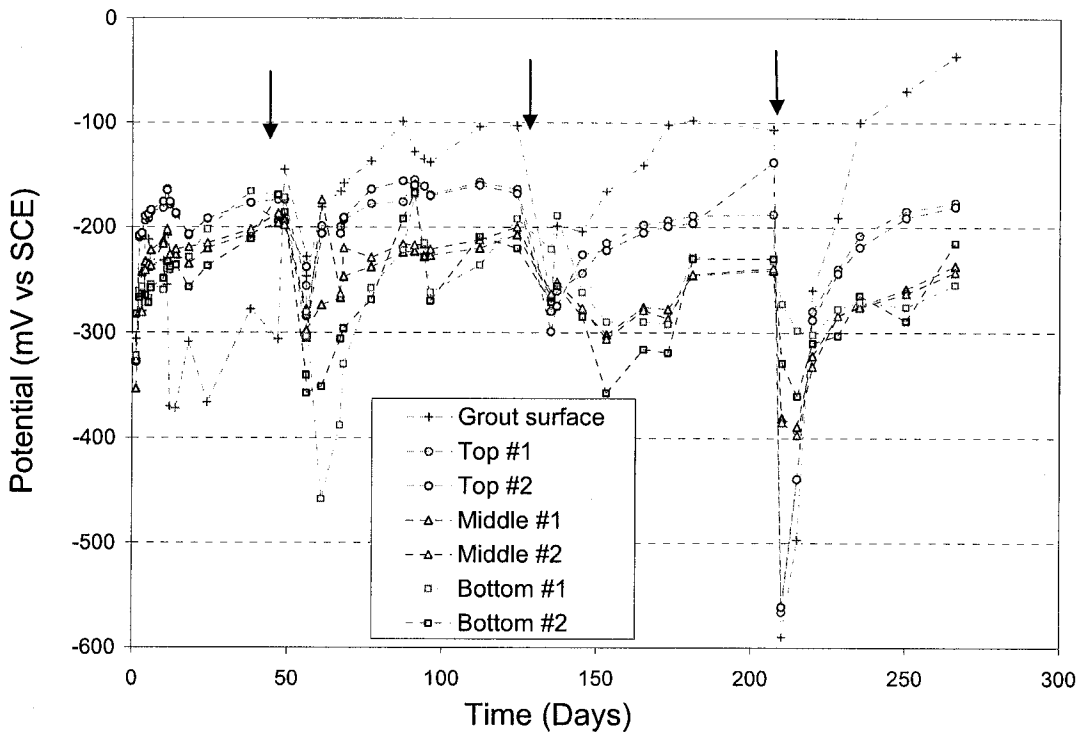
Figure 12 Potential Change Of The Anchor-Strands System With Time For S1 Assembly (arrows present the water recharge events listed in the table 3; locations for potential readings measured at the top, middle and bottom was listed as 5-1,2,3 in Figure 1)

Inter-strand and grout-anchor voids: Recharge fresh water trapped in inter-strand voids (observed only in the S assemblies) appeared to have extended corrosion of the strands to those inter-strand voids locations, as suggested by the potential differences between top and middle/bottom port readings noted above (Figure 12). This would not be surprising, as these interstices were likely efficiently exposed to external air during dry periods and the depassivation mechanism considered above for the main grout/void interface would apply equally. Corrosion of the anchorage at grout-anchor interstices would be suggested as well by the same potential observations and mechanism.

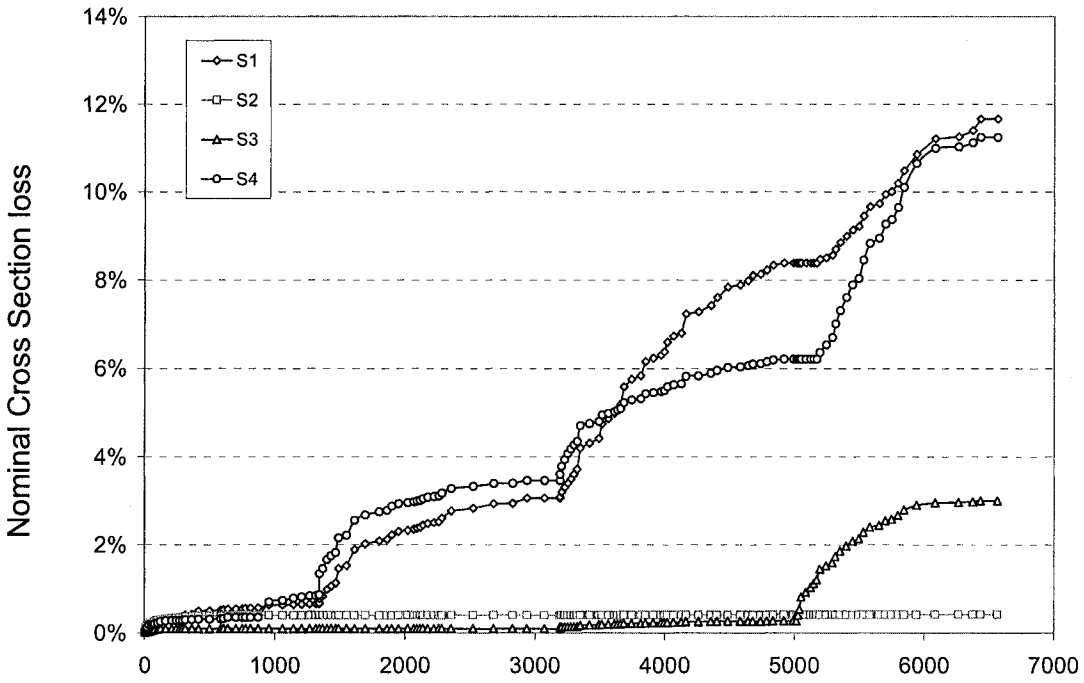
Figure 14 Nominal Cross Section Loss of A Single Strand

Attempts at corrosion rate measurements using polarization methods will be reported elsewhere. At present however, a working assumption was made that the total strand corrosion current is in the order of the anodic galvanic current measured. This assumption is not necessarily conservative, as local cell action is ignored, but preliminary experiments^[4] suggest that it may be sufficient to obtain a rough indication of the expected damage. Since the grout-void interface corrosion appeared to be limited to a small zone, it was further assumed that the corroded zone affected a 1 mm high band around the strand bundle perimeter (surface $\sim 2.5 \text{ cm}^2$). The metal loss was considered to affect equally each of the six strands in the perimeter, and the loss of any given strand was calculated as a simple percentage of its total 7-wire cross sectional area ($\sim 1.4 \text{ cm}^2$); detailed distribution among wires was not addressed. The results of this analysis are given in Figure 14 using the S assemblies as an example. The calculations project between $\sim 0.4\%$ and $\sim 12\%$ strand cross section loss after a period of 9 months with a few recharge events. As a normally stressed strand could easily fail after 30% cross section loss by pit-like corrosion^[4], fractures could take place after as little as ~ 2 years under these conditions (Table 3). These projections, albeit based only on rough assumptions, are consistent with other preliminary work^{1,4} and with the observation of tendon failures in the field as early as after 7 years of service.

(Assume that all metal loss is in a 1 mm high band around the strand bundle at air/grout interface and anodic galvanic current in Figure 9 equals to corrosion current)
