LONG-TERM CORROSION BEHAVIOR OF EPOXY COATED REBAR IN FLORIDA BRIDGES

Kingsley Lau and Alberto A. Sagüés
Dept. of Civil and Environmental Engineering, University of South Florida
4202 E. Fowler Ave. ENB118
Tampa, FL 33620

Rodney G. Powers
State Materials Office, Florida Department of Transportation
5007 NE 39th Ave.
Gainesville, FL 32609

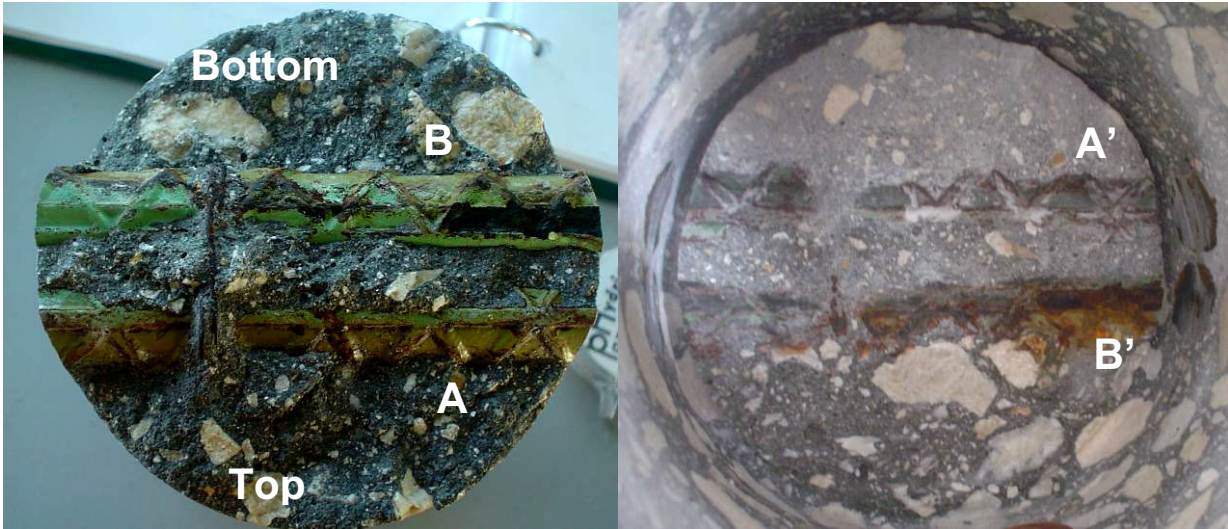
In Vaca Cut, two shafts were cored in five locations fully exposing ECR in three cores. Two of those cores were an on-crack and off-crack pair at the largest vertical crack, 46 cm AHT. The ECR both on- and off- the main crack showed extensive corrosion (Figure 1). Lesser but still significant corrosion distress was observed on samples from a core at 165 cm AHT. There, the distress was limited to small coating breaks of rusty appearance and to thin rust spots and discoloration on as much as 10% of the steel substrate observed after removal of the coating. ECR was fully exposed at four core locations in Snake Creek, including a low-elevation on- and off-crack pair that showed significant corrosion but not as severe as in Vaca Cut. Complete coating disbondment was observed on all ECR samples from both bridges.

Severe ECR corrosion and coating disbondment was observed at low elevations at the Vaca Cut Bridge and to a lesser extent in Snake Creek. The corrosion was sometimes associated with cracks. These cracks were not noticed in the investigation a decade earlier, and in one instance there was associated deeper cracking closer to the rebar. The findings suggest that the cracking was the result of expansive corrosion products, but the evidence is limited and at least some preexisting cracking cannot be completely ruled out at present. Corrosion was minor at higher elevations, consistent with lower chloride contents at the rebar depth there. At low elevations in those bridges chloride penetration was high, consistent with the high chloride diffusivities and permeability observed from the present cores and in earlier

Figure 1. Severe ECR corrosion observed at the Vaca Cut bridge. Drilled Shaft (VA2A) ~45 cm AHT on crack (0.33 mm). The location of ECR A and B corresponds to the position at the bottom of the core hole A' and B', respectively.

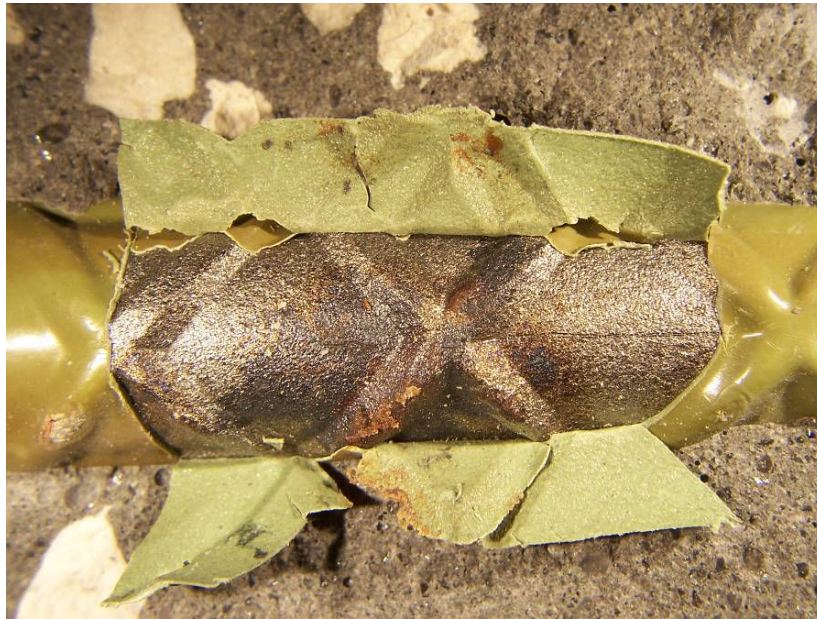
In the low elevation samples the coating could be easily separated from the substrate on the entire specimen surface, indicating complete coating disbondment. Backside coating contamination was typically observed on 1-2% of the peeled coating. Consistent with field observations, vestigial rusting was observed on the steel substrate exposed by coating breaks. The steel surface exposed after removing the coating was mostly bright metal with some discolored zones around the coating breaks. No preferential corrosion or coating disbondment was observed at the ECR zone intersected by a crack, compared to the rest of the rebar segment. In the cap beam coring, complete coating disbondment was observed on seven of the ten ECR samples, while failure of the coating upon knife peeling was mostly cohesive on the remaining three samples. Backside coating contamination in the disbonded samples and presence of rust and discoloration were comparable to those noted in the low elevation samples. No correlation was found between the presence or position of the crack and the extent or location of rusting or coating disbondment in the ECR segments.

In contrast with the category A bridges, corrosion at ECR in the Sunshine Skyway Bridge was limited to minor rusting at coating breaks and discoloration, usually nearby, underneath disbonded coating. The cracks under consideration were observed early on and did not result from corrosion. Although enhanced chloride penetration through cracks has been well documented⁹, the present results revealed no physical evidence of enhanced deterioration on ECR in cracked concrete at either the low elevations near the waterline or at the higher elevation cap beams. It is cautioned however that these results are preliminary. Sampling to obtain a greater population of ECR segments in cracked concrete exposed to sea splash, where conditions are most severe, is in progress and results will be presented subsequently. The findings to date are consistent with earlier model predictions that did not anticipate early corrosion development in this structure, based on the high concrete quality and the thick concrete cover used.

Figure 6. Typical steel and undercoating condition in disbonded ECR extracted from Sunshine Skyway Bridge, showing minor rust at coating breaks, and nearby discoloration of the metal surface. Trestle cap beam, 7.5 m AHT (SSK140E2).
