CORROSION OF EPOXY COATED REBAR IN CRACKED MARINE SUBSTRUCTURE CONCRETE

Kingsley Lau and Alberto A. Sagüés
Dept. of Civil and Environmental Engineering, University of South Florida
4202 E. Fowler Ave. ENB118, Tampa, FL 33620

Rodney G. Powers
State Materials Office, Florida Department of Transportation
5007 NE 39th Avenue, Gainesville, FL 32609

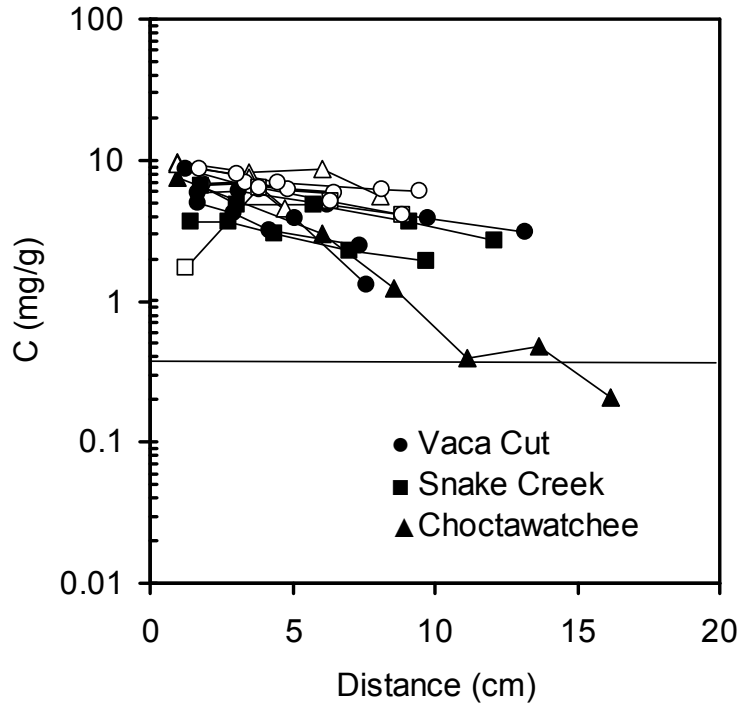
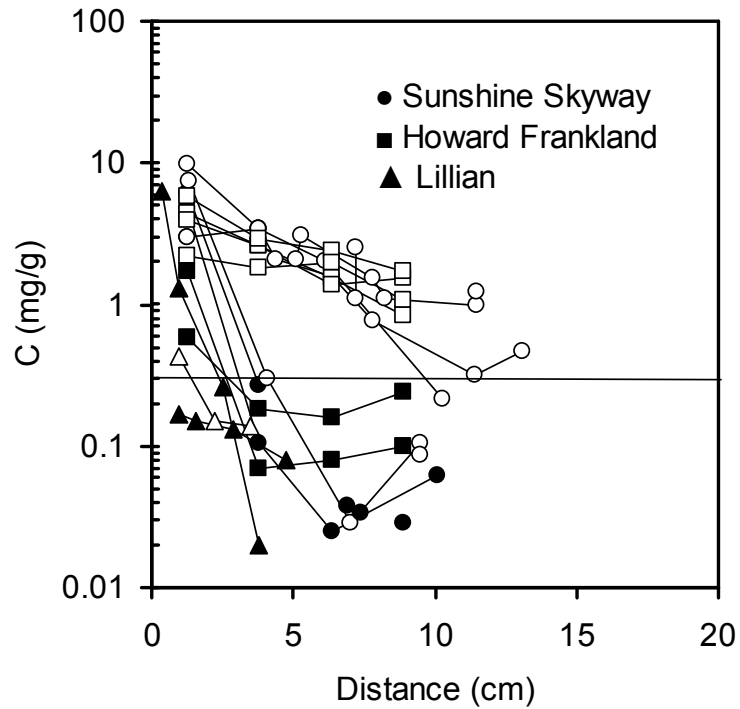
Vaca Cut and Snake Creek Bridges. Results from these bridges are detailed in the previous paper⁹. Evaluation showed severe ECR corrosion and coating disbondment at low elevations at the Vaca Cut Bridge, and to a lesser extent in Snake Creek. Chloride profiles are shown in Figure 1 for samples evaluated to date. Chloride concentrations greater than typically assumed conservative chloride threshold values were amply exceeded in most cases at reinforcement depth. Any evidence of preferential chloride penetration through cracks was obscured due to the high chloride bulk diffusivity prevalent at the sea splash locations examined. In general, previous model predictions^{1,8} of corrosion development at ECR in these bridges by the time of the present study were confirmed by the examination.

Preferential chloride ion penetration through cracks in the Choctawatchee Bridge (similar to the other Category A bridges⁹) was overshadowed by fast bulk diffusion through the sound concrete at low elevation locations exposed to sea splash. Chloride concentrations at reinforcement depths (~4 inch (10.2 cm)) for sound and cracked concrete locations were larger than the commonly assumed 1.2 lb/yd³ (0.7 kg/m³) conservative chloride ion threshold value. The average chloride ion diffusivity for sound concrete from the Choctawatchee Bridge was lower than that measured in an earlier investigation¹ but it was within the range of calculated diffusivities from the same investigation. Nevertheless, a high value was still calculated (0.09 in²/yr (1.8x10⁻⁸ cm²/s)).

Distinct preferential chloride penetration at cracks was observed in this bridge (Figure 1), similar to that noted for the Sunshine Skyway Bridge, at elevations exposed to sea splash. Chloride ion concentration at the ~4 inch (10 cm) reinforcement depth for cracked concrete was greater than commonly assumed conservative threshold values (1.2 lb/yd^3 (0.7 kg/m^3)). Much lower chloride levels were measured at bar depth in adjacent sound concrete, consistent with the low chloride bulk diffusivity ($0.036 \text{ in}^2/\text{yr}$ ($\sim 7 \times 10^{-9} \text{ cm}^2/\text{s}$)) determined for this low permeability concrete.

Figure 1. Chloride Ion Penetration Profiles for Category A and B Bridges. Open symbol: Cracked concrete, Closed symbol: Sound concrete. Horizontal line: Conservative chloride corrosion threshold value (0.3 mg/g, equivalent to 1.2 lbs/yd³)

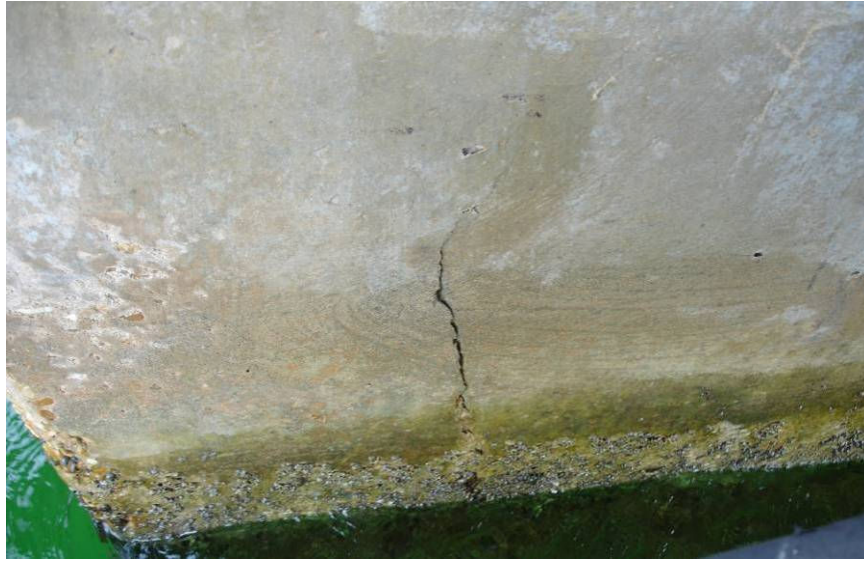
Choctawatchee Bridge. This is a newly evaluated Category A bridge and results are presented in detail. Two of 20 footers from the ten high elevation piers had cracks wider than 40 mils (1.0 mm) (Figure 2); ten of the footers had cracks larger than 9 mils (0.2 mm). Minor concrete cracking was typical on all of the footers. Vertical and map-type cracking was observed on one of 20 columns from the high elevation piers. Rust bleedout was observed on two columns and one strut. The origin of that bleedout was not confirmed as samples of reinforcement were not obtained, but corrosion of reinforcement may be possible.

Core samples were extracted from two footers each with one wide vertical crack (>40 mils and ~25 mils (1.0 and 0.63 mm) wide respectively). Approximately 4.5 ft^2 (0.42 m^2) and 1 ft^2 (0.1 m^2), respectively, of concrete around the crack locations seemed to be delaminated as determined by hammer sounding. Extensive corrosion of the reinforcing steel (Figure 3) was observed on both footers at elevations 3.5 to 7 inch (8.9 to 17.8 cm) above high tide level, both where the crack intersected steel and in adjacent sound concrete locations

Figure 2. Large crack, >40 mils (1 mm) (Bridge over East Pass-Choctawatchee Bay).

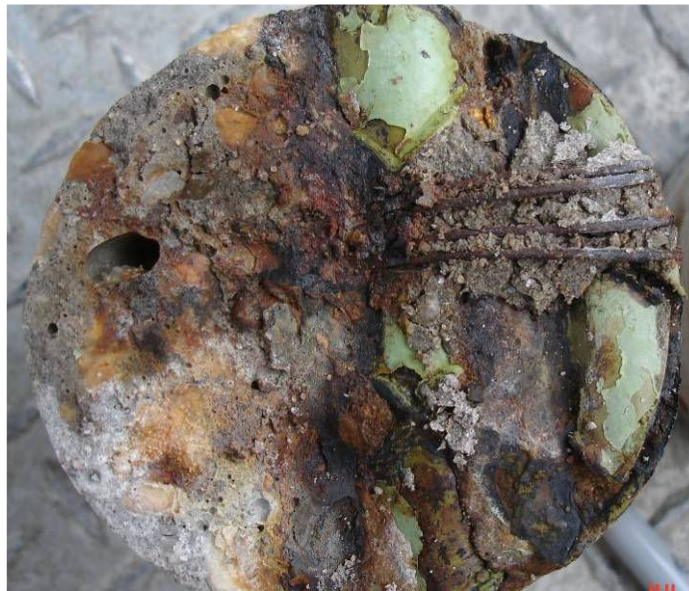
All seven ECR samples from Choctawatchee (sound and cracked concrete locations) showed significant loss of coating adhesion and severe corrosion of the steel bar.

Figure 3. Extensive reinforcement corrosion. (Bridge over East Pass-Choctawatchee Bay Pier 29, North footer).

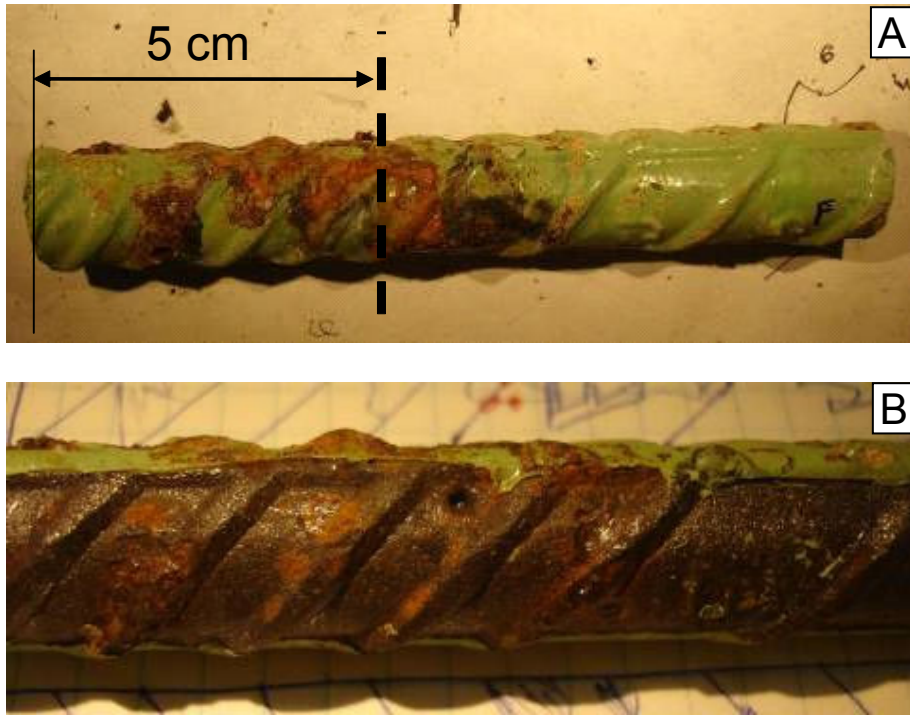
The corrosion observed on the four ECR samples extracted from cracked locations from this bridge merits note. The crack plane was usually perpendicular to the rebar. Corrosion products were generally observed around locations with coating defects, especially near the intersection of the crack plane with the rebar. Upon removal of the coating (which was found to be fully disbonded) the underlying surface was relatively dry, with dark corrosion product regions. Exploration with a sharp knife tip at the dark region pried out some of the products, revealing pit-like features as shown in Figure 4. Sectioning of the bar with a thin diamond blade and water-free lubrication was performed at a pit-like location, with subsequent metallographic mounting of the section. The cross section (Figure 5) revealed that corrosion had affected a region much wider than the pit-like feature, having proceeded in relatively uniform fashion within the region to as much as ~1 mm deep. Except for some surface reddening, the corrosion products in that region were dense and dark-gray, suggesting a low oxidation state. As the knife tip scratched that material away with some difficulty, exploring with the tip (creating initially only a small crater) had given the appearance of clearing away corrosion products from a pit, but in reality corrosion had proceeded along a more uniform front. The corrosion product-base metal interface was examined at higher magnification revealing upon etching a ferrite-pearlite grain structure that extended, with no indication of microstructural alteration, all the way up to the corrosion penetration front where it was being consumed. Representative features are shown in Figure 6. This observation nearly rules out ascribing the observed features to causes alternative to corrosion, for example the presence of an isolated defect in the form of trapped slag or mill scale during rolling, since such condition would have been manifested by microstructural changes near the interface. Metallographic sections of the other bar samples from crack locations revealed corrosion penetration of depth and morphology similar to the one shown, always near the region of intersection of the rebar with the crack. Exposure of the metallographic sections to laboratory air resulted in slow reddening of initially dark products, as seen in Figure 5, suggesting that the corrosion product was evolving toward a higher iron oxidation state. No indications of severe corrosion were externally observed or revealed metallographically, on ECR from the peer cores on the sound concrete location next to the cracks.

Figure 4. ECR corrosion at crack location (Howard Frankland Bridge) A. Corrosion products on bar surface. The line represents the location of the crack intersection. B. Appearance after partially removing the coating and exploring into the corrosion products.

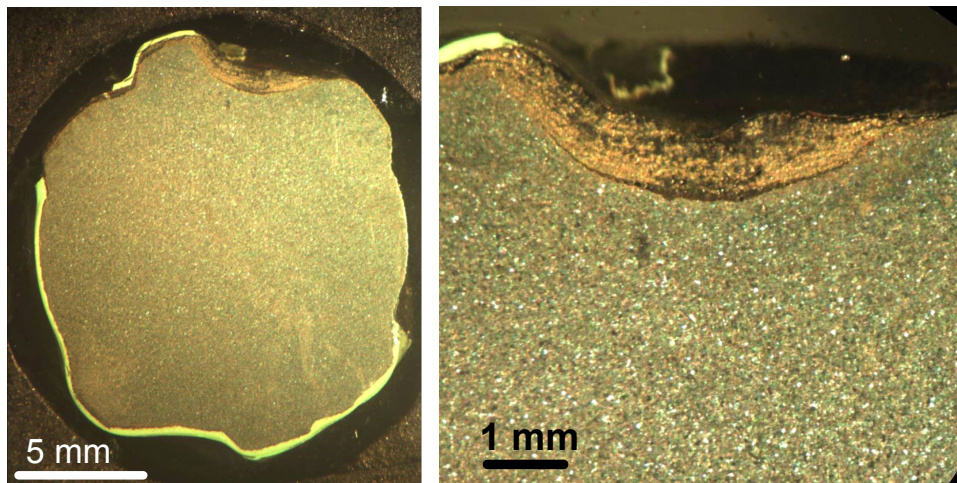
Figure 5. Cross section of ECR bar showing severe corrosion at a crack location of Howard Frankland Bridge. Left: Entire Bar cross-section. Right: Close up of corrosion penetration.

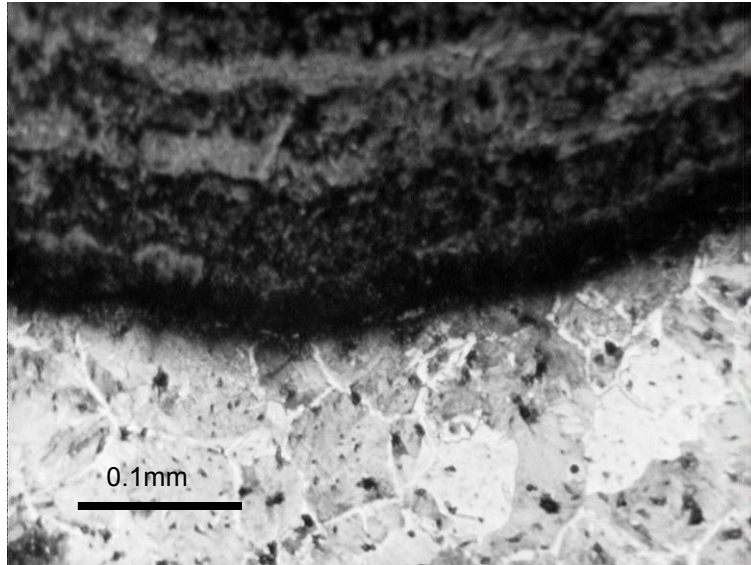
Figure 6. Corrosion product - base metal interface showing progression of corrosion into the microstructure of the rebar steel (Howard Frankland Bridge).
