EFFECT OF CONCRETE ENVIRONMENT ON THE CORROSION PERFORMANCE OF EPOXY-COATED REINFORCING STEEL

A.A. Sagiúes
Department of Civil Engineering and Mechanics
University of South Florida
Tampa, Florida 33620

R.G. Powers
Materials Office
Florida Department of Transportation
Gainesville, Florida 32602

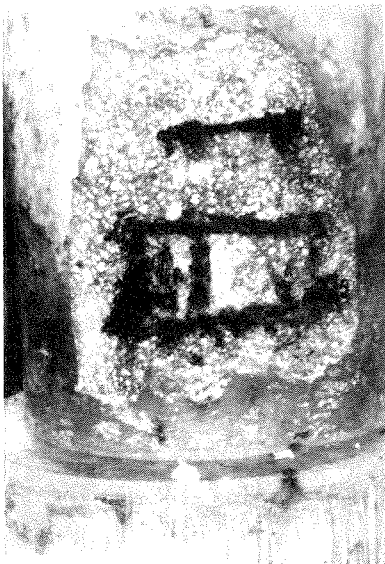
the time corrosion was first observed. The damage, illustrated in Figure 1, affects approximately 1/3 of the bents in three major bridges in the area (Seven Mile Bridge, Long Key Bridge and the Niles Channel Bridge). The locations affected had an average of 2 inches (50 mm) of concrete cover over the rebar. Both fabricated and straight rebars show corrosion, typically in the region extending from 2 to 6 feet (0.6 to 1.8 m) above the high water line. Advanced stages of damage involve severe pitting (Figure 2), and accumulation of corrosion products between the epoxy and remaining metal as well as corrosion products in direct contact with the concrete. A chloride-rich liquid (pH typically 5.5) is observed frequently in freshly exposed rebar between the epoxy and the steel, even when the surrounding concrete was relatively dry (see Figure 3). Soundings under these conditions reveal extensive delamination of the concrete, which can be easily removed with a hammer. In the areas of severe corrosion, the coating was completely disbonded from the rest of the bar. Examination by a major epoxy powder supplier did not reveal any abnormal product characteristics.

FIGURE 1 - General appearance of corrosion in a bridge column using epoxy-coated reinforcing steel.

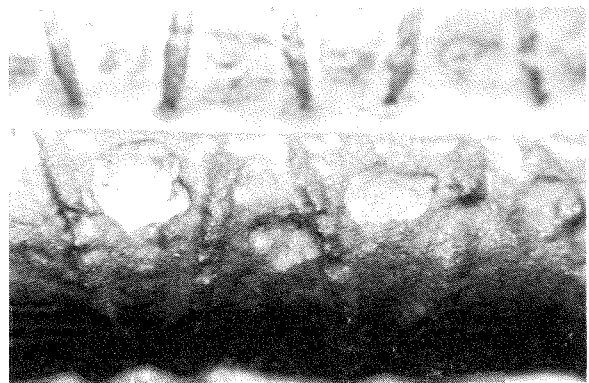
FIGURE 2 - Appearance of a #5 reinforcing bar (horizontal hoop portion of a bridge substructure column) after sandblasting.

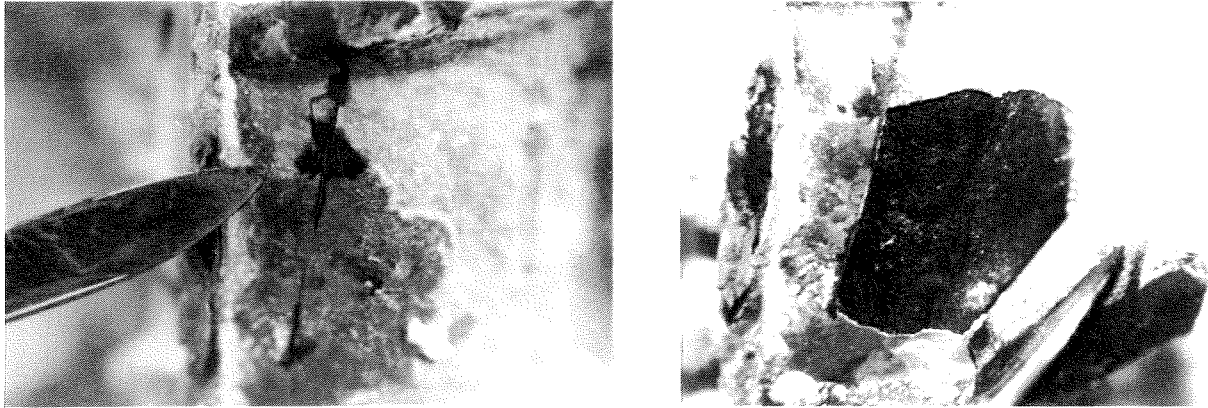
FIGURE 3 - Left: Knife incision on a corroding vertical #8 rebar just after removing the concrete cover, showing liquid flowing out of the cut; the surrounding concrete was not wet. Right: The same area after separating the coating.

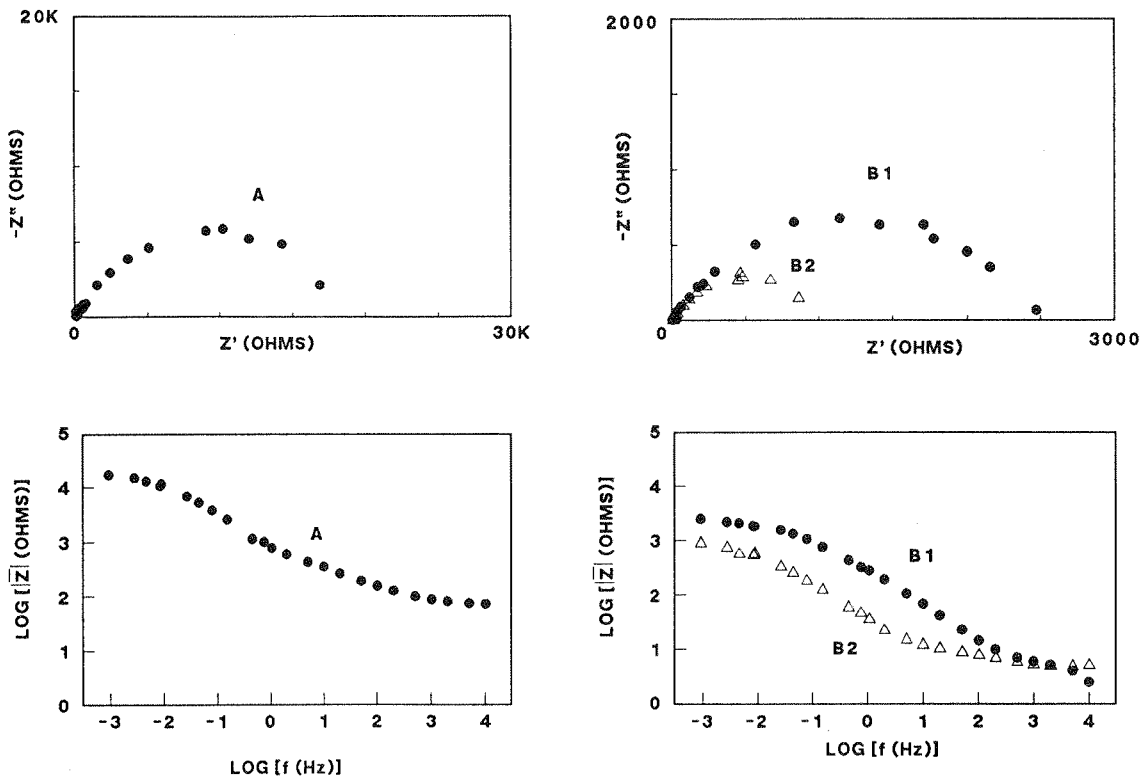
FIGURE 7 - EIS behavior of specimens in the sodium chloride solution (Type II).
 A) Material in the as-received condition, one month of exposure.
 B) Material with intentional surface damage; B1:one week; B2:one month of exposure.

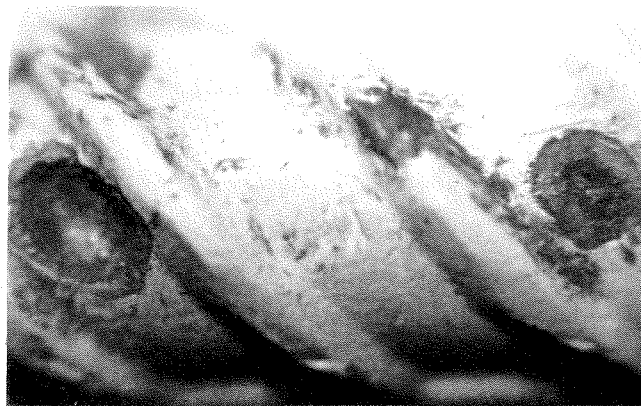
At -400 mV (intentionally damaged coating only tested) conspicuous external corrosion products were seen at all the damaged spots and also at some preexisting, small holidays. The corrosion crests resembled red and black tubercles. Underneath the coating imperfection circular corrosion pits, as large as 6 mm in diameter were present (see Figure 8). The pits were filled with pasty, black corrosion products. Around the pits and at the smaller imperfections disbondment took place to a distance of 3 to 10 mm. The underlying metal was dark near the imperfection and bright further away. Clear liquid with a pH between 4 and 5 was present in the disbonded region and liquid-filled blisters had formed at places.

FIGURE 8 - Appearance of the surface after removing disbonded coating from a specimen exposed to Solution Type III (calcium hydroxide plus sodium chloride) for one month at -400 mV vs SCE.
