CORROSION OF POST-TENSIONED TENDONS IN FLORIDA BRIDGES

Abstract

Severe corrosion distress and failures in post-tensioned tendons has been found in two major bridges in the State of Florida. Corrosion distress and complete tendon failure has been identified in horizontally oriented tendons that support pre-cast bridge superstructure box segments. In virtually all instances, the observed corrosion has been associated with the presence of grout voids and visual evidence of grout bleed water having been present for indeterminate periods of time. With few exceptions, corrosion induced strand failures have occurred in the immediate vicinity of the anchorage. The anchorage systems in both bridges utilize a proprietary multi-plane anchorage (housing) comprised of ductile cast iron and forged steel wedge plate. The presence of these metals coupled with high strength strands gives rise to concerns relative to galvanic corrosion thus prompting this preliminary investigation focusing on dissimilar metals corrosion. The investigation involves laboratory tests that examine the corrosion aspects of grout bleed water and re-charge water in contact with dissimilar metals comprising the tendon and

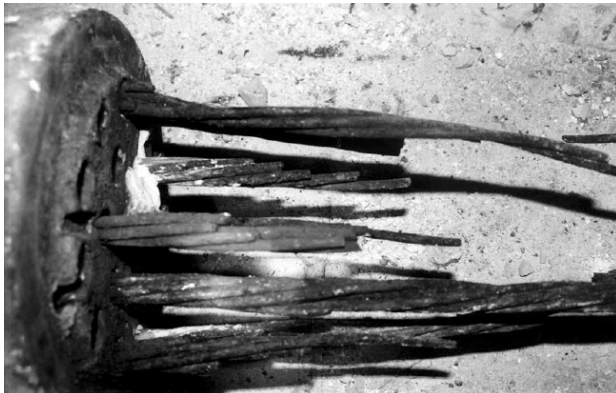
Corrosion of post-tensioned strands has been identified in two Florida Bridges. The first reported incident was at the Niles Channel Bridge (NC) in the Florida Keys (Powers 1999) followed by Mid Bay Bridge (MBB) in the Western panhandle (Corven, 2000). The superstructure of both bridges utilizes non-bonded (external) tendons arranged in a configuration such that the center lengths of the tendons are draped downward from the anchorages through deviation blocks along the length of the spans (Figure 1). The anchorage assembly is depicted in Figure 2. In both structures, the tendons failed in the anchorage region (Figure 3).

Figure 3 – Failed tendon-Niles Channel Bridge (June, 1999).

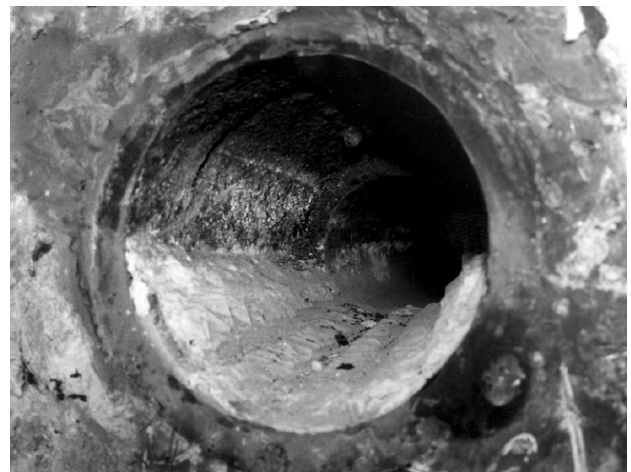
Figure 4 – Anchor at failed tendon showing chalky grout, partial grout filling and heavy corrosion.

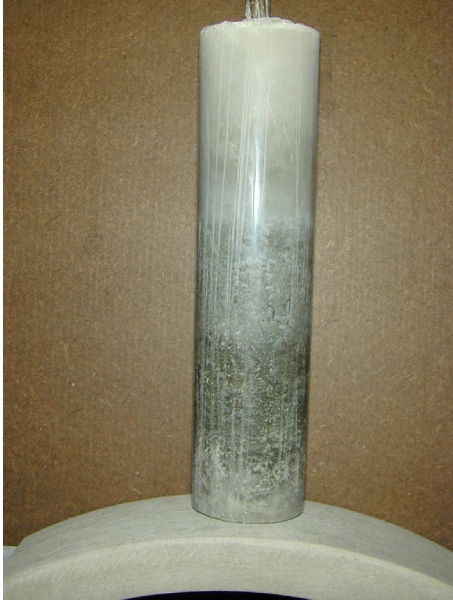
Standard Grout Tests: In these standard tests (Figure 7) grout shrinkage is characterized by the loss of grout volume due to water loss (grout bleed-water) during the plastic phase. Results of these tests showed grout shrinkage and bleed-water volumes to be within expected parameters for the aluminum admixed specimen, and the non-admixed control specimen. However, when these materials were exposed to low amplitude vibration as previously described, the volume of bleed water increased dramatically. The non-vibrated control specimen developed 1.81% bleed-water, and the vibrated specimen developed 6.2% bleed-water. Comparatively, the aluminum admixed specimens developed 1.94% bleed-water (non-vibrated) and 10.2% bleed-water (vibrated) with a correspondingly equal loss of grout volume. Visual examination of the test specimens (except for the vibrated, aluminum-admixed specimen) showed the grout to be of relatively uniform consolidation and coloration throughout. Comparatively, the aluminum admixed specimen showed wide variations in coloration (Figure 8) along its length. The lower portion of the specimen was dark and dense in appearance but with increasing height, the grout was increasingly lighter in coloration until finally at the uppermost portion of the specimen (~1cm) the grout was near white in color and chalky in texture (Figure 9). The pH of the grout at the top of the specimen was determined to be 8.7 (+/- 0.5). The pH of the grout near the bottom of the specimen was $> \sim 12$.

Figure 8 – Photograph depicting increasing chalkiness toward the top of the aluminum admixed grout (vibrated).

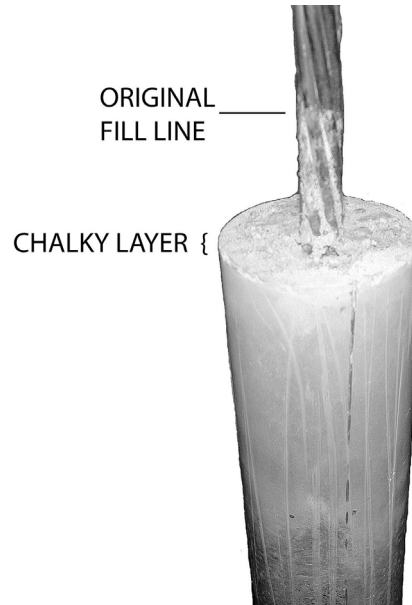
Figure 9 – Close-up photograph depicting large grout volume loss and heavy chalk development in the aluminum admixed grout (vibrated).

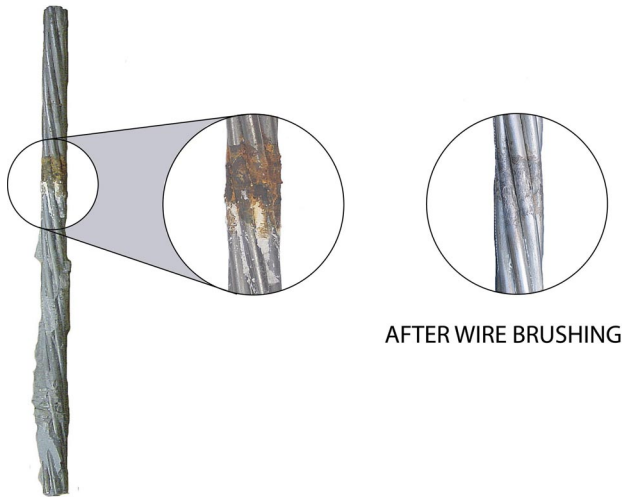
Condition of the Strands: The surfaces of the strands in contact with the grout were found to be unaffected during the experiment except for the area beginning approximately 2.5cm below the top of the grout and 2cm above the top of the grout. The area beginning approximately 2cm above the top of the grout and extending downward to approximately 1cm below the grout had heavy deposits of red to dark brown colored corrosion products (Figure 11). Extensive corrosion pitting was noted on the wire surfaces in the area coinciding with ~0.5cm above and below the top of the grout. The grout immediately adjacent to the strands in the zone beginning at the top of the grout and extending downward approximately 3cm was soft and chalky and the pH was

Figure 11 – Typical appearance of the strand upon removal from the mock-up.

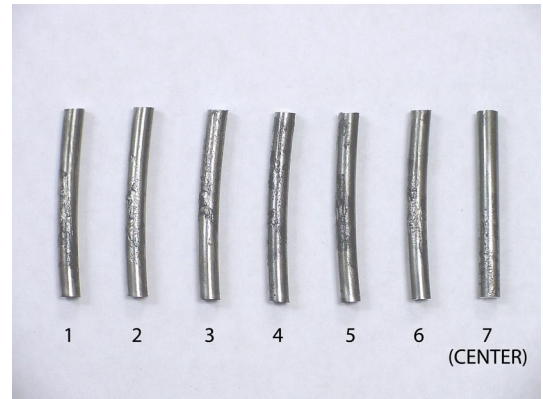
Corrosion of the strands (penetration depth as much as ~7% of a wire diameter) was severe in view of the relatively short duration of the tests and the low tolerance of a loaded system to localized reductions in cross section (Stauder 1998, Vermaas 2001). The corrosion morphology of the strands (Figure 12) is consistent with that of shallow pitting, constrained to a small region by local acidification from hydrolysis of ejected metal cations (Jones 1996), and protection of the surrounding region by local potential depression (Pedferri 1996). An order-of-magnitude estimate of the total amount of corrosion in the strands can be made by assuming that each outer strand wire had an equivalent integrated pitted area $\sim 10 \text{ mm}^2$ with a depth $\sim 0.23 \text{ mm}$ (average depth from Figure 13). For 6 corroding wires in the 7 strands this corresponds to a total metal loss of $\sim 100 \text{ mm}^3$, or an anodic charge of $\sim 2,600 \text{ C}$ if the steel corroded as Fe^{++} . This value may be contrasted with the integrated value over time of the anodic macrocell current data in Figure 10 (the longest recharge event), which yields $\sim 1,200 \text{ C}$. While the corrosion charge estimate is subject to considerable uncertainty, the similarity of the macrocell and corrosion charges suggests that galvanic coupling with the anchorage accounted for much of the metal loss at the strands. Nominal corrosion current estimates from polarization resistance tests (Table 1) are available for moist conditions only for instances when the strands were cathodic early in recharge events 4 and 5. Nevertheless, these results also illustrate cases where the macrocell currents ($304 \mu\text{A}$ and $136 \mu\text{A}$) were a significant fraction of the estimated local cell action at the strands ($749 \mu\text{A}$ and $875 \mu\text{A}$ respectively).

Figure 12 – Typical appearance of the corrosion pits on the strands near the top of the grout.

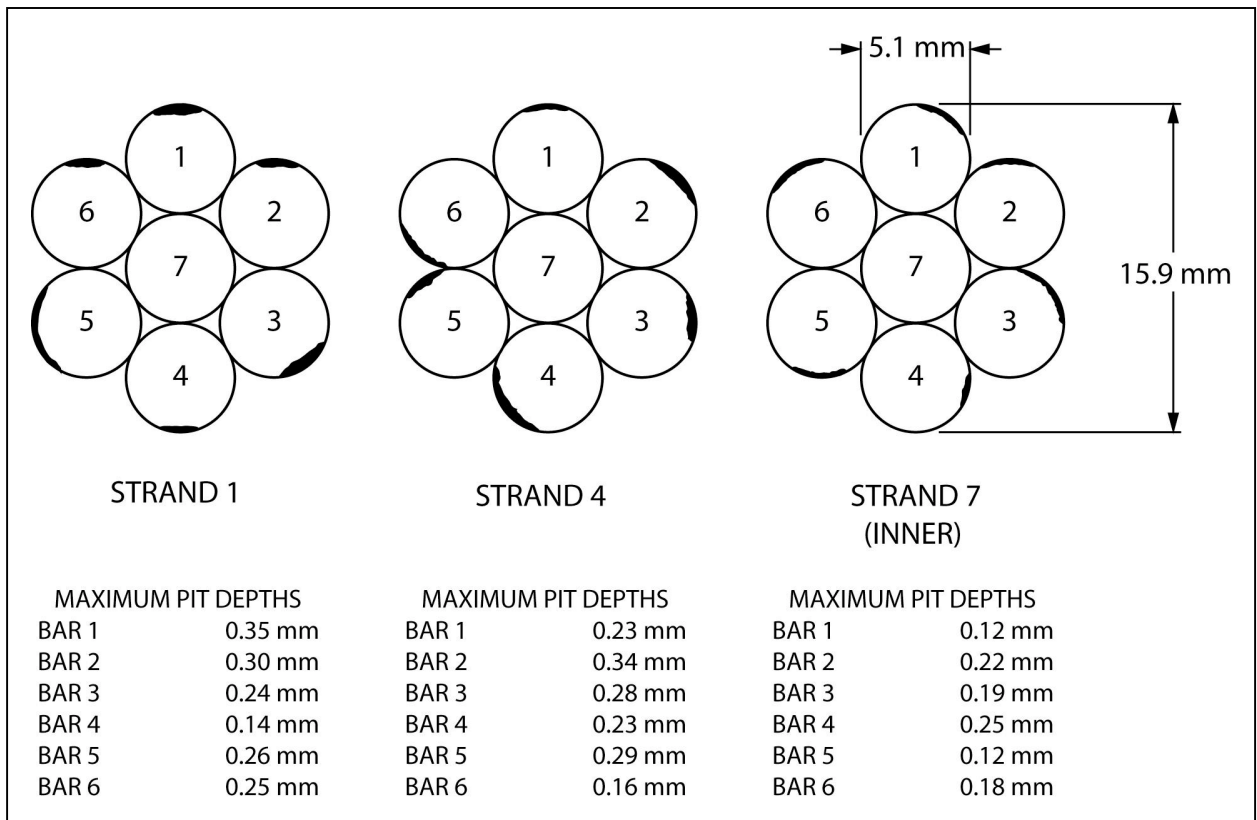
measured at 8.7 (+/-0.5). The individual wires of the three selected strands were separated for further examination. The previously mentioned corrosion pitting (near the top of the grout) was confined entirely to the outer surfaces of the individual wires. Although multiple pits existed along this ~1cm long affected zone, the area of heaviest attack was mostly centered at the area coinciding with the top of the grout. The typical appearance of the pitted areas is depicted in Figure 12, and a schematic representation of the maximum measured pit depth and relative sizes of the pits is presented (Figure 13) for each of the three strands examined.

Figure 13 – Schematic representation of the maximum observed corrosion pitting for each of the wires of the three selected strands.
