Engineering Failure Analysis

Failure analysis of the oil transport spiral welded pipe

The spiral welded pipe for oil transport failed catastrophically fracturing along the spiral welding line. The failure was in the base metal close to the heat-affected zone. Passive inclusions in the rolled metal are responsible for the pipe failure. Microstructure examination and Charpy-V notch tests reveal that the crack follows the oxide inclusions and is associated with their distribution, since the base metal toughness is insufficient to retard cracking. Improvement of the steel purity is suggested to prevent future pipe failures. Improving the welding technique to reduce the residual stress acting on the base metal also decreases the risk of pipe failure.

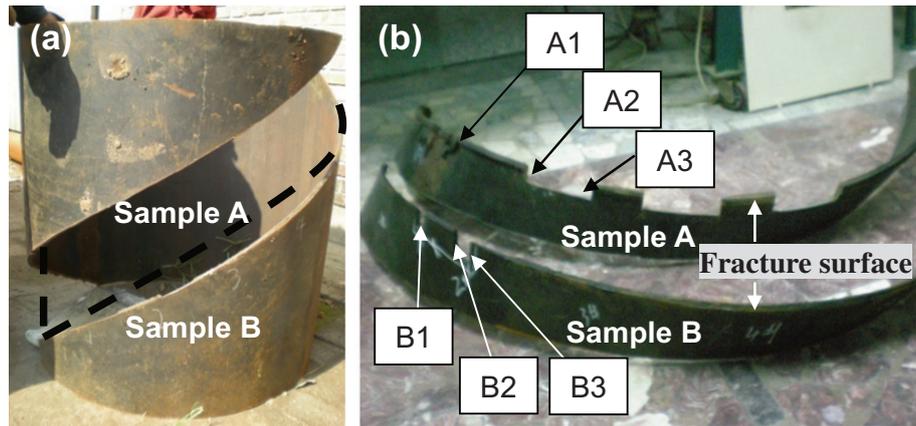
Spiral welded pipes are extensively used in the petroleum industry for oil and gas transport. They are made from a coiled hot-rolled steel strip with a single continuous helical weld from end to end [1,2]. This article describes examples of the spiral welded pipe failures. The spiral welded pipe for transporting oil was made from API 5L X52 steel. The pipe diameter is 720 mm with 8–10 mm wall thickness. The weld joint is a double V type. The outside and the inside welds were made by submerged arc welding with 60° welding angle. The pipe maximum working pressure is 3.8 MPa with 30–60 °C working temperature range. Although the working pressure never exceeded the maximum working pressure limitation, parts of the pipe broke catastrophically along the spiral weld (Fig. 1a).

Fig. 1. (a) Fractured spiral welded pipe as received; (b) locations of analyzed specimens.

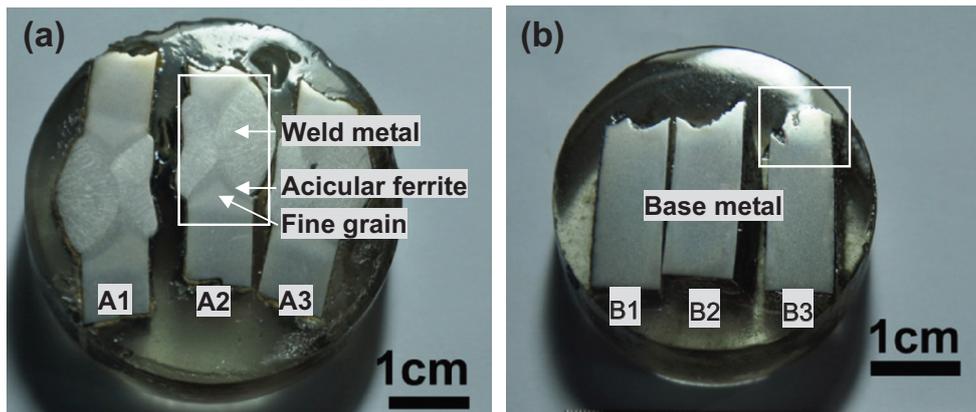
Visual inspection of the etched specimens revealed that the fracture did not occur at the welding zone, but at the heat affected zone, or base metal; thus the weld was left on one fracture side, as seen in Fig. 3a and b. The spiral welded pipe microstructure is divided in three zones: welded metal, heat-affected zone (surrounding the weld), and the base metal.

Fig. 3. Visual inspection of cross sections of fractured pipe after etching: (a) from sample A; (b) from sample B.

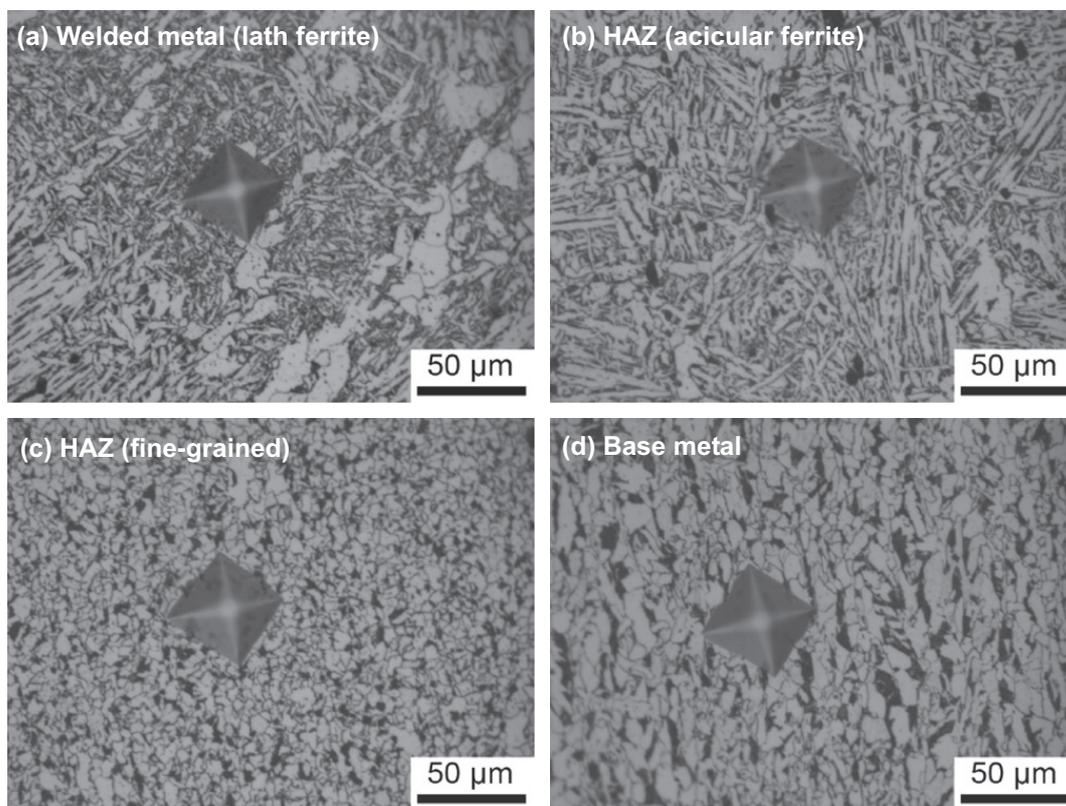
In order to investigate the weld metal and the base metal compatibility, their microstructures and hardness were compared. The weld metal microstructure is lath ferrite [4] (Fig. 4a), and next to it is the heat-affected zone (HAZ). Since the heating temperature and subsequent cooling rate vary with the distance to the heat source [4,5], the heat-affected zone contains two different structures: acicular ferrite and the fine grained zone, as presented in Fig. 4b and c. Base metal exhibits fiber texture, indicating that the base metal sheets were produced by rolling (Fig. 4d). The microhardness of the weld metal, acicular ferrite zone, is HV 200, while for the fine grained zone and base metal it is HV 170. Thus, plastic deformation compatibility between weld and base metals appears suitable.

Fig. 4. Optical micrographs of cross-sections and Vickers hardness indentation of: (a) welded metal zone, lath ferrite with HV 200 hardness; (b) heat-affected zone (HAZ), acicular ferrite with HV 200 hardness; (c) fine grain ferrite with HV 170 hardness; (d) base metal with fiber texture and hardness similar to the fine-grained zone (HV 170).

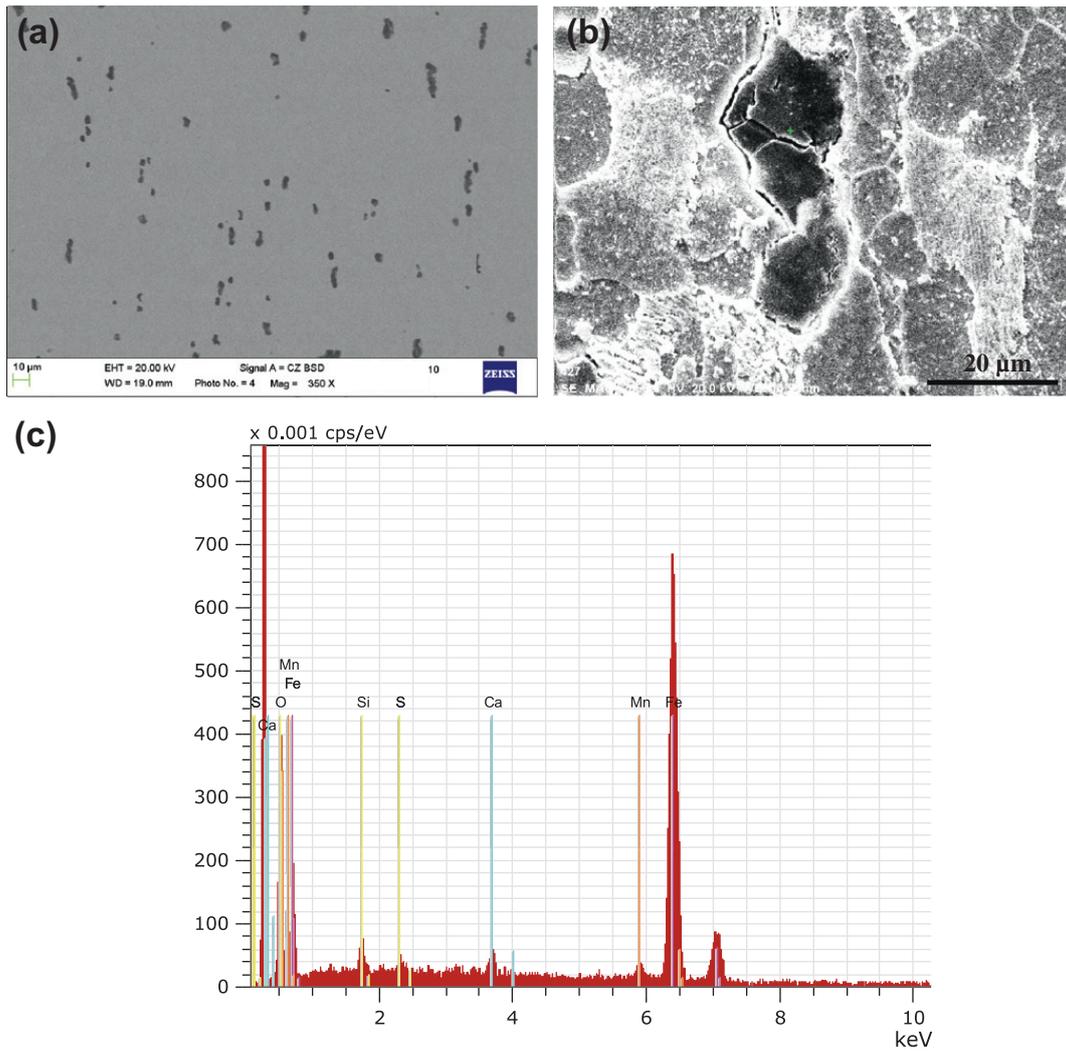
However, it was found that the base metal has low purity. Fig. 5a shows passive inclusions distributed in the base metal. A crack has nucleated at the matrix-inclusion interface (Fig. 5b). In addition, analysis by energy dispersive spectroscopy (EDS) revealed these inclusions to be iron oxide (Fig. 5b and Table 1). A number of studies [6–9] have been made on the effects of nonmetallic inclusions on the mechanical properties and fracture of alloys. Rosenfield [11] has published a thorough review of the mechanisms of initiation, growth, and coalescence of microcracks resulting from either inclusion-matrix interface separation or inclusion fracture during mechanical testing. It has been observed that the microcracks associated with inclusions can cause premature fracture and ductility. Therefore, the oxide inclusions presenting in the base metal would attribute to the pipe failure.

Fig. 5. (a) Distribution of inclusions in the fiber texture; (b) the oxide inclusion on the polished surface of the base metal of the pipe, (c) EDS spectrum of the oxide inclusion in (b) with, quantitative composition results shown in Table 1.

The improvement of steel purity may offer a solution to the fracture and subsequent failure of the pipe. Besides, improving the welding technique to reduce the residual stress acting on the base metal, may also decrease the risk of pipe cracking.

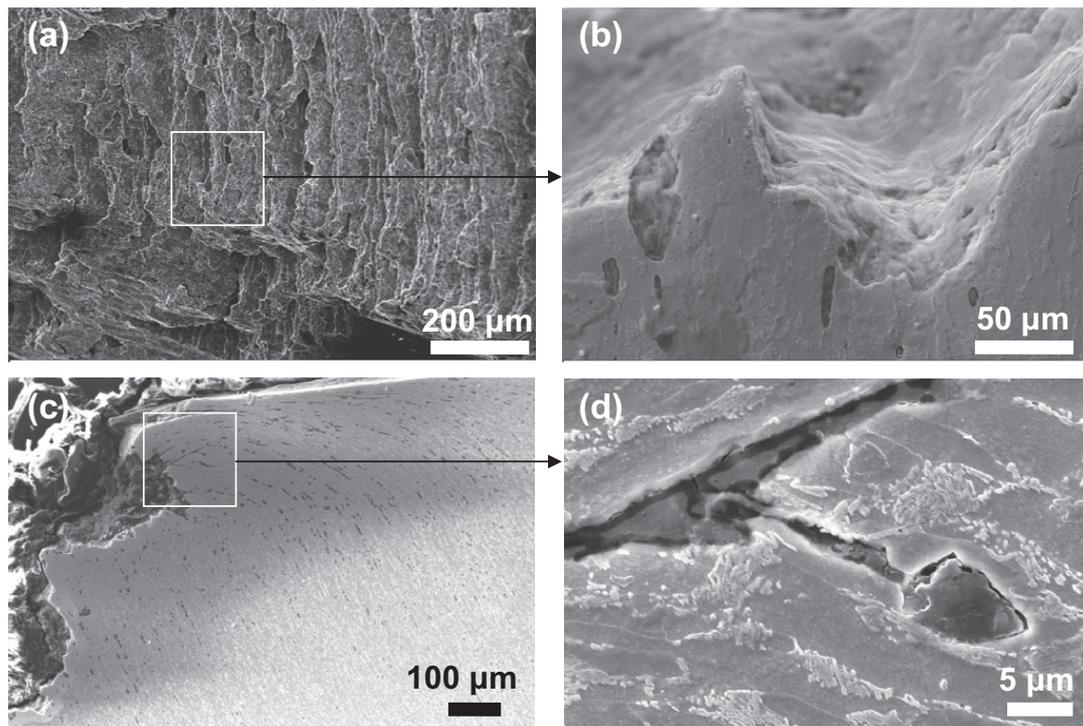
SEM micrographs of the failed pipe are presented in Fig. 6a and b. Lamellar and deep groove fracture topography was observed, associated with inclusions distribution. SEM micrographs of the failed pipe cross-sections (Fig. 6c and d) contribute significantly to explanation of the pipe failure mechanism. Crack propagation is dominated by the inclusions distribution. The mechanical resistance of base metal is significantly reduced by the inclusions presence, resulting in cracks associated with inclusions. Many studies have been conducted concerning the influence of inclusions on strength and toughness reduction [6–9]. The base metal of the failed pipe is subject to significant stress concentration due to the existence of inclusions. Consequently, it is reasonable to believe that these passive inclusions are the major reason leading to pipe failure.

Fig. 6. SEM micrographs of the failed pipe: (a and b) fracture surface; (c and d) cross sections and material cracking associated with inclusions.

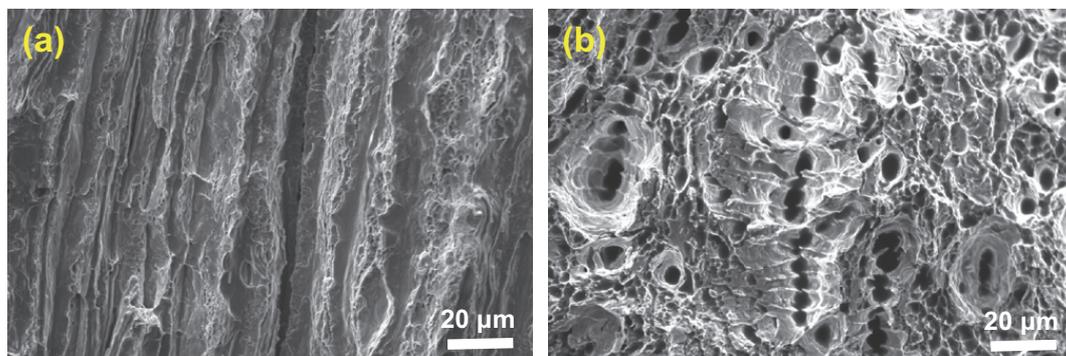
test is shown in Table 2. Longitudinally orientated specimens with respect to the rolling direction (No. 3 through No. 7) exhibited 40–44 J Charpy V-notch impact energy, while the impact energy of the perpendicular orientated samples (No. 1 and No. 2) significantly decreased to 10–12 J. SEM micrographs of perpendicular-orientated specimens (No. 1, 10 J impact energy) and longitudinally-orientated specimens (No. 4, 40 J impact energy) are shown in Fig. 7a and b. The low impact energy specimen (10 J, perpendicular orientation) exhibits deep grooves and laminate fracture topography. Ductile fracture topography in terms of dimples is associated with high 40 J impact energy for the longitudinally-oriented specimens (parallel to the rolling direction). Therefore, the CVN test revealed that due to passive inclusions aligned along the fiber texture, the base metal exhibits insufficient strength and toughness along the rolling direction. Significant cracking occurs at low stress, consequently leading to pipe failure [6].

Fig. 7. The fracture morphology of the impact test specimens: (a) along the rolling direction with the Charpy V-notch impact energy of 10 J, and the fracture morphology revealing lamellar tearing; (b) perpendicular to the rolling direction with the Charpy V-notch impact energy of 39 J, and dimple fracture surface.

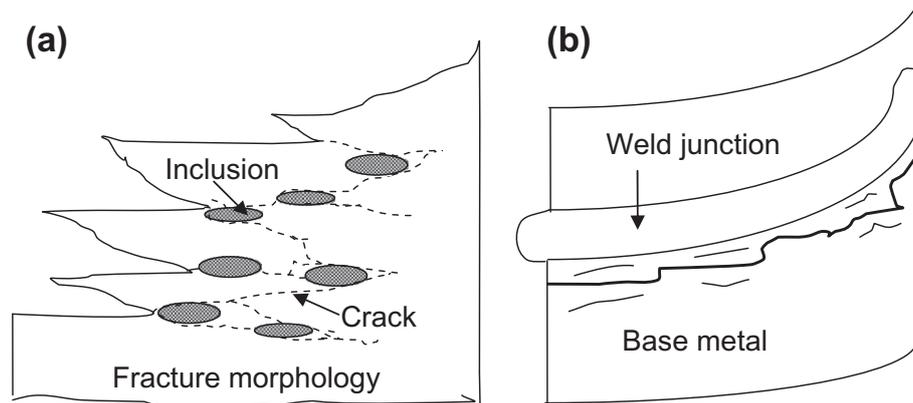
In this study proposed failure mechanism is summarized in Fig. 8. Significant amount of inclusions aligned along the fiber rolling texture significantly reduced the base metal mechanical resistance, resulting in propagating cracks associated with the inclusions. Finally, combination of welding residual stress and stress concentration promote crack growing easily along the spiral weld, and subsequent pipe failure.

Fig. 8. Schematic of the failure mechanism: (a) crack progression through inclusions; (b) residual stress promoting material cracking and consequent pipe failure along the spiral weld.
