## **Engineering Failure Analysis**

# Analysis of the tube-sheet cracking in slurry oil steam generators

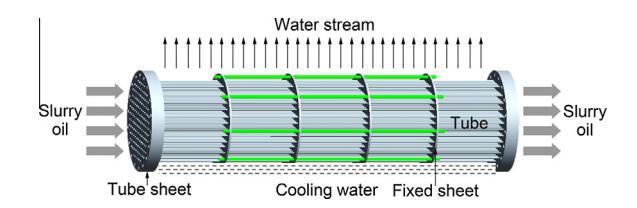
**Fig. 1.** Schematics of the heat exchange process in the slurry oil steam generator, in the process the temperature of the slurry oil varied from 318 °C to 260 °C, the temperature of the cooling water went up from 200 °C to 242 °C, and the cracking occurred in the tube sheets.

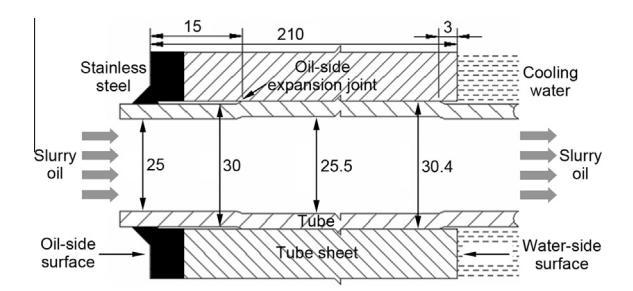
Fig. 2. Schematics of the tube and the tube sheet in the slurry oil steam generator, where the thin stainless steel layers were welded on the oil-side surfaces of the 16Mn tube sheet. A hydraulic expansion technique was applied to eliminate the 0.4 mm-width gap between the tube and the tube sheet, and the oil-side expansion joint was about 15 mm away from the oil-side surface.

In brief, considering the fact that the oil-side expansion joints are approximately 15 mm away from the oil-side surface in Fig. 2, it is concluded that the three cracks initiated on the edges of the tube–tube ligaments around the oil-side expansion joints. Since the slurry oil was inside the tubes and it did not exist at the crack initiation sites, it is impossible that this kind of cracking was induced by the slurry oil.

Which stresses cause SCC in the tube sheets? The diameter of the tube sheet hole was about 0.4 mm larger than the external diameter of the unexpanded tube, shown in Fig. 2. After the hydraulic expansion, the inner diameter of the tube increased by about 0.5 mm, shown in Fig. 2. Therefore, the residual contact stresses exist on the interfaces between the expanded tubes and the tube sheets. Finite element analysis results have indicated that the maximum residual contact stresses occurred around the expansion joints [4]. As shown in Fig. 9, on account of stress relaxation of the cracked tube and the cracked tube sheet, the width of the gap between the cracked tube and the cracked tube sheet was about 0.15–0.4 mm, but the minimal gap occurred at a distance of about 10–20 mm away from the oil-side surface, near the oil-side expansion joint. As a consequence, the larger residual contact stresses concentrate near the expansion joints, where cracks are supposed to nucleate. However, the results in this work show that the fracture initiation sites only located around the oil-side expansion joints. Why did not the cracks initiate near the water-side expansion joints? It is noted that there was no stainless steel layer welded on the water-side surface, shown in Fig. 2. It is possible that the peak stresses near the water-side expansion joints relax more easily during the high-temperature operation.

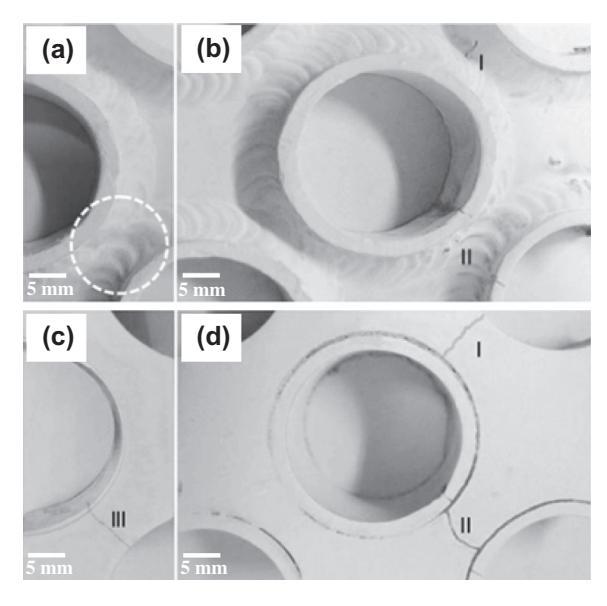
To examine cracks in tubes and tube sheets, non-destructive dye penetrant inspection materials were sprayed on surfaces and sections, shown in Fig. 3. Three types of cracks were observed on the sprayed surfaces. Cracks I and II are located in the upper right corner and the lower right corner in Fig. 3(b) and (d), respectively, and Crack III is located in the lower right corners in Fig. 3(a) and (c). It was found that the Crack I on the oil-side surface in Fig. 3(b) was very small, but the same crack on the section, 5 mm away from the oil-side surface, shown in Fig. 3(d), crossed the whole tube-tube ligament. This macroscopic feature seems to indicate that the Crack I did not initiate on the oil-side surface. As for the Cracks II and III, they did not emerge on the oil-side surface of the tube sheet, shown in Fig. 3(a) and (b). However, the two cracks also crossed the whole tube-tube ligaments in the section, 5 mm away from the oil-side surface, shown in Fig. 3(c) and (d). The visual observation shows that the two cracks' initiation sites were not yet on the oil-side surface. Besides, Fig. 3 also shows that this kind of cracking always occurred in the shortest tube-tube ligaments where stresses concentrated, and the Crack II existed in the tubes as well.

**Fig. 3.** Photographs of the surfaces sprayed with dye penetrant inspection materials: (a) view of an oil-side surface, (b) view of another oil-side surface, (c) view of a section at a 5 mm distance from the oil-side surface in (a) and (d) view of another section at a 5 mm distance from the oil-side surface in (b), where I, II and III indicate the Crack I, the Crack II and the Crack III, respectively, and the locations of the three cracks. However, the Crack III did not emerge on the corresponding oil-side surface marked by a circle ring.

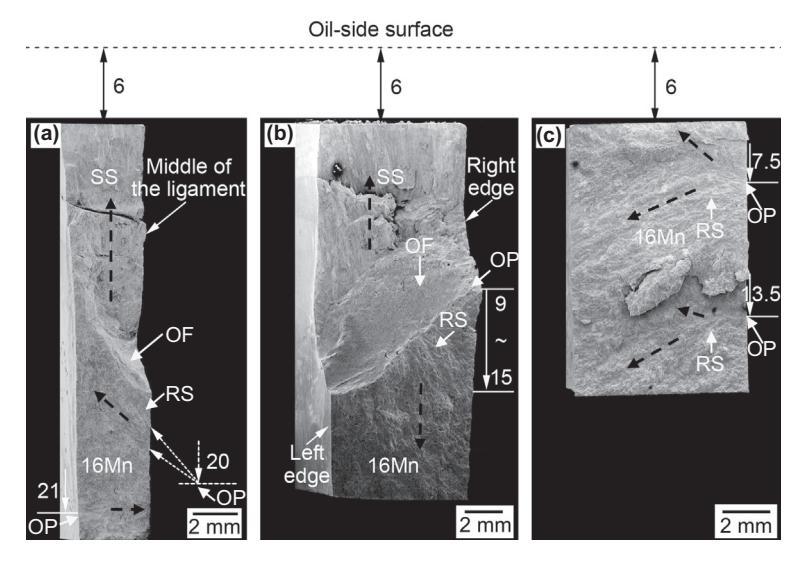
The initiation sites of the cracks were identified according to the directions of the radial stripes on the fracture surfaces, shown in Fig. 4. It has been found that several short radial stripes converged on the left edge of the tube–tube ligament,

**Fig. 4.** Fractographs of (a) the Crack I, (b) the Crack II and (c) the Crack III, where the radial strip, the oblique face, the origin point and the stainless steel are shortened to "RS", "OF", "OF" and "SS", respectively, the crack propagation directions are indicated by the black dotted arrows.

about 21 mm away from the oil-side surface, which indicated that the Crack I initiated at this point, shown in Fig. 4(a). Besides, a few radial strips in the middle of the ligament did not converge at a point. Therefore, the other initiation site of the Crack I was probably on the right edge, about 20 mm away from the oil-side surface, shown in Fig. 4(a). There were also obvious radial stripes on the fracture surface of the Crack II, shown in Fig. 4(b). Most of the radial stripes converged at the boundary between 16Mn and the stainless steel. This shows that the Crack II's initiation site located at this boundary, about 9– 15 mm away from the oil-side surface. As for the Crack III, shown in Fig. 4(c), dozens of radial stripes on the fracture surface indicate that two fracture initiation sites were on the right edge of the tube–tube ligament, 7.5 mm and 13.5 mm away from the oil-side surface, respectively. After the cracks were initiated, they propagated in the tube–tube ligaments. For the Crack I, when materials changed from 16Mn to the stainless steel, the crack propagation direction also changed. An oblique face at the boundary between 16Mn and the stainless steel was observed on the fracture surface of the Crack I in Fig. 4(a). As seen in Fig. 5, the length of the Crack I in the sections 5 mm, 2.5 mm and 1 mm away from the oil-side surface was 8 mm, 7 mm and

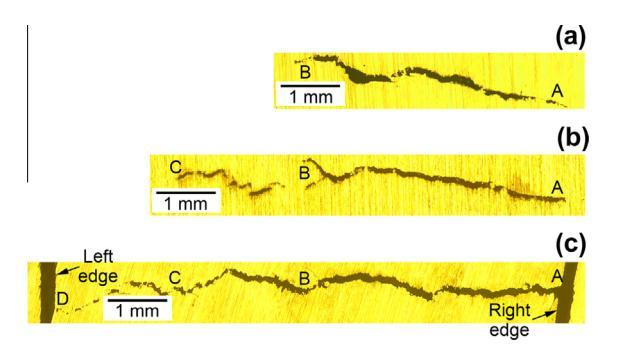
Fig. 5. The partial morphology of the Crack I in the sections: (a) 1 mm, (b) 2.5 mm and (c) 5 mm away from the oil-side surface.

4.5 mm, respectively. This indicates that the Crack I became smaller and propagated from the inside to the oil-side surface when it approached the oil-side surface.

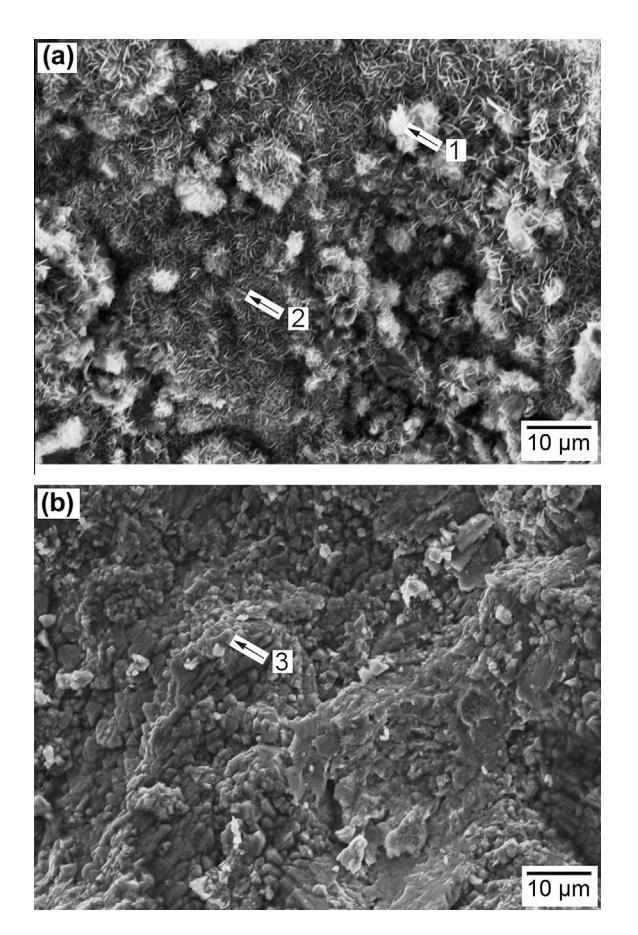
Fig. 6. SEM views of the corrosion products on the original fracture surfaces of (a) the Crack I and (b) the Crack III, where the spot-like, needle-like and particle-like corrosion products are in areas marked "1", "2" and "3".

The corrosion products on the original fracture surfaces of the Crack I and III were observed by a LEICA S440i SEM, shown in Fig. 6. The EDS spectra of the spot-like, needle-like and particle-like corrosion products in areas marked "1", "2" and "3"

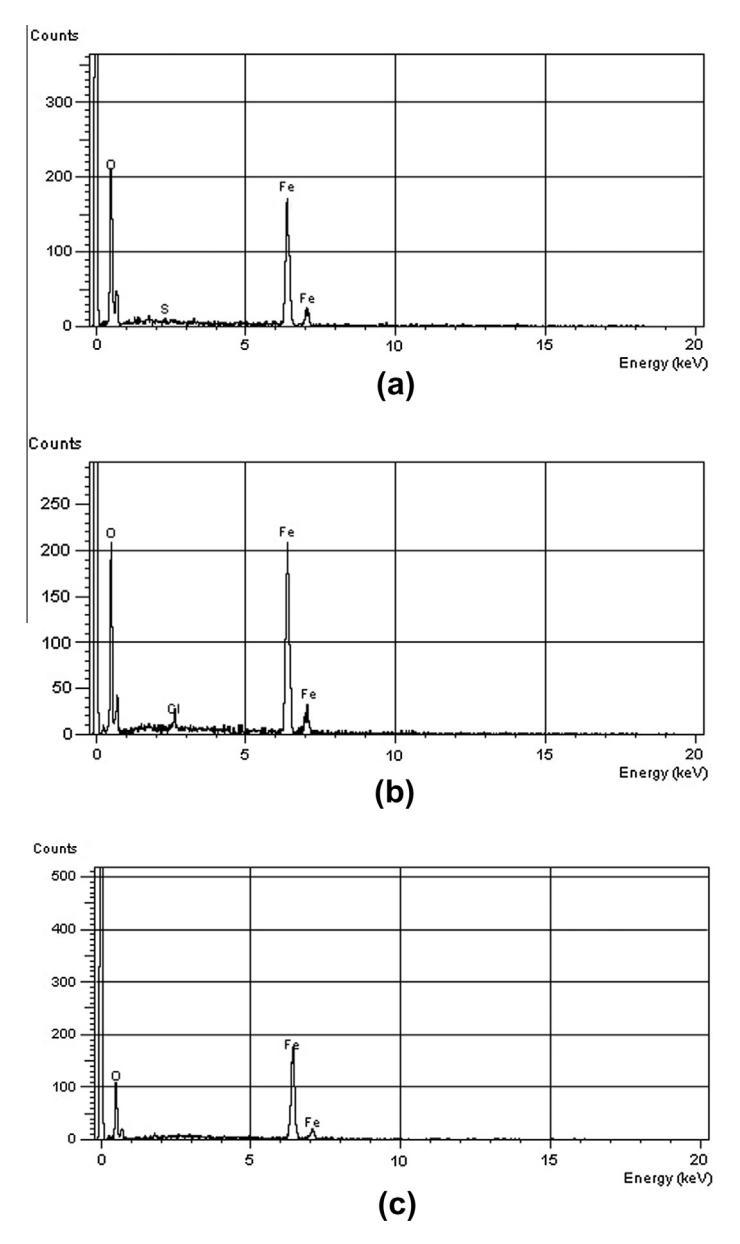
Fig. 7. EDS spectra of the corrosion products: (a) spectrum of the area marked "1" in Fig. 6(a) and (b) spectrum of the area marked "2" in Fig. 6(a) and (c) spectrum of the area marked "3" in Fig. 6(b).

are given in Fig. 7(a–c), respectively. It can be seen from Fig. 7 that the corrosion products mainly consisted of iron oxides on the original fracture surfaces of the Cracks I and III. Besides, there was a small amount of elemental sulfur in the spot-like corrosion products on the original fracture surfaces of the Crack I, shown in Fig. 7(a). Elemental chlorine with very low content existed in the needle-like corrosion products on the fracture surface of the Crack I, seen in Fig. 7(b). As a result, the corrosion products on the original fracture surface of the Crack I contained iron oxides and elemental sulfur and chlorine, while there were only iron oxides in the corrosion products on the original fracture surface of the Crack II.

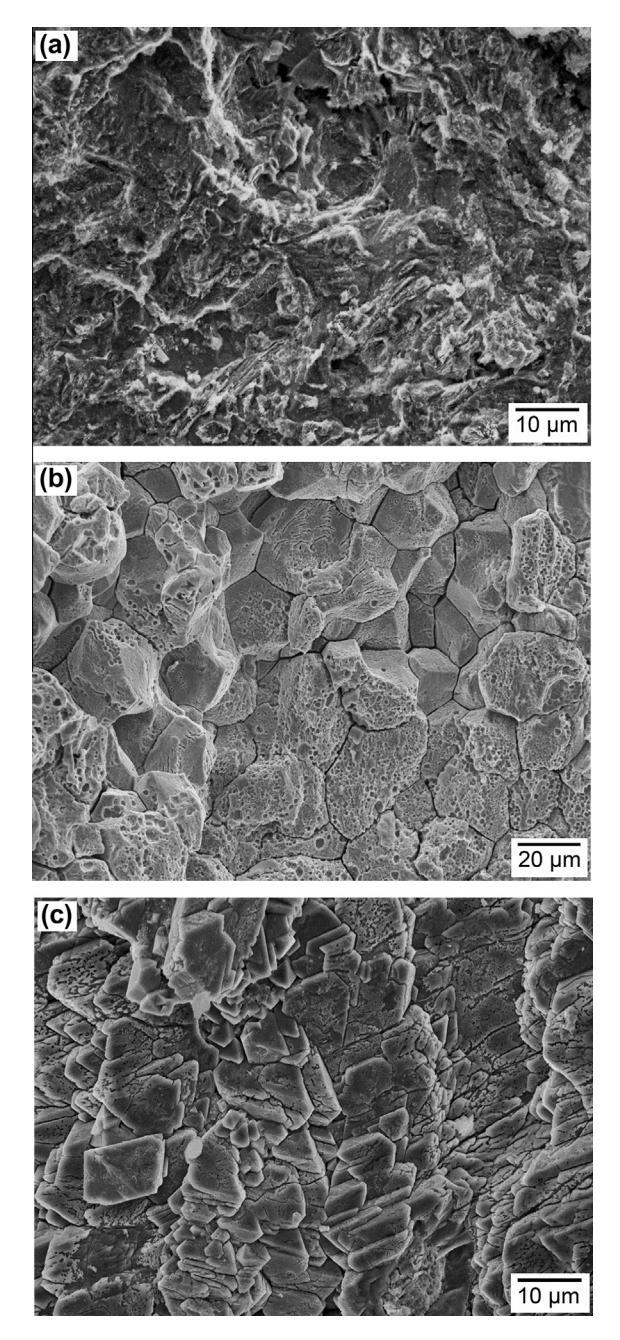
Fig. 8. SEM fractographs of different materials: (a) the 16Mn tube sheet's fractograph, (b) the 321 stainless steel tube' fractograph and (c) the stainless steel layer's fractograph.

The fracture surfaces washed with the solution containing HCl and  $C_6H_{12}N_4$  in an ultrasonic cleaner were studied by LEI-CA S440i SEM. The typical fractographs of the 16Mn tube sheet, the 321 stainless steel tube and the stainless steel layer are shown in Fig. 8(a–c), respectively. The quasi-cleavage brittle fracture occurred in the 16Mn tube sheet, shown in Fig. 8(a). As seen in Fig. 8(b), there were secondary cracks on grain boundaries, and lots of rock-candy-like grains distributed on the fracture surface. These features indicate that the fracture mode of the 321 stainless steel tube was intergranular brittle fracture. As shown in Fig. 8(c), no ductile dimples were observed on the fracture surface, and the brittle fracture also occurred in the stainless steel layer. To sum up, the tube-sheet cracking was the brittle fracture, rather than the ductile fracture.

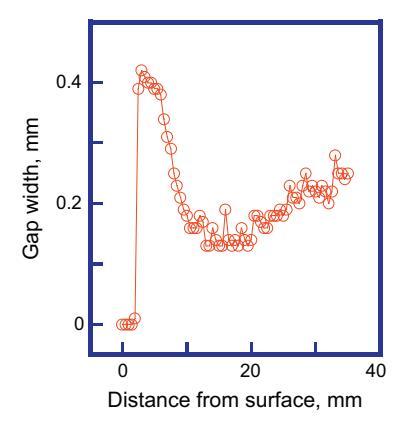
**Fig. 9.** Variation of the width of the gap between the cracked tube and the cracked tube sheet vs. the distance away from the oil-side surface, it is shown that the minimum gap was 10–20 mm away from the oil-side surface, meaning that there was stress concentration near the oil-side expansion joint in the uncracked tube sheet.

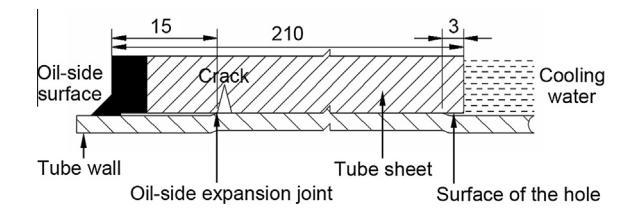
The SCC process can be described as follows, shown in Fig. 10. During operation, the 3.5 MPa, 200–242 °C cooling water permeated through the gap between the tube and the tube sheet. The hole surface of the tube sheet was subjected to corrosion. If the effective stress concentrating near the oil-side expansion joint reached a critical value, the SCC crack would preferentially initiate on the hole surface. Then, the crack propagated from the surface to the interior, and also grew in the axial direction of the tube under the action of the effective stress and the occluded cell at the crack tip. Finally, some cracks, such as the Crack I, emerged on the oil-side surface.

Fig. 10. A schematic plot of the SCC crack in the tube sheet, where the tube-sheet cracking occurred near the oil-side expansion joint, about 15 mm away from the oil-side surface.
