Corrosion Assessment of Mechanically Formed Aluminized Steel

Mersedeh Akhoondan, Alberto A. Sagüés Department of Civil and Environmental Engineering, University of South Florida, 4202 East Fowler Ave., Tampa, FL 33620, U.S.A.

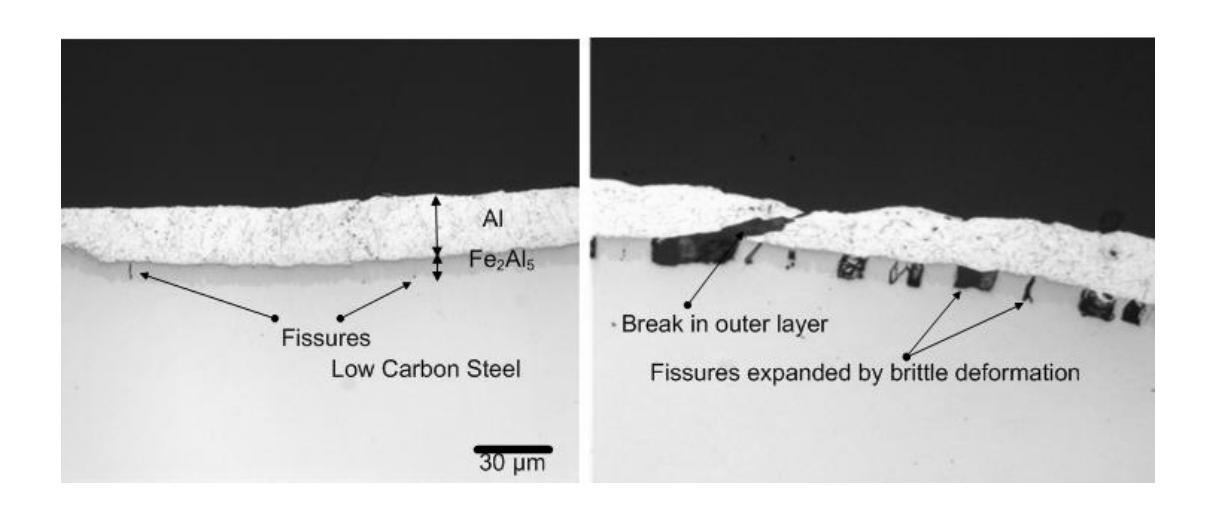
Figure 1 (left) shows a metallographic cross section of the as-received (flat) material showing the coating microstructure described in the Introduction. Figure 1 (right) shows the coating condition of a bent sample (radius ~2 mm). The most notable feature is nearly completely brittle fracture of the intermetallic layer, as manifested by its many elongation gaps. The outer coating was much more ductile, with few instances of fracture as that illustrated on the left side of the right figure, apparently originating at one of the larger brittle gaps of the inner layer. The number and severity of fractures in the inner layer increased as the bending stress increased. For completely brittle fracture, the integrated gap length measured on a line parallel to the perimeter, divided by the initial length (that is, that of the remaining visible intermetallic) should equal the total strain at the outer fiber. To test that hypothesis, the strain ε_M calculated from measurements of the ratio of inner layer gaps to visible intermetallic length was compared with the strain at the outer fiber expected from the local macroscopic bending radius and the sheet thickness. For a simply bent sheet in which the neutral axis of metal sheet stays constant, the theoretical relationship between the strain of outer fiber and radius of curvature ⁶ is:

FIGURE 1 – Flat Specimen (left), Bent Specimen (right)

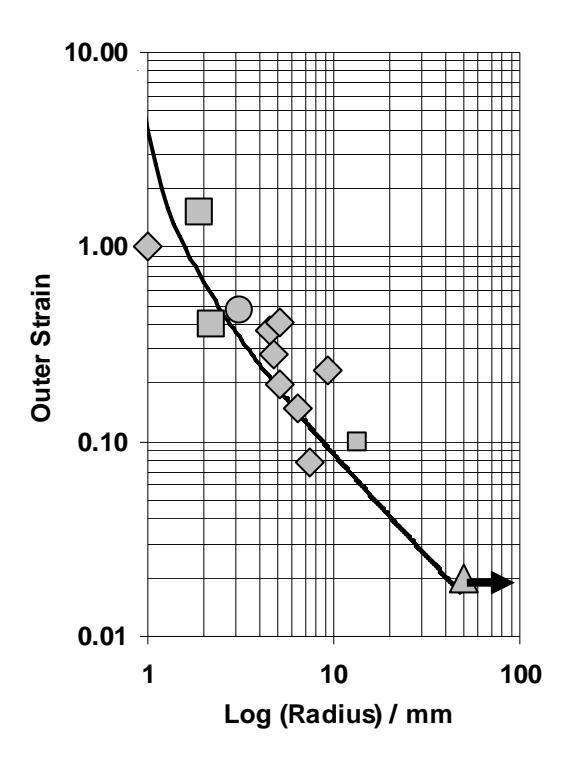
Figure 5 compares the values of ideal outer fiber strain computed per Eq. (1) from the radius of curvature determined for various specimens from the low magnification micrographs and the sheet thickness, and ϵ_M from the micrographic analysis of the intermetallic layer. Flat samples were assigned a radius > 50 mm in the graph. The results support the hypothesis of nearly completely brittle behavior for the inner intermetallic layer. Tests in progress address behavior of specimens bent by spherical indenting and ductile fracture of the outer layer, which will be reported in the future.

FIGURE 5 – Outer Strain ε_I per Eq(1) (solid line) and ε_M per Micrographic Analysis of Intermetallic Layer Gaps (symbols) as Function of Radius of Curvature for Various Specimens. Multiple Symbols Indicate Various Radii Locations in a Given Specimen.

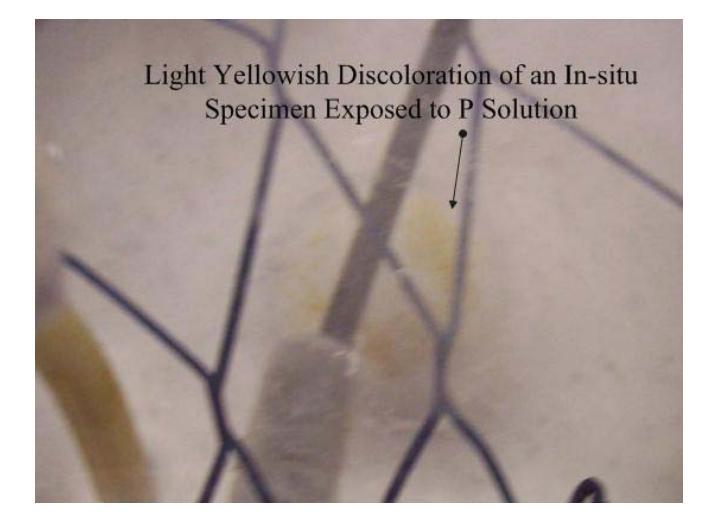
Visual examination of the specimen surfaces in solution P (high total alkalinity with carbonate precipitation) showed early appearance of light yellowish discoloration uniformly distributed over the convex indentation surface in all dimpled specimens tested, indicative of ongoing corrosion there (Figure 6). Symptoms were more sever in solution C (low alkalinity and no precipitating tendency), where appearance of strong reddish discoloration was first noted early on in the exposure around the convex indentation of all dimpled specimens, and gradually propagating covering the entire indentation surface (Figure 7). Corrosion appeared to be more intense for the 1-in diameter indentation specimens, although it is noted that the affected area was greatest for those even though maximum local strain may have been less severe than for the smaller radius indentation specimens. In both solutions, corrosion of the surrounding aluminized surface was minimal, suggesting preservation of passive behavior there during the test interval sampled. Correspondingly, no sign of corrosion was observed in any of the flat surface specimens exposed to both solutions, suggesting good corrosion performance to date in those cases. Clearly, for the time being any galvanic protection from the aluminized portion was insufficient to avoid initiation of active corrosion of the exposed steel especially in the C solution, in agreement with the results reported elsewhere for specimens with machined coating breaks $^{\prime}$.

Figure 6 - Light Corrosion at a 1-in Convex Dimple Exposed to Solution P. (Picture shows immersed sample surface at 21 days exposure).

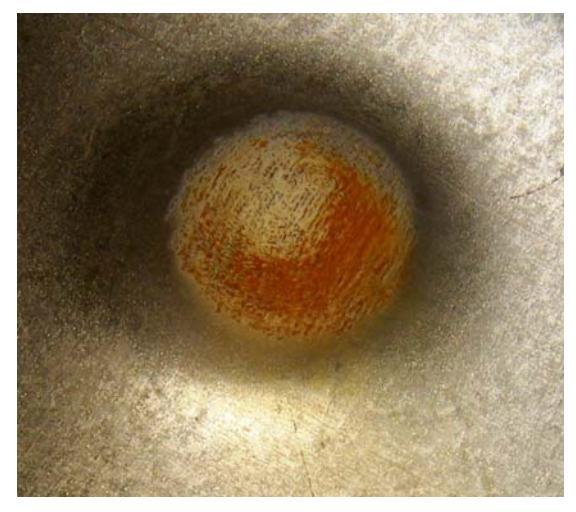
FIGURE 7 – Severe Corrosion at a 1-in Convex Dimple Exposed to C Solution (Immersed sample at age of 19 days).

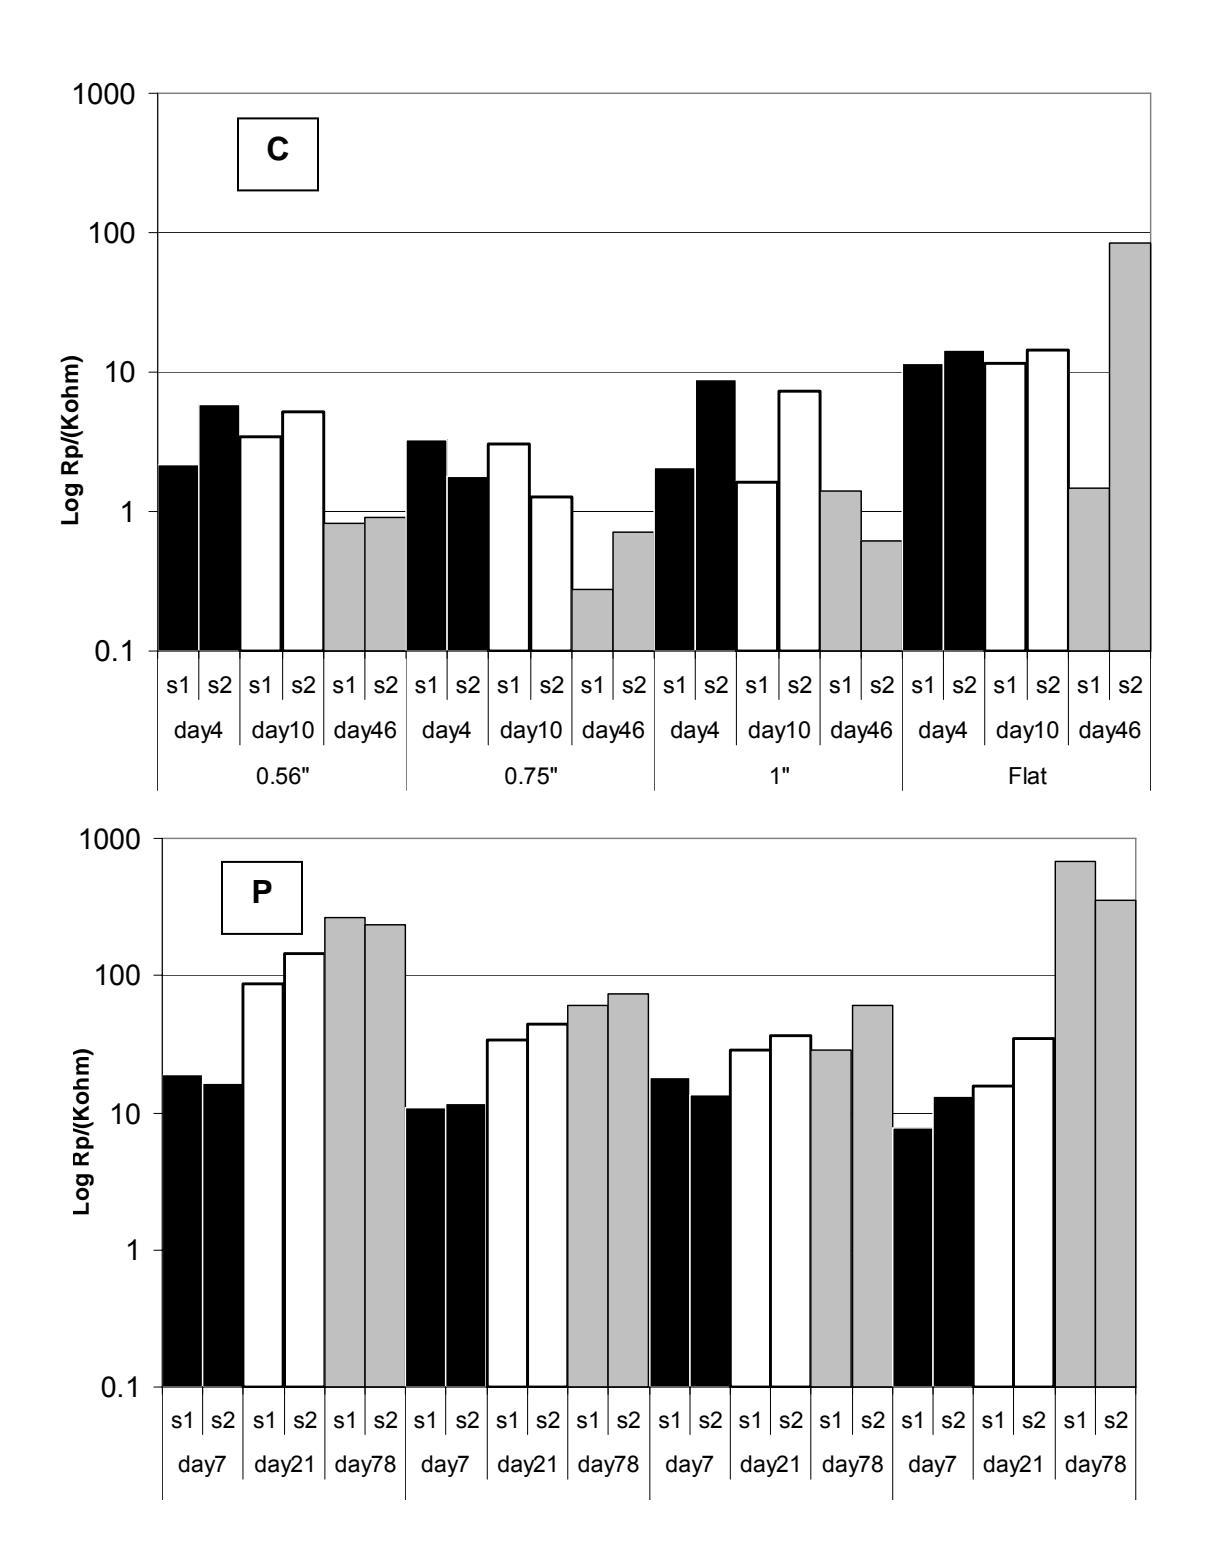
The Rp values were typically much greater in the P solution, in agreement with the expected more benign character of that precipitating solution. Rp there tended to increase with time, indicating a maturing of the protective regime. Furthermore, there was little differentiation between the Rp values of the flat and dimpled specimens, indicating that the light corrosion manifested by direct observation had likely been arrested in this medium after some initial active period. These results are consistent with protective regimes reported by Caseres⁸ for blemished aluminized steel in the same solution.

The Rp values correspond to more aggressive conditions in the C solution, in agreement with visual observations. There the Rp values were generally much lower than in P, and decreased with time indicating increasing corrosion. Moreover, Rp in the dimpled specimens was generally lower than in the flat specimens, indicating an adverse effect of forming. It is noted however that one of the duplicate flat specimens experienced a significant decrease in Rp before 46 days of exposure, which may be indicative of onset of protective corrosion by the aluminized layer^{1,7} but also possible development of crevice corrosion artifacts in the cell. Continuing test with multiple replicates is being implemented to elucidate this issue.

FIGURE 9 – Polarization Resistance Values for Different Bent Categories at Three Exposure Times in C Solution and in P solution (B)
