**CORROSION RESISTANCE AND SERVICE
LIFE OF DRAINAGE CULVERTS**

**State Job 99700-3335-119, WPI 0510756
Contract No. B-9898
Final Report to Florida Department of Transportation**

**Alberto A. Sagüés
Principal Investigator
Department of Civil and Environmental Engineering
August 20, 2001**

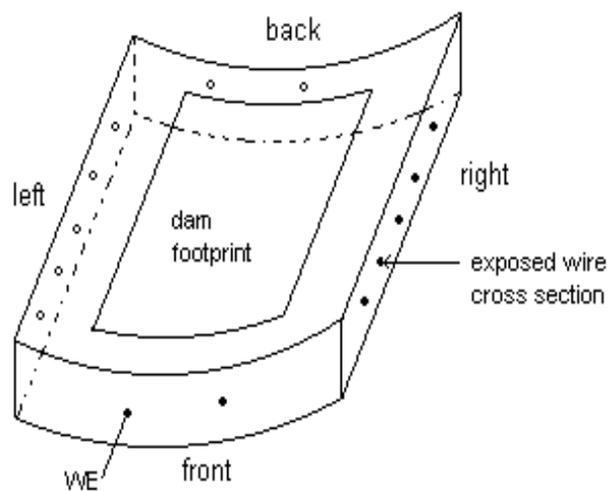
Figure 1. Sketch of the specimens used. The cut edge with the connection for the working electrode (WE) was considered to be the front of the specimen.

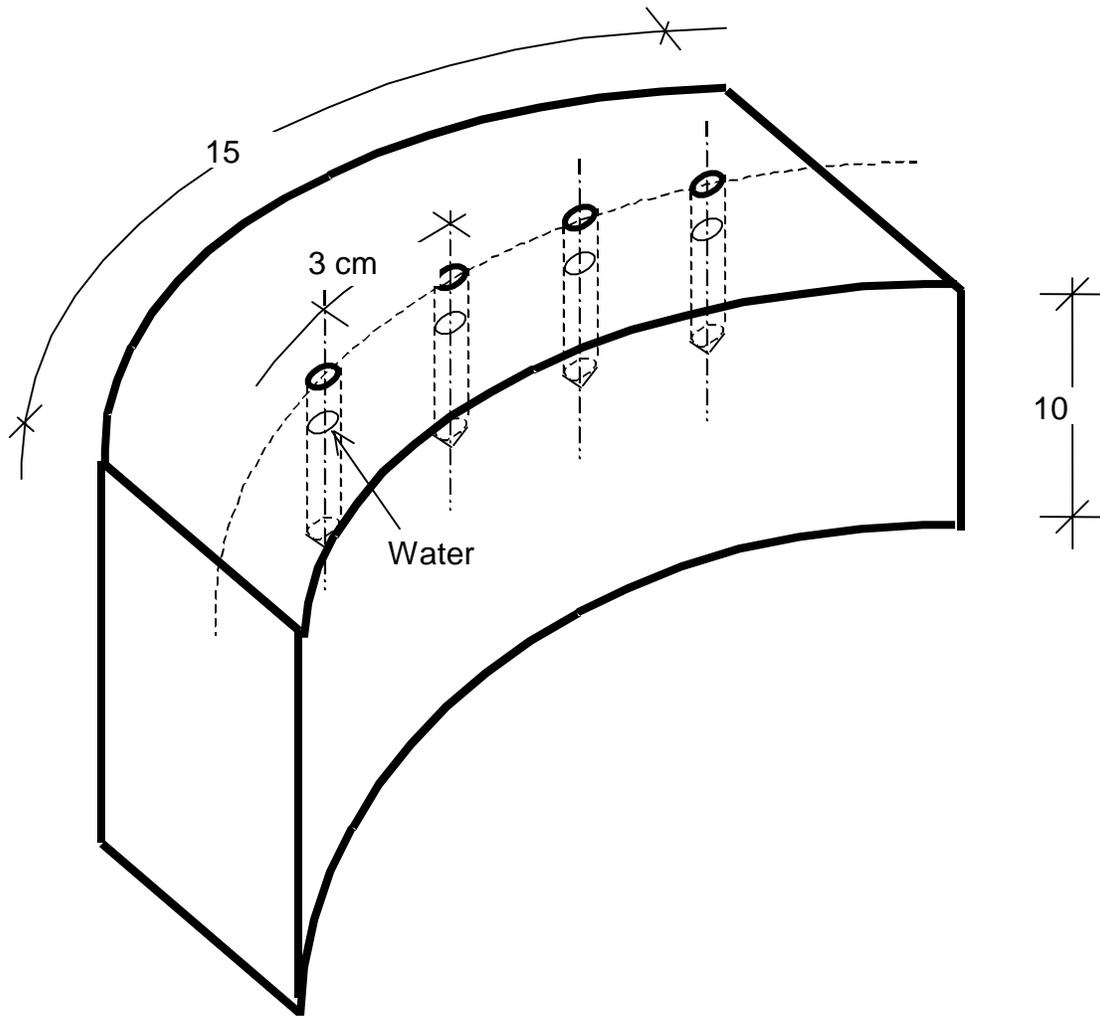
Figure 2. Concrete Culvert Segment for Pore Water pH Measurements.
 Note: Plastic toppers are not represented in this

Pore water pH measurements were conducted using a procedure described by Sagüés et al. [9]. Samples of concrete from each culvert type were saw-cut in the form of arches ~ 15 cm wide along the perimeter direction and ~ 10 cm long in the direction of the longitudinal axis of the pipe. Holes were drilled on one of the faces of the arch. The holes have a diameter of 3.5 mm and 35 mm depth (See Figure 2). A plastic fixture with a rubber stopper kept the holes covered. The samples were placed and kept in a conditioning chamber at 100% relative humidity. To each hole 0.25 ml of distilled water was added. The amount of water in each hole was measured and made up periodically with distilled water for a period of 43 days until no further replenishing of water was required. The pH of the water was measured 17 days and 67 days after the level of water was stable.

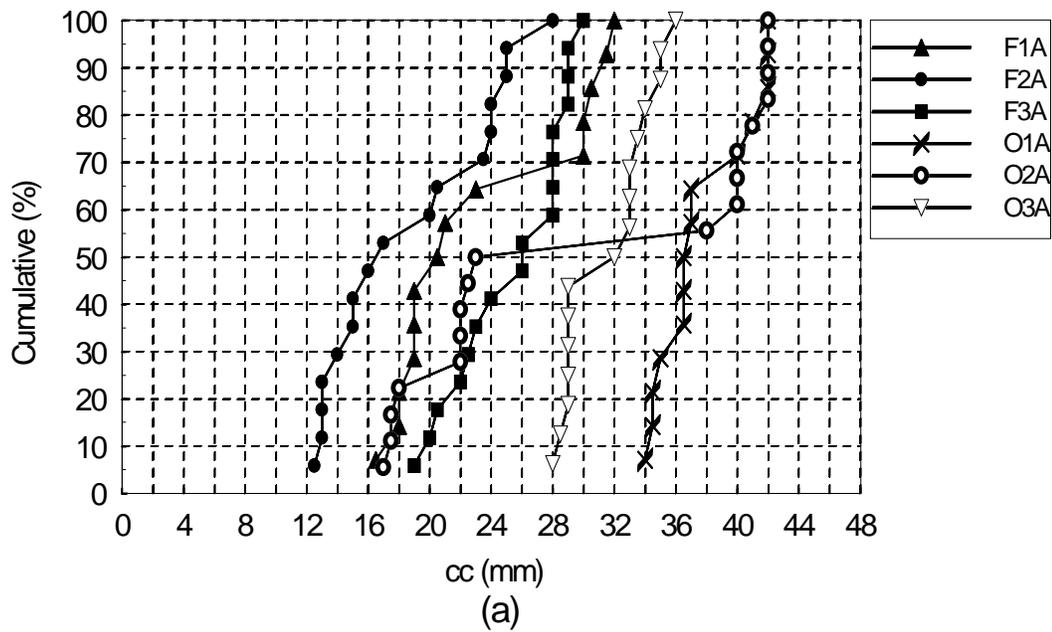
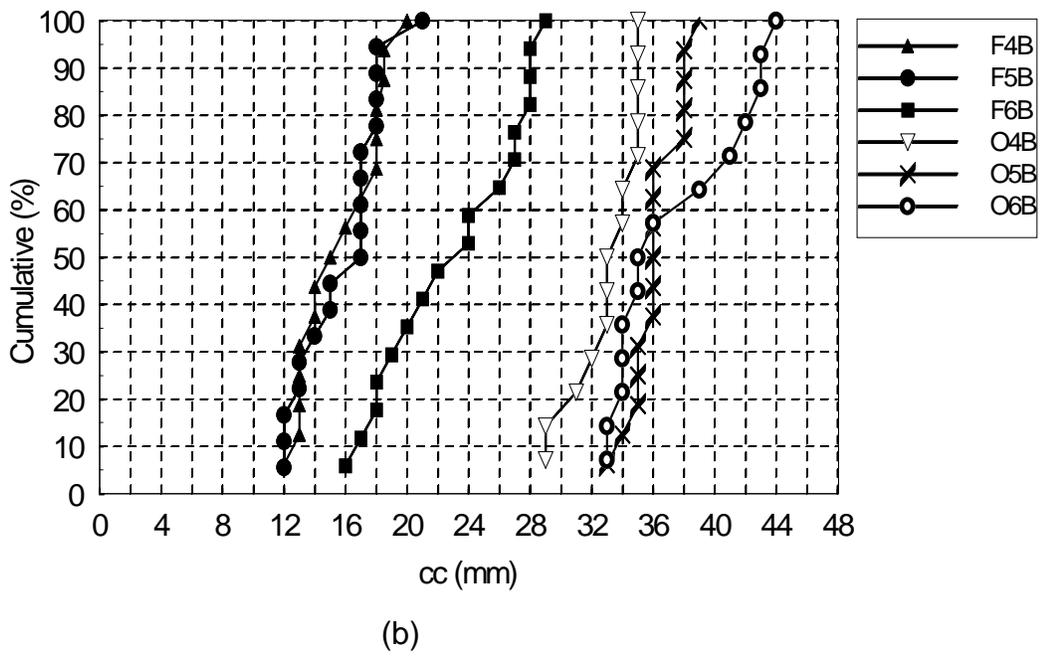
Figure 3. Cumulative percentage of steel wire cross sections examined in the cut edges vs concrete cover thickness (cc) for specimens corresponding to : a) set A and b) set B.

Figures 3 (a) and 3 (b) show plots of the cumulative % of exposed wire cross sections in the cut edges of the specimens versus clear concrete cover thickness, for set A and set B, respectively. The average cover for type O specimens was generally greater than for type F. One exception was specimen O2A for which approximately 50% of the spots examined presented values of cc in the same range as specimens F1A and F3A for the same cumulative level. The lowest values of cc (about 12 mm (~ 0.5 in)) were found in specimens F2A, F4B and F5B. As expected, in both types of concrete pipes (O and F) the longitudinal reinforcement was closer to the inner surface of the pipe than the transversal (hoop) reinforcement. Figure 4 confirms that the lower values of cc were normally found in the spots corresponding to longitudinal wires, although in some cases, probably due to tight winding of the hoop wire, the opposite was observed. In Figure 5 the cumulative frequency distributions of concrete covers for specimens F1A and F2A are plotted again, but using different symbols for wire cross sections examined in different cut edges of the specimens. It is clear that the cover was not uniform around the pipe perimeter, showing some degree of eccentricity in the placement of the reinforcing cage within the walls of the concrete pipe.

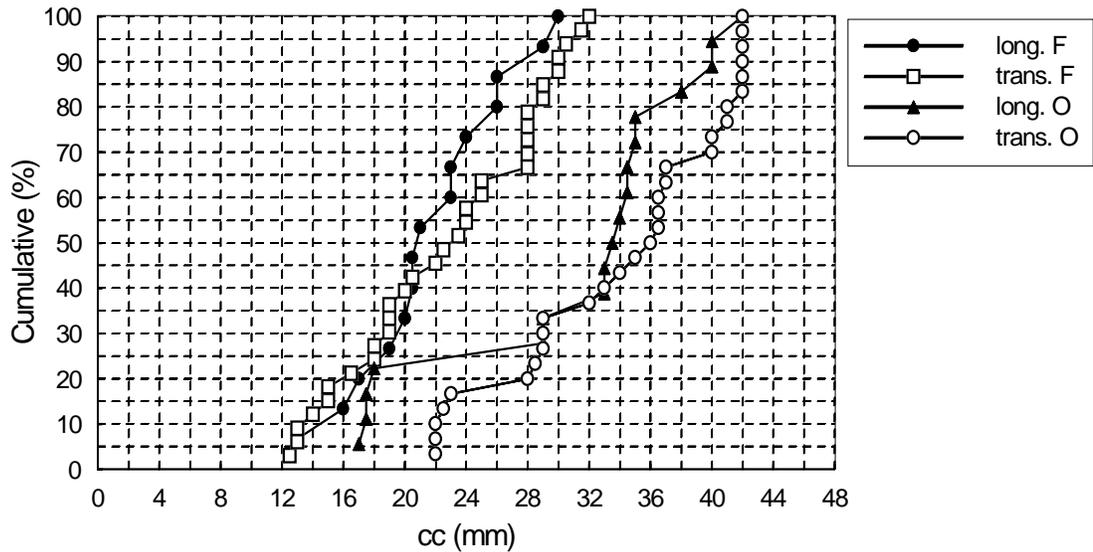
Figure 4. Distribution of concrete cover with cc values for cross sections of longitudinal and transversal wires plotted separately. Data for all six specimens of a) set A and b) set B.

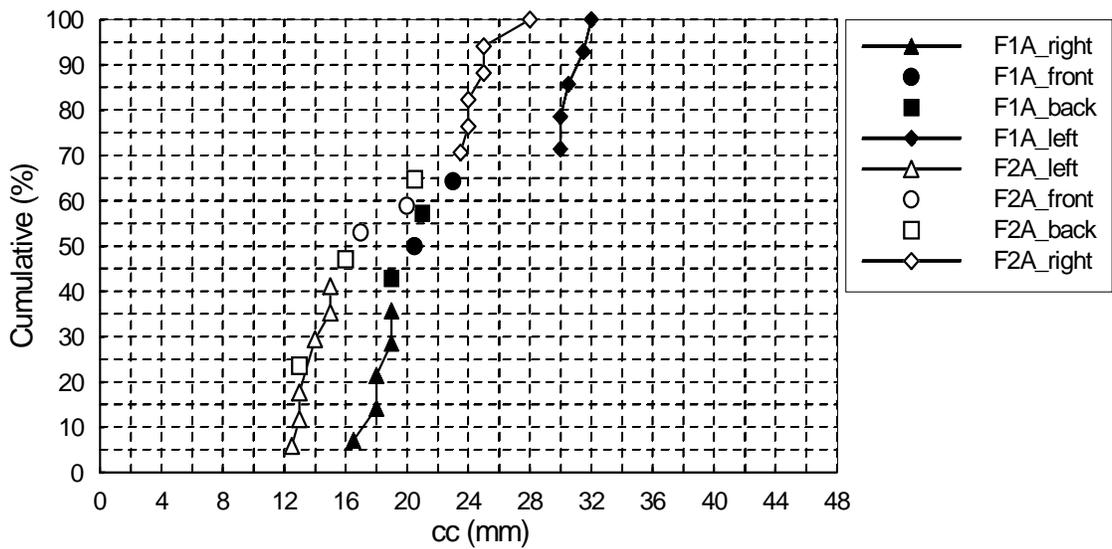
Figure 5. Distribution of concrete cover for specimens F1A and F2A, using different symbols for spots corresponding to different cut edges of the specimens, according to the convention given in Figure 1.

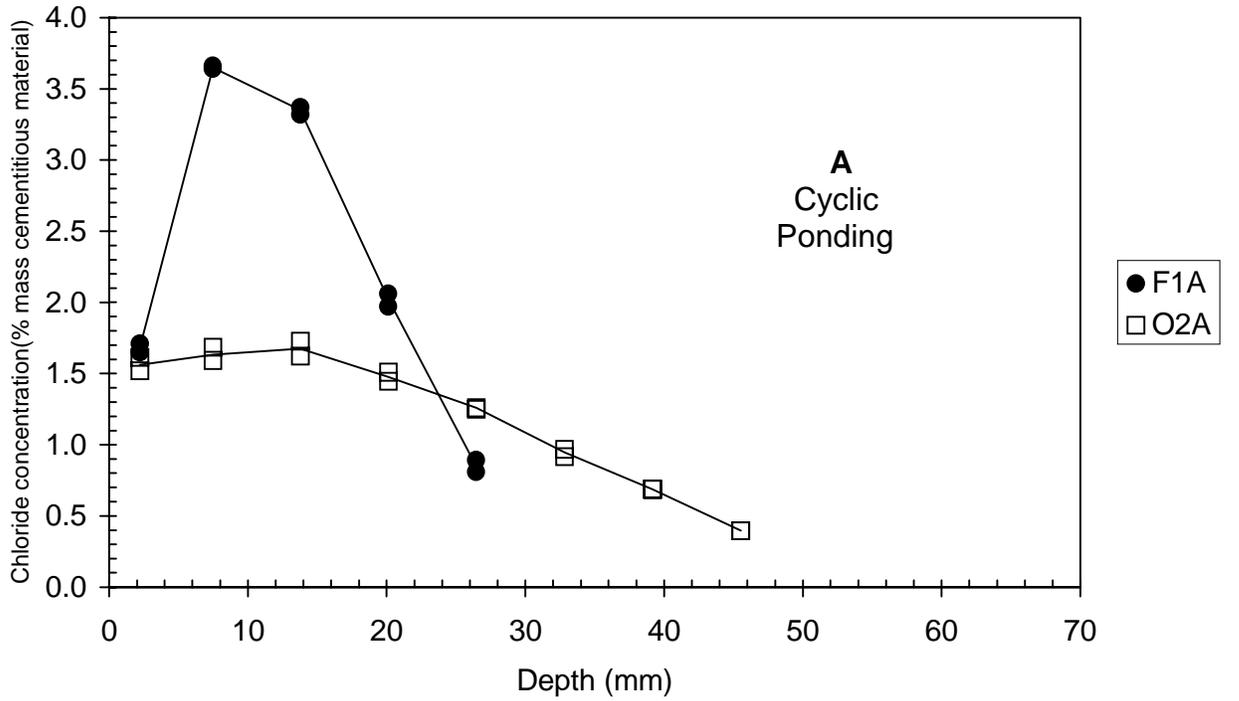
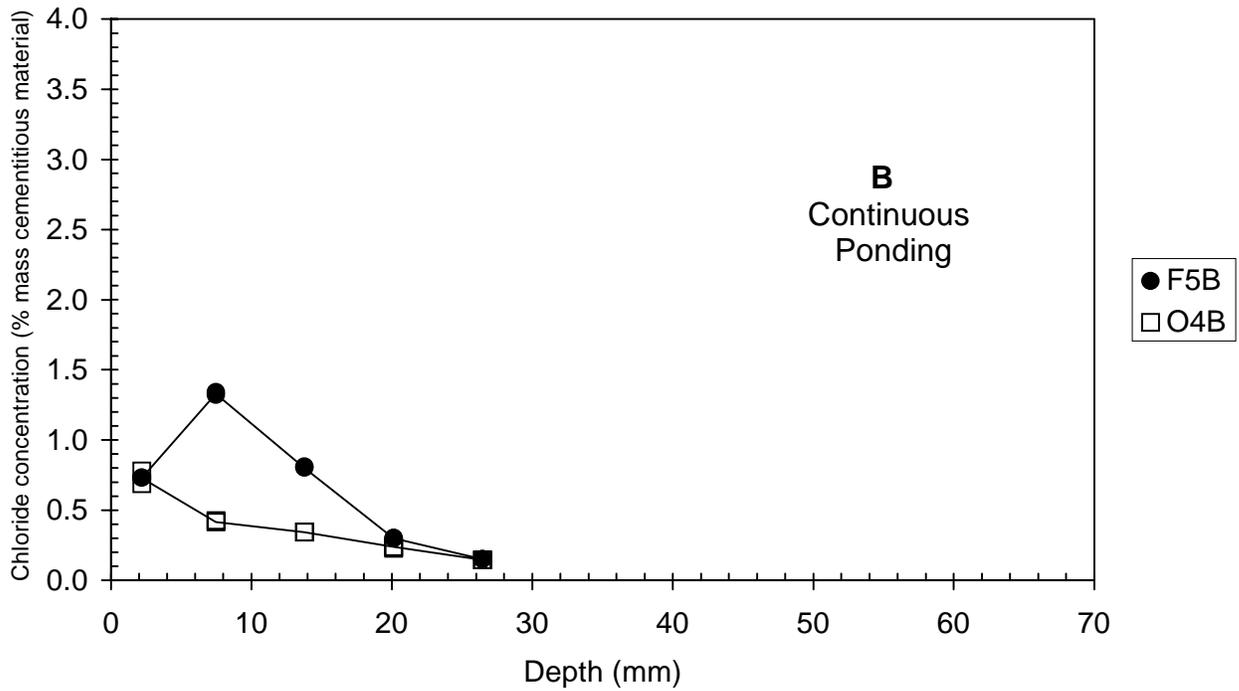
Figure 6. Chloride profiles for selected specimens of set A (756 days of exposure) and set B (390 days of exposure). Symbols show values of duplicate chloride analyses of each concrete powder sample.

The chloride concentration profiles at two different time periods for selected specimens of each pipe type are presented in Figures 6 and 7. The chloride profiles for F specimens showed a pronounced maximum a few mm inside the concrete surface, ahead of the carbonation front (located at 4 mm from the surface). Such an effect has been observed by other authors [2,14-16]. It has been proposed that in carbonated layers both the porosity [17] and the chloride binding ability [15,16] of the concrete are reduced, thus decreasing the total chloride content compared to the amount present in uncarbonated concrete exposed to the same medium. The O specimens had an apparent carbonation depth of only ~1 mm and did not show such a pronounced peak in the chloride concentration profile as in the F specimens. However, the concentration in the O specimens exposed to cyclic ponding showed a near plateau in the first ~20 mm from the surface, which cannot be explained at present. Nevertheless the O specimens showed lower chloride concentrations in the region ~6mm to ~25 mm from the concrete surface than those observed for the companion F specimens, which suggests that the O mix had less chloride binding capability than the F mix. This interpretation would agree with reports by other authors of greater chloride binding in fly ash versus unblended cement concretes [18,19].

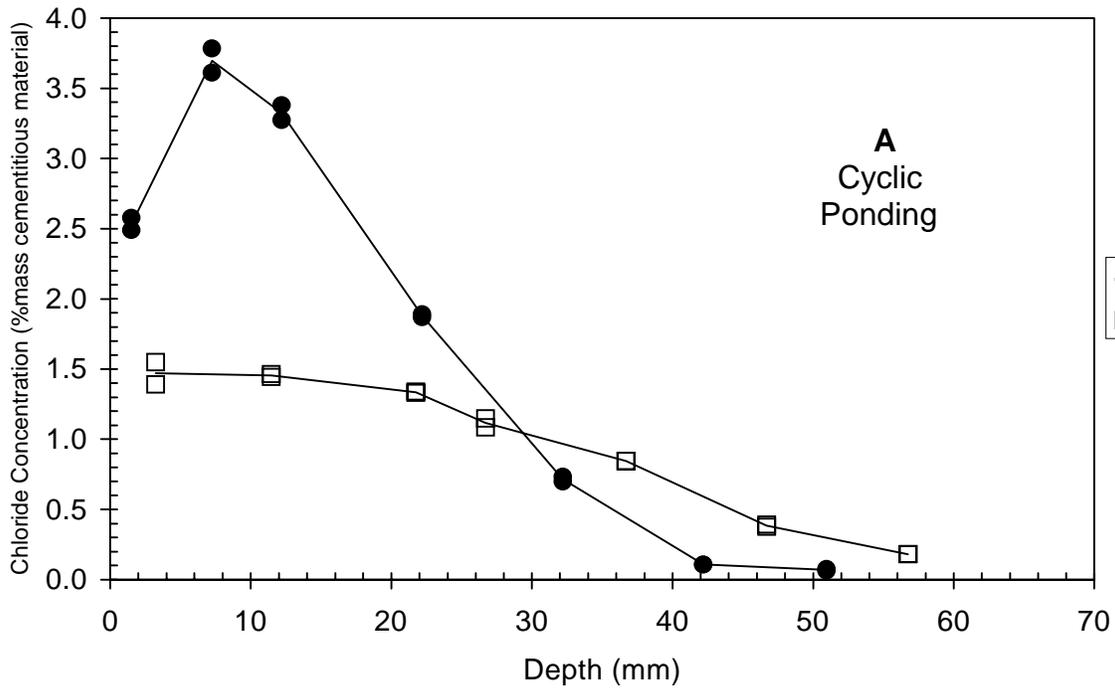
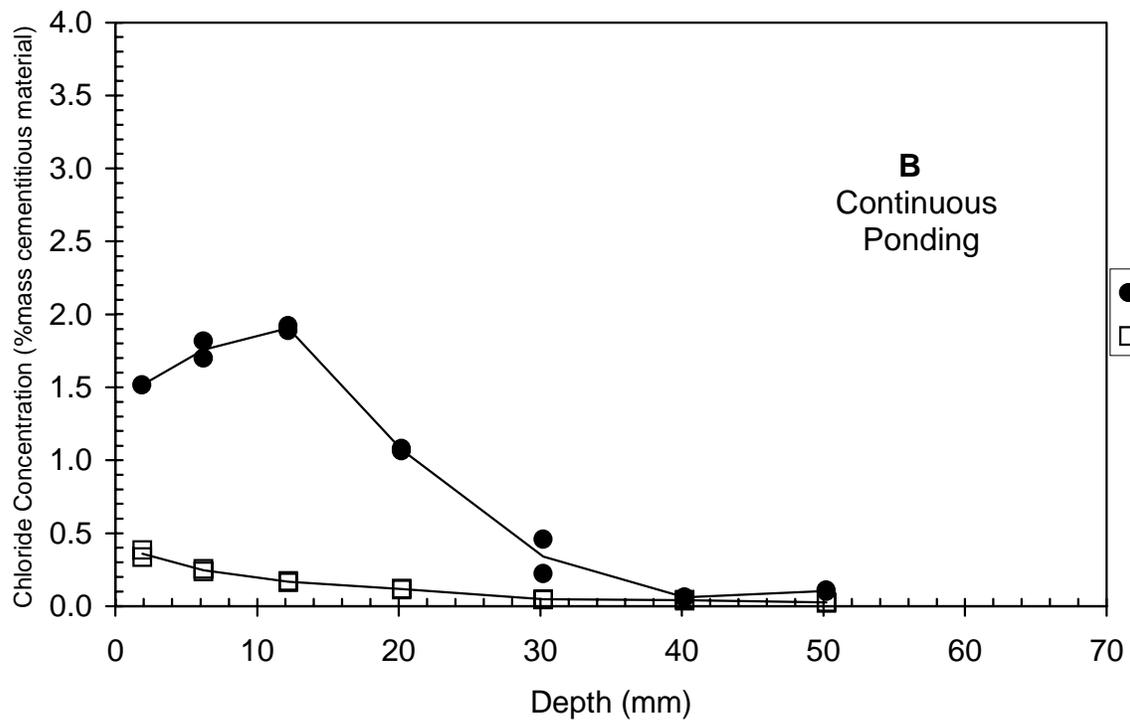
Figure 7. Chloride profiles for selected specimens of set A (1650 days of exposure) and set B (1200 days of exposure). Symbols show values of duplicate chloride analyses of each concrete powder sample.

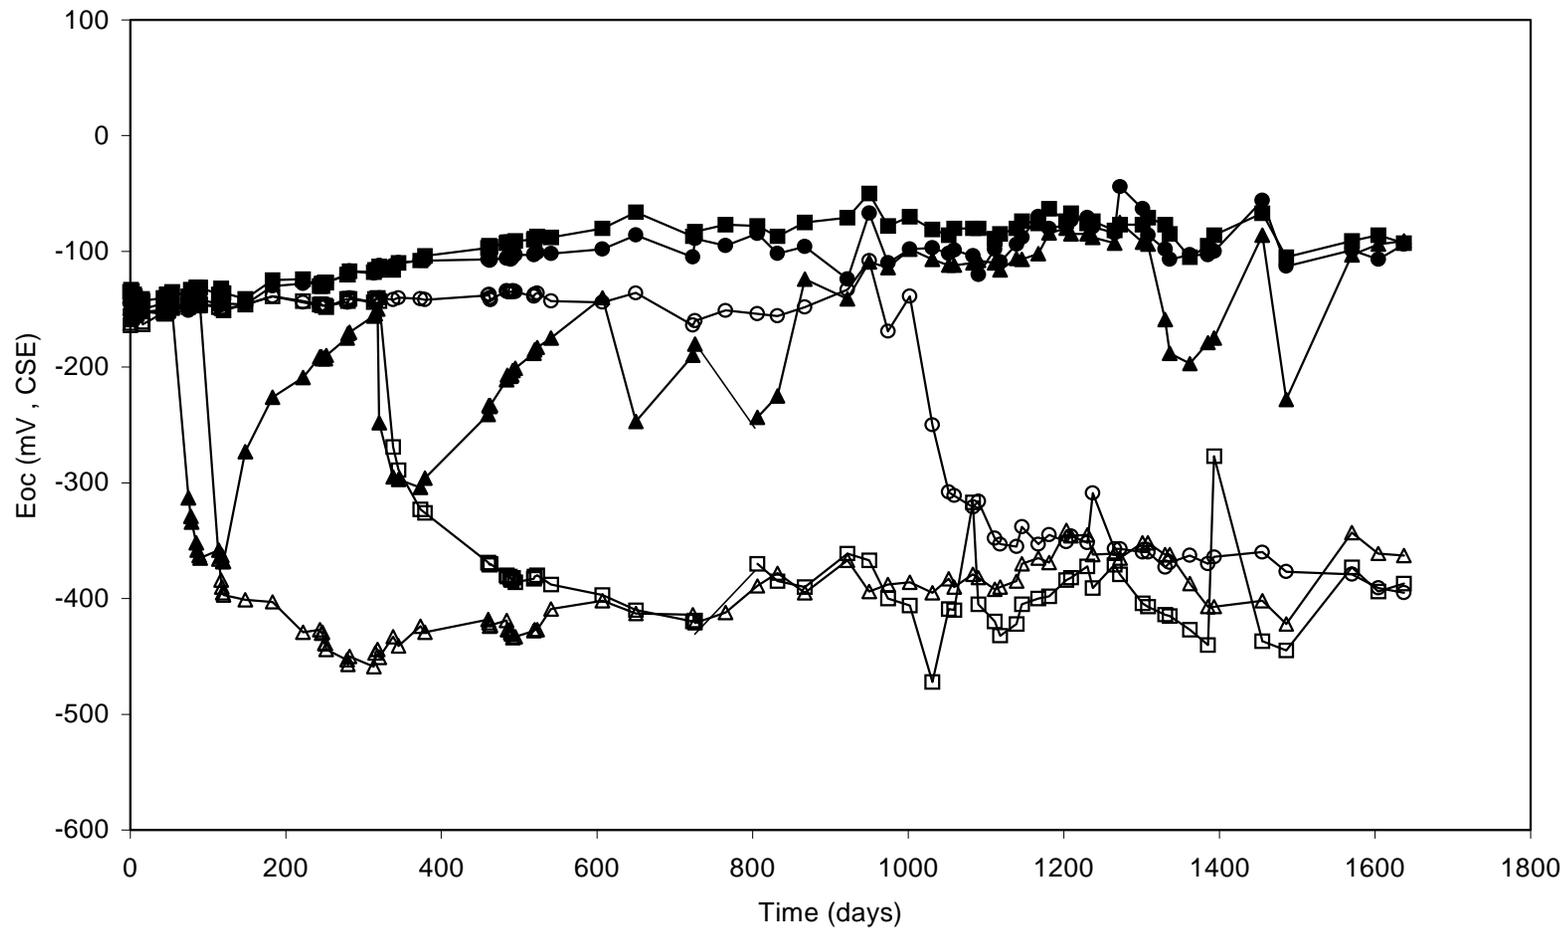
Figure 8. a. Open circuit potentials as a function of exposure time for specimens of set A (near the end of the wet cycle).

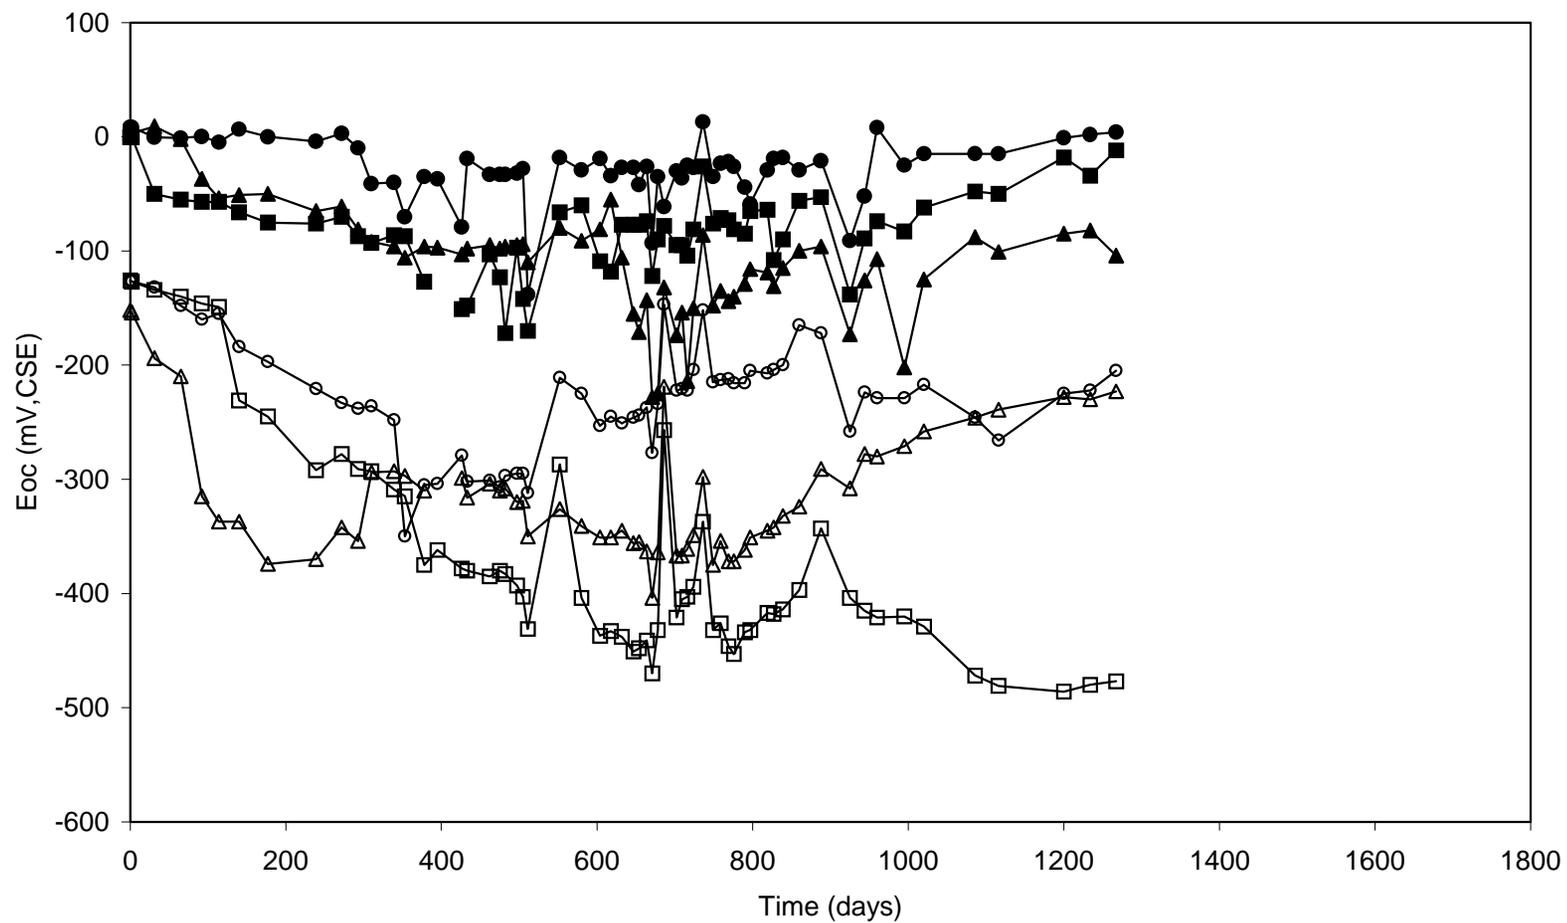
Figure 8. b. Open circuit potentials as a function of exposure time for specimens of set B.

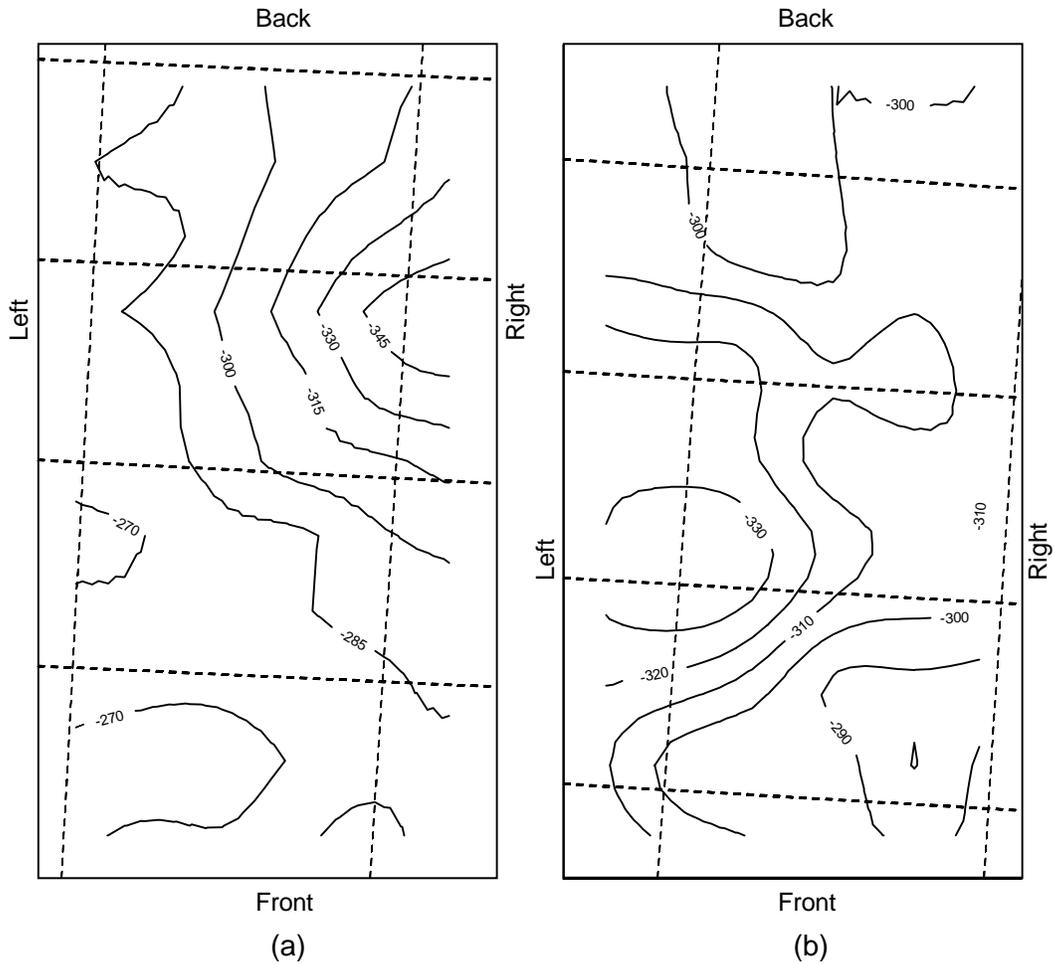
Figure 9. Potential mapping obtained after 9 days in the 21st. dry cycle for specimens :
 a) F1A and b) F2A . The equipotential lines are drawn inside a scaled plan view of the dam footprint. The labels (front, back, left and right) in the border of each map are given to define the orientation of the specimens, according to Figure 1. Potentials vs. SCE.

Figures 9 (a) and (b) show equipotential contour maps for specimens F1A and F2A, plotted on a suitably scaled plan view of the dam footprint. The potentials were measured placing a SCE sequentially over points of a grid ($1/2$ in centers) traced on the specimen's inner surface. The measurements were made after 9 days drying during the 21st dry cycle (330 days). It can be observed that, although the maximum potential difference within each specimen does not exceed 75 mV, there are regions with potentials less than -300 mV vs SCE. The dashed lines in both figures represent the approximate locations of the wires under the ponding area. The data in Figure 5 suggest that for specimen F1A the part of the reinforcing cage on the right hand side of the dam area was closer to the specimen inner surface. Figure 9 (a) shows that it was precisely in that region where the potentials were more negative. A similar observation can be made for specimen F2A, but with the region with closest distance to the inner surface being on the left hand side of the dam area.

The specimens showing the earliest indications of corrosion initiation during the test period were among those with the lowest minimum cover values within each group. The potential maps in Figure 9 show that for specimen F1A the more negative potentials are in the right hand side region of the grid. According to the distribution of cover depths (Figure 5) the longitudinal steel wire in that region was the closest to the inner surface, with a minimum cover depth $cc_{min}=19$ mm. Similarly for specimen F2A, the more negative potentials corresponded to the longitudinal wire in the left hand side of the dam area, and cc_{min} was found to be 16 mm.

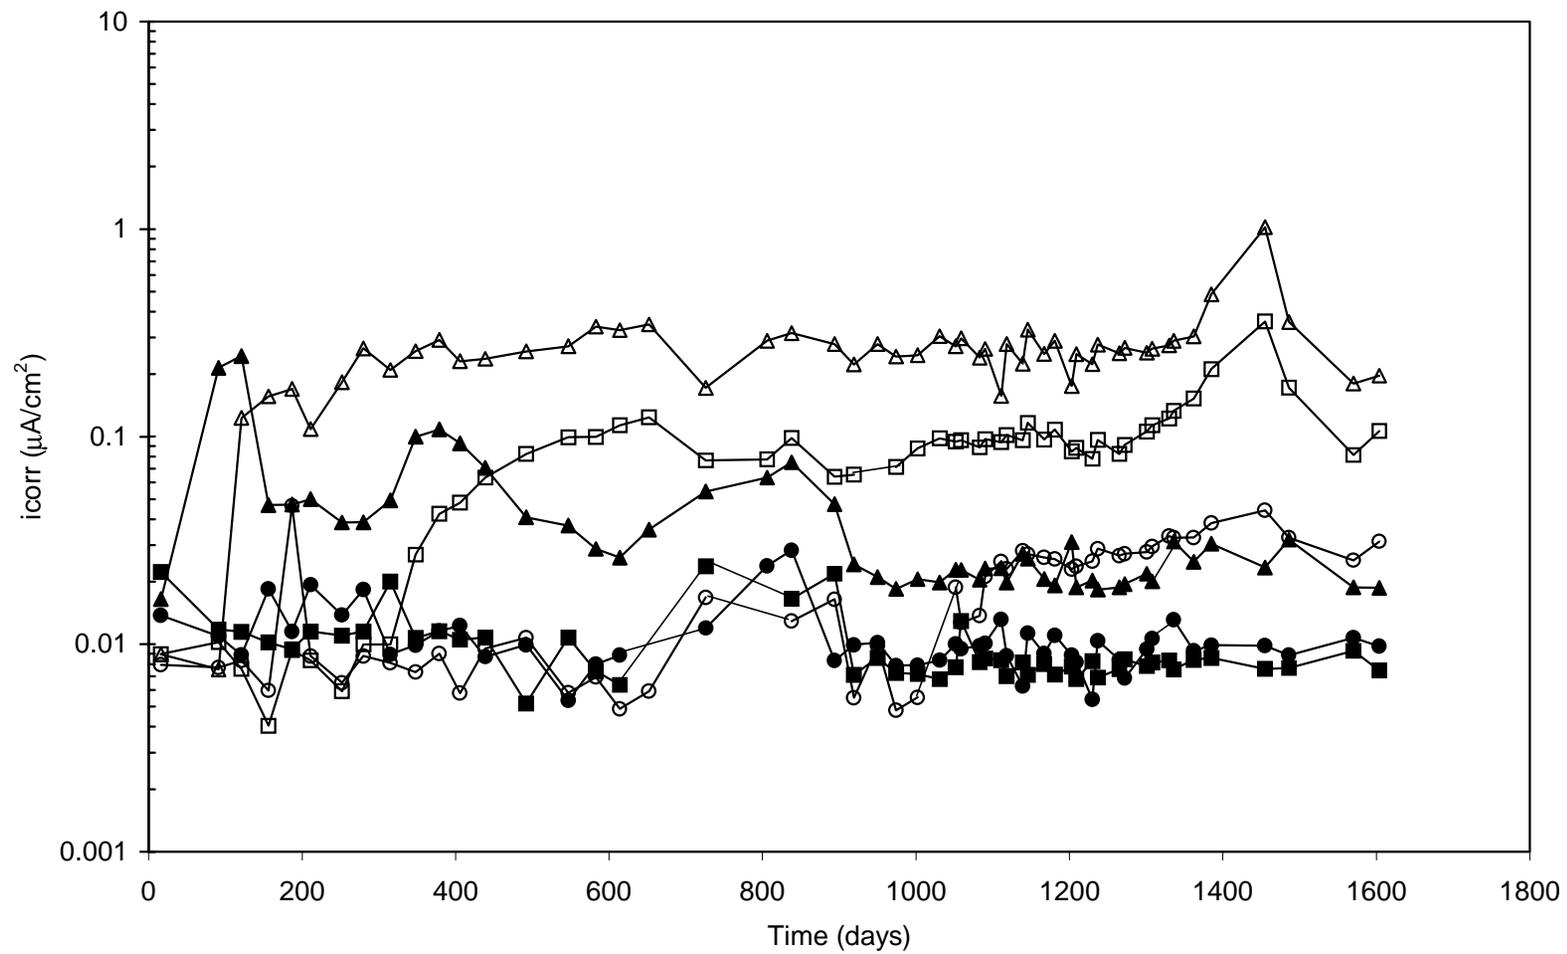
Figure 10. a. Evolution of nominal corrosion current density as a function of exposure time for specimens of set A (near the end of the wet cycle).

Apparent corrosion current densities (i_{corr}) for the specimens of sets A and B are presented, respectively, in Figures 10 (a) and (b) as a function of exposure time. In agreement with indications from the trends in E_{oc} , two specimens (O1A and O3A) in the cyclic ponding tests had very low apparent corrosion rates ($\sim 0.01 \mu\text{A cm}^{-2}$) suggesting that they were still under passive conditions at the end of the test period. For specimens O2A, F1A, F2A and F3A the time for the onset of active corrosion, inferred from the open circuit potential trends, seems to be consistent with the time when i_{corr} reached values several times greater than the low current density plateau of O1A and O3A. The highest sustained apparent corrosion current densities (F1A, F2A) were roughly between $0.1 \mu\text{A cm}^{-2}$ and $0.3 \mu\text{A cm}^{-2}$, thus suggesting a moderate corrosion rate. For the continuously ponded set only one specimen (F4B, consistent with the open circuit potential trends) reached apparent corrosion current densities indicative of sustained active corrosion. In this case the highest values were also modest ($1-2 \mu\text{A cm}^{-2}$) but larger than for the cyclic ponding specimens.

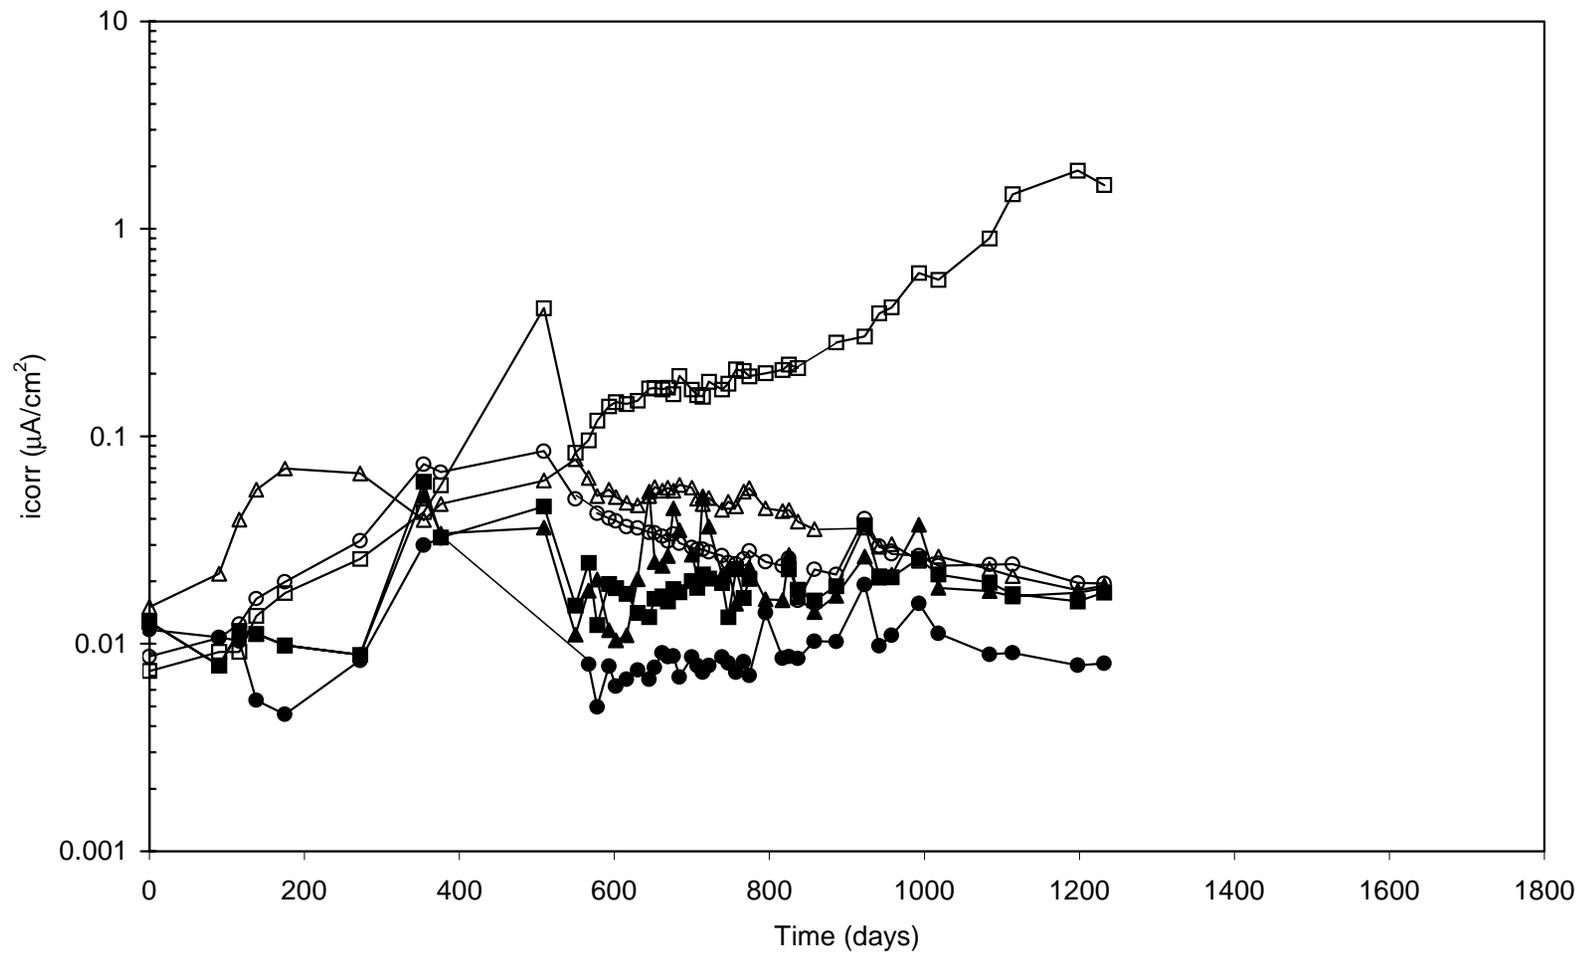
Figure 10. b. Evolution of nominal corrosion current density as a function of exposure time for specimens of set B.

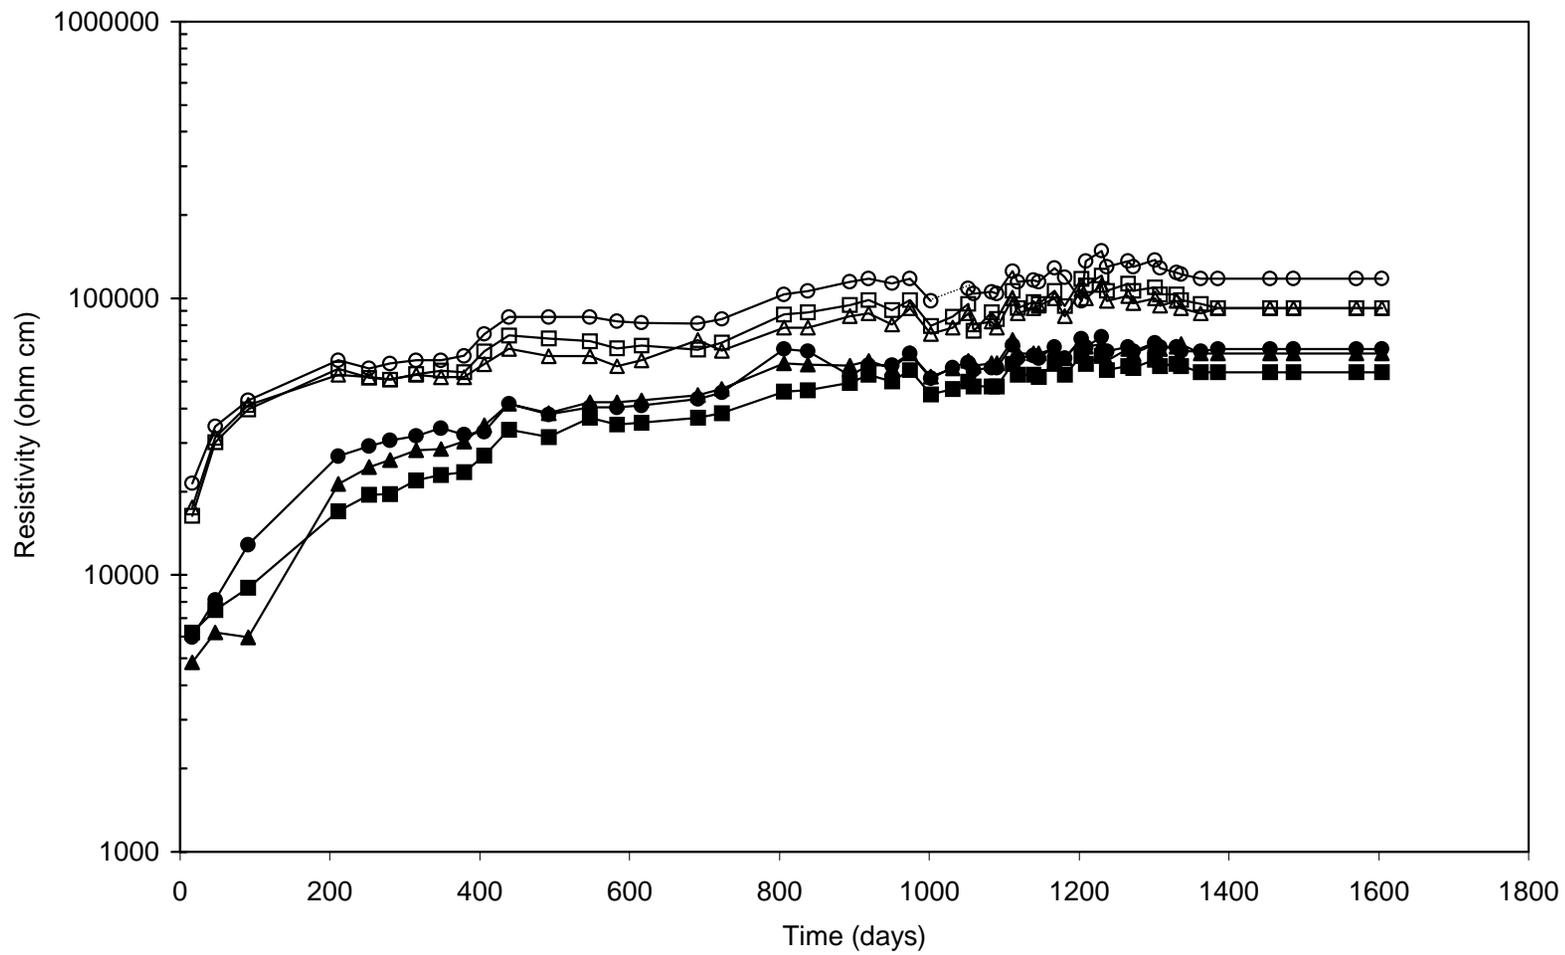
Figure 11. a. Evolution of concrete resistivity as a function of time for specimens of set A (during the wet cycles).

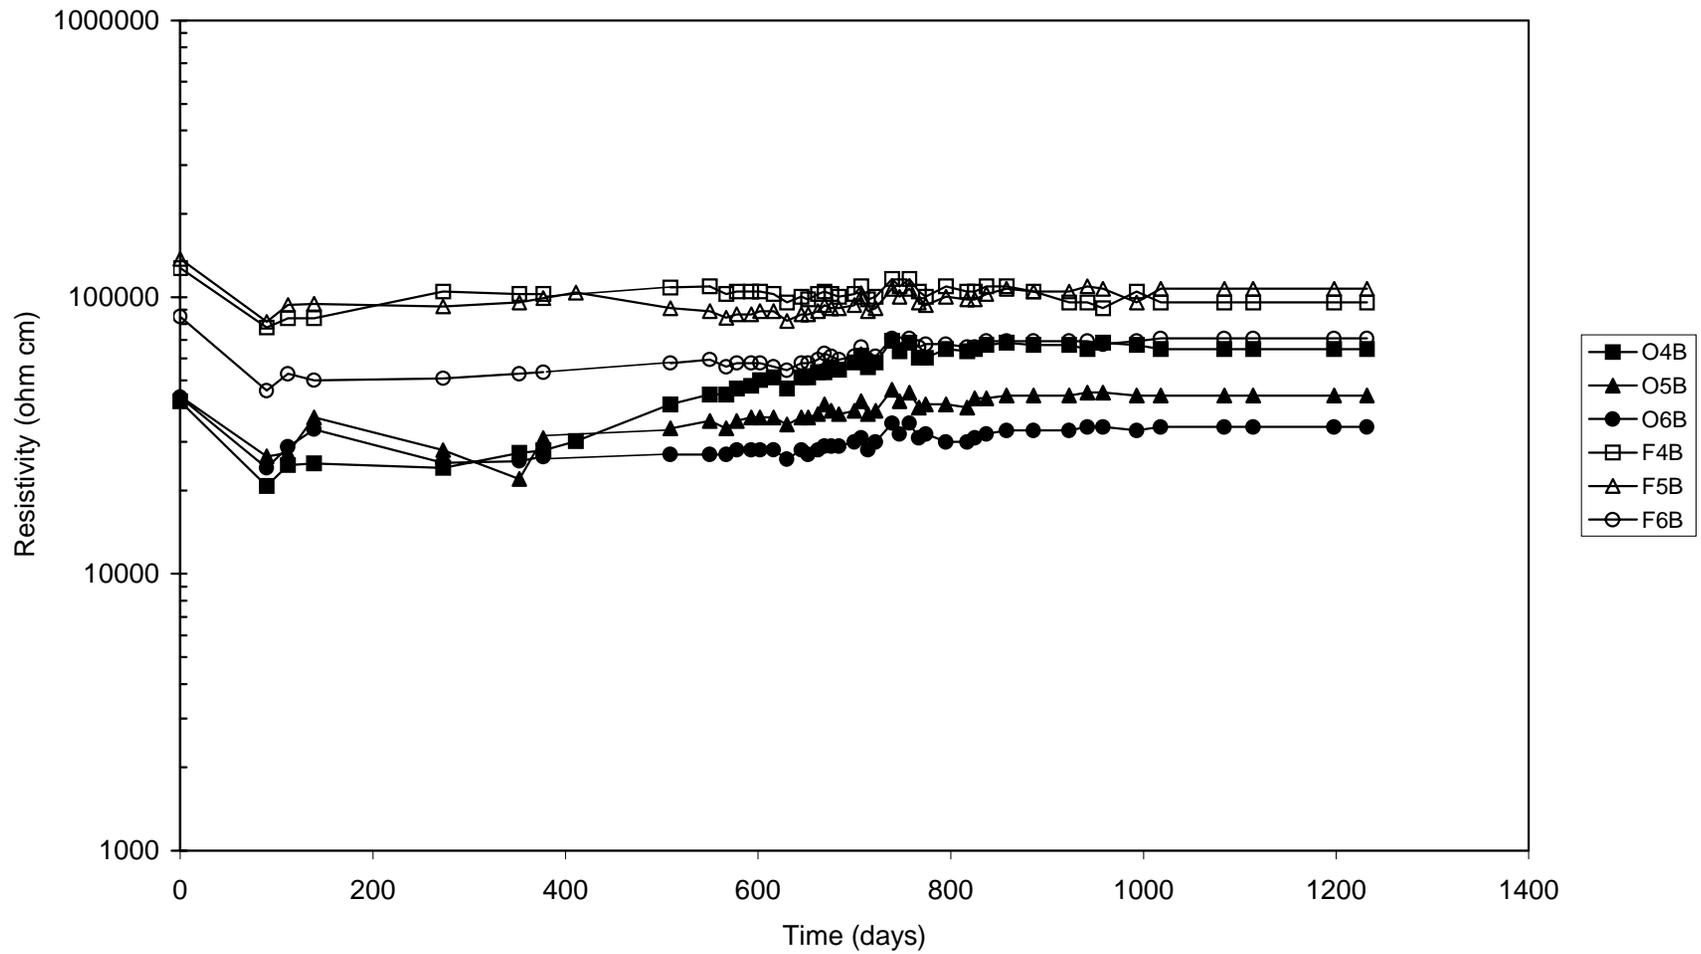
Figure 11. b. Evolution of concrete resistivity as a function of time for specimens of set B (permanently wet, with 8 months fresh water preconditioning before day 0).

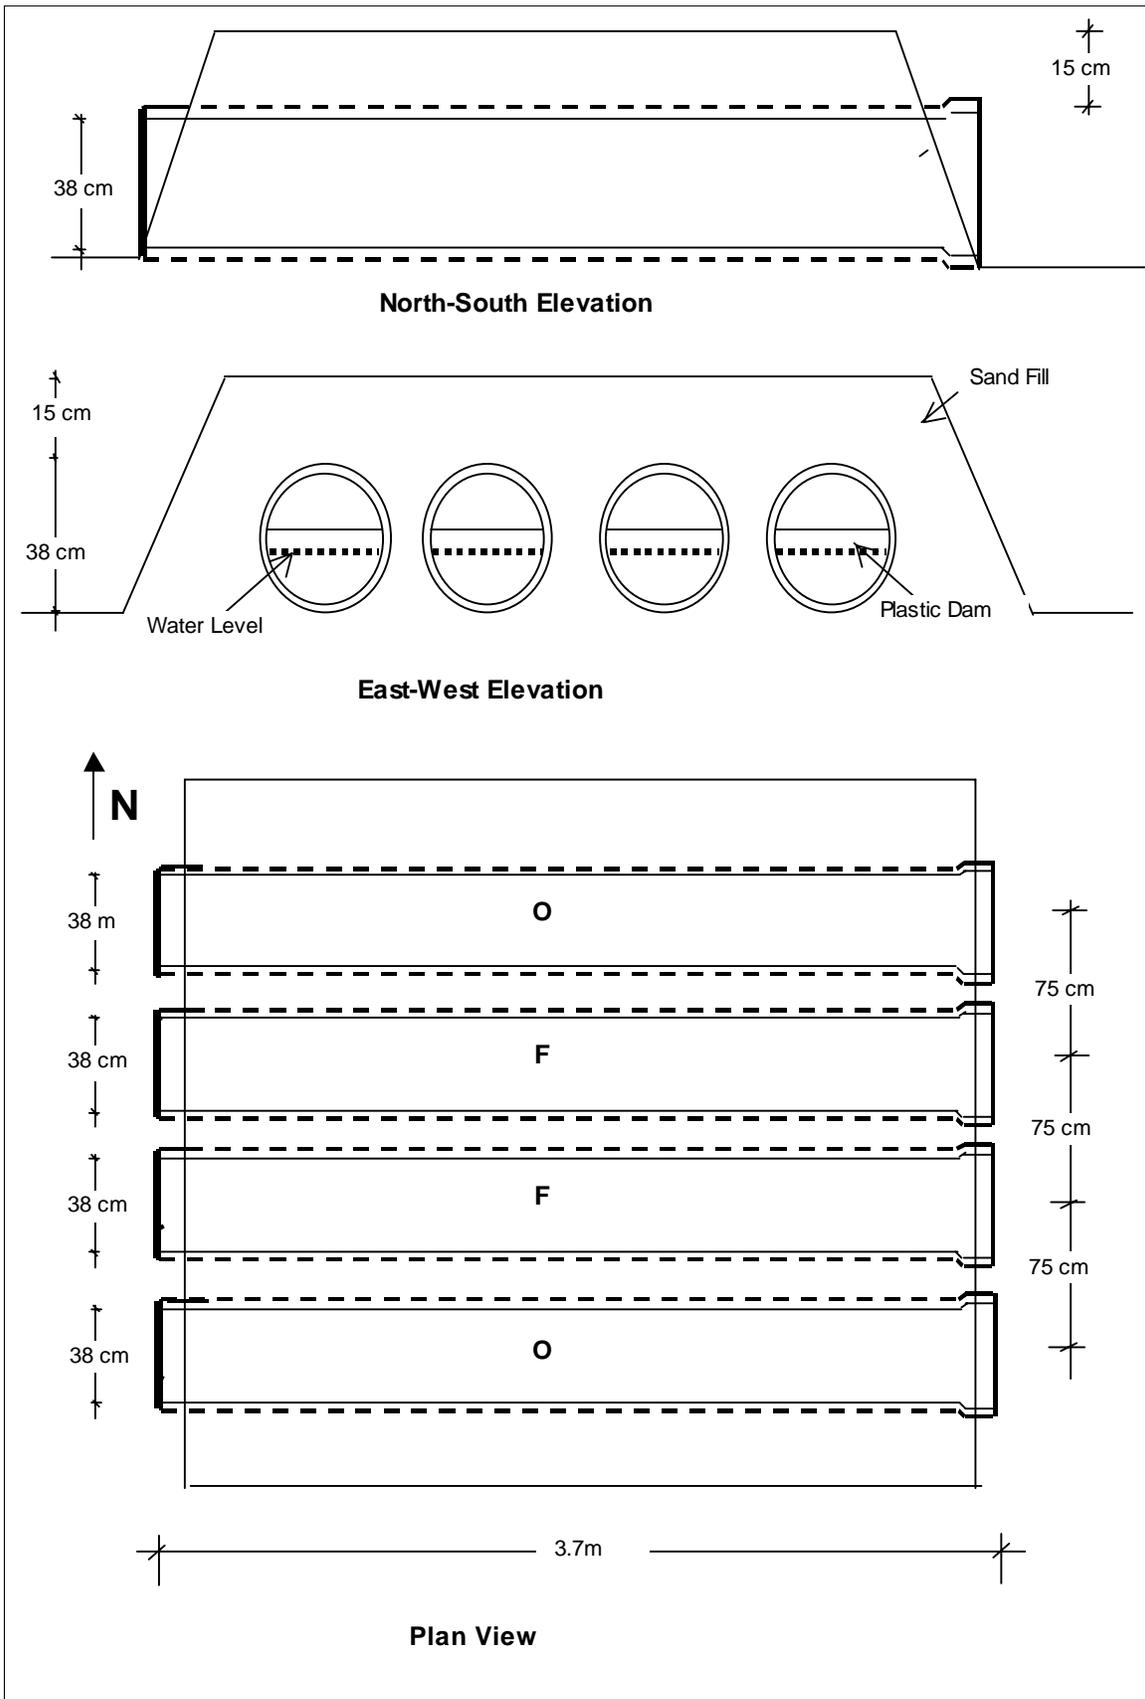
Figure 12. Culvert Yard Test Set up.

Full size pipes (38 cm (15 inch) diameter, 3.7 m (12 ft.) long) of the same stock as those used for the laboratory corrosion experiments described in the previous section, were tested by exposing in an open yard location at the University of South Florida Campus. The pipes (2 type O and 2 type F) were placed horizontally and parallel to each other (See Figure 12). The pipe group was covered by a sandy fill mound with a clear cover of ~ 15 cm (~ 6 inch) over the top and with sloping sides on each of the two external culverts. The mound left both the front and back ends of the pipes uncovered. Acrylic dams were placed at the ends of each pipe to retain up to 10 cm (4 inch) of water. The ends of the pipes were left otherwise unobstructed. Stainless steel bolts were placed at each end embedded in the concrete and in contact with the culvert reinforcement. Potential of the reinforcement was monitored between the stainless steel bolt and a Copper/Copper Sulfate Electrode (CSE) in contact with the concrete at the end of the pipe before water was placed inside, or in the water afterwards. Polarization resistance measurements were performed following the same instrumental settings as in the laboratory tests and using the stainless steel bolt for the working electrode connection, the CSE as the reference electrode, and a 6 ft length of rebar or steel wire immersed in the water inside the pipe as the counter electrode.
