**CORROSION RESISTANCE AND SERVICE
LIFE OF DRAINAGE CULVERTS**

**State Job 99700-3335-119, WPI 0510756
Contract No. B-9898
Final Report to Florida Department of Transportation**

**Alberto A. Sagüés
Principal Investigator
Department of Civil and Environmental Engineering
August 20, 2001**

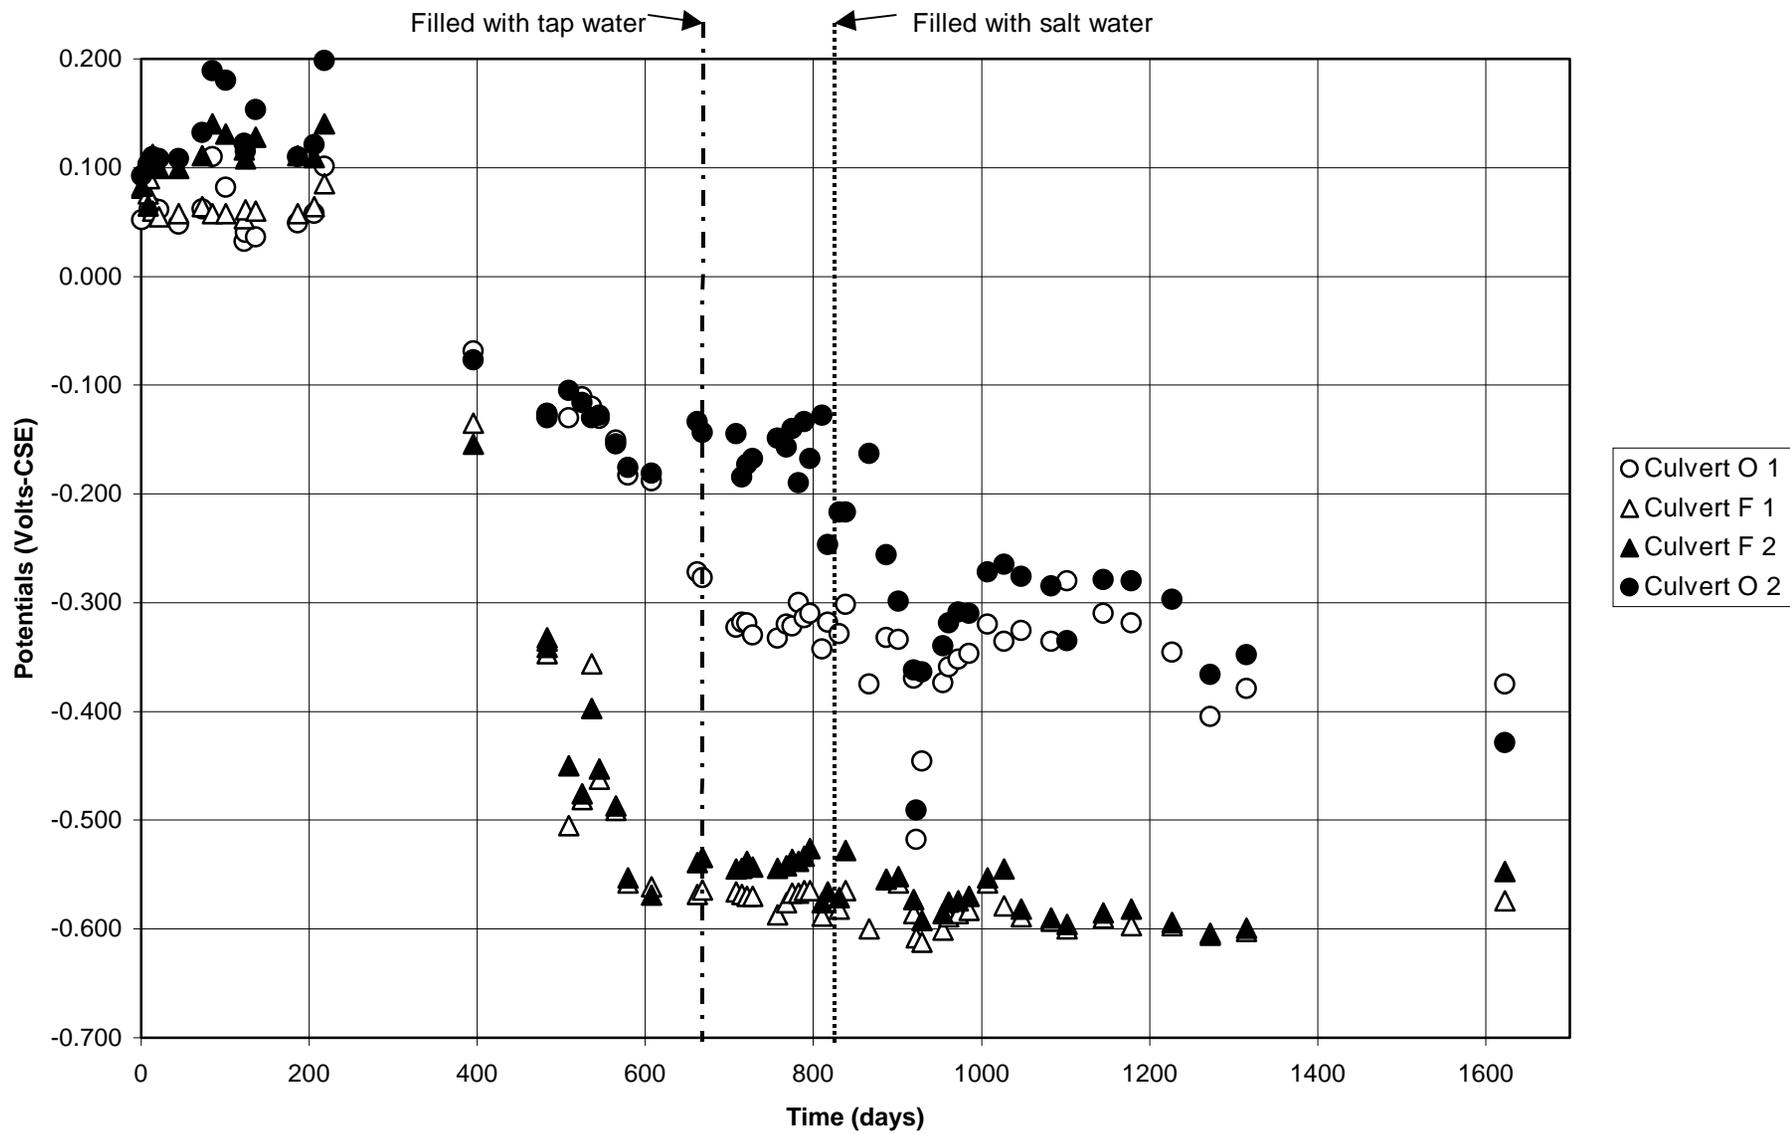
Figure 13. Potential as a function of time for reinforcement in each pipe.

Figure 13 shows the potential measurements as function of time for the reinforcement in each one of the pipes. The potentials were initially all distinctly characteristic of passive steel, but drifted to more negative values during the first ~ 1-year conditioning period without water. By the end of that period potentials in the O culverts were still indicative of passive conditions but had reached ~-500 mV CSE in the F culverts. After introduction of fresh water potentials in both F culverts and one of the O culverts decayed by another ~100 mV. After saltwater introduction the potential in the F culverts decayed slightly more to reach an apparently stable value of ~-600 mV CSE. Potentials in both O culverts reached ~-400 mV CSE after ~2 years of introducing saltwater.

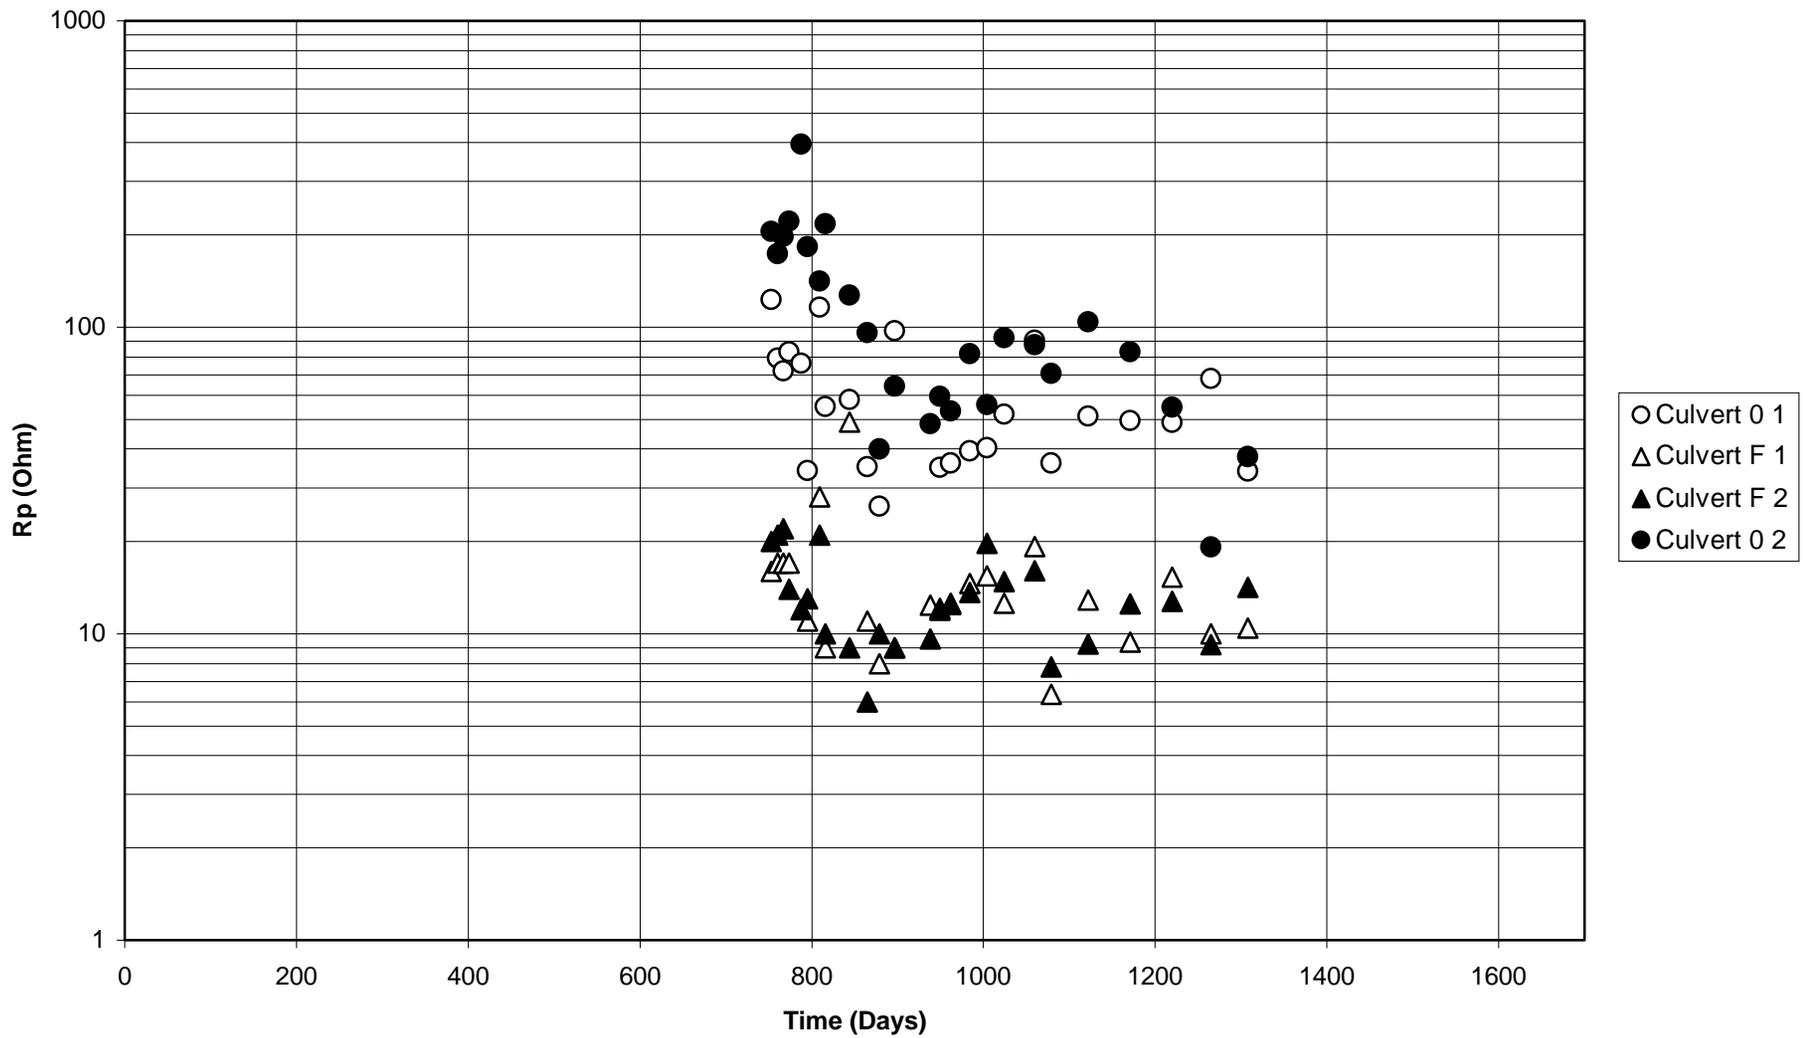
Figure 14 . Polarization resistance as a function of time for each pipe (solution resistance (solution resistance subtracted)).

Polarization resistance measurements (solution resistance subtracted) are reported in Figure 14. The area of steel sampled by the measurements is uncertain since current distribution is likely to be quite uneven. Accordingly, only the total polarization resistance (expressed in ohms, not ohm-cm²) is reported, but a very rough estimate indicates that the lowest polarization resistances observed correspond to an apparent corrosion current density on the order of 1 $\mu\text{A}/\text{cm}^2$. Such value is comparable to the highest values observed in the laboratory specimens. Although experimental scatter is large, R_p for the F culverts was clearly several times smaller than that for the O culverts, and the latter appears to have a

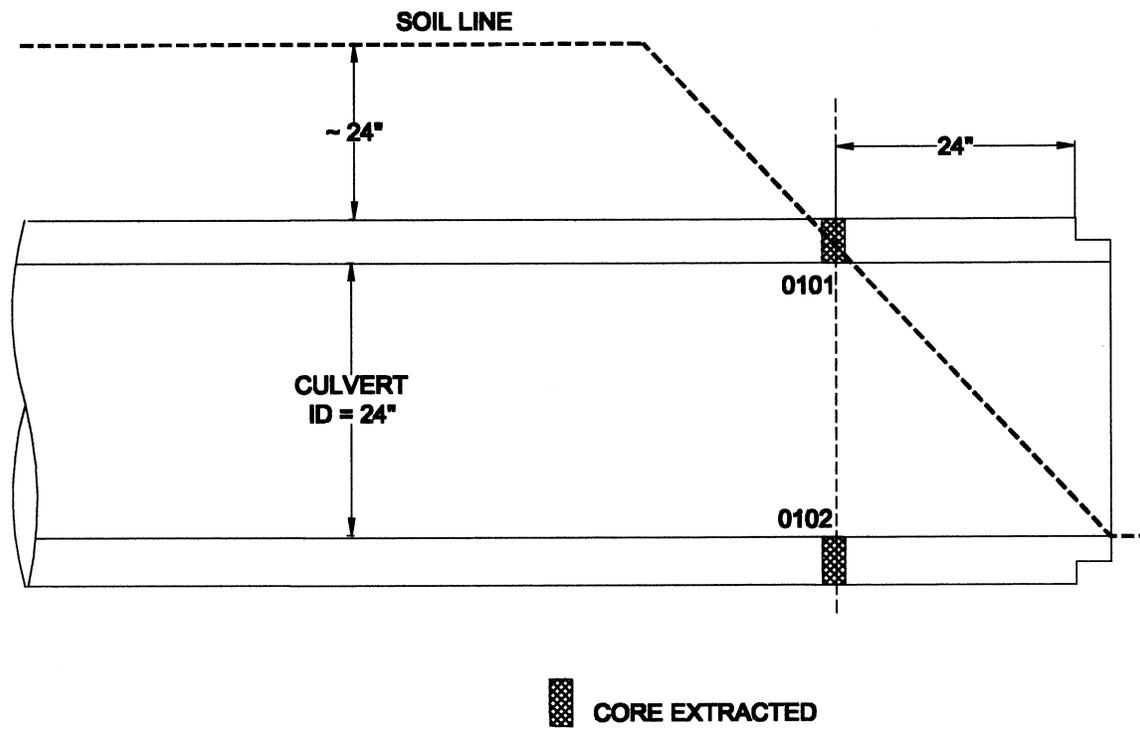
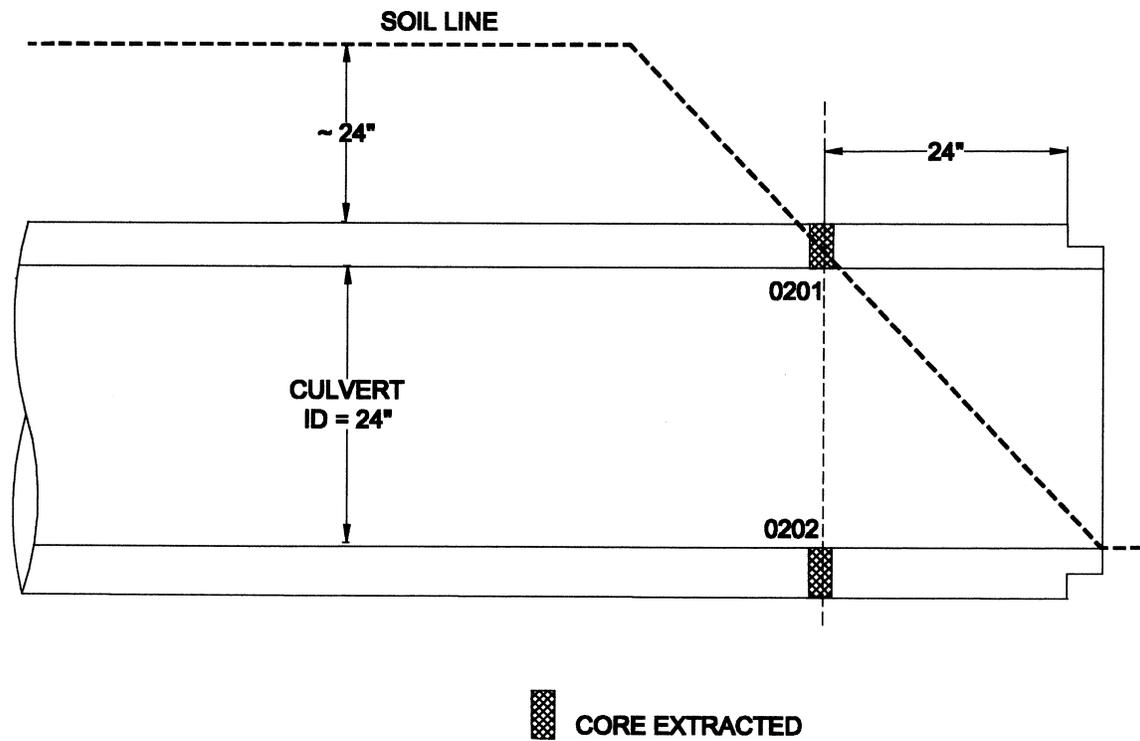
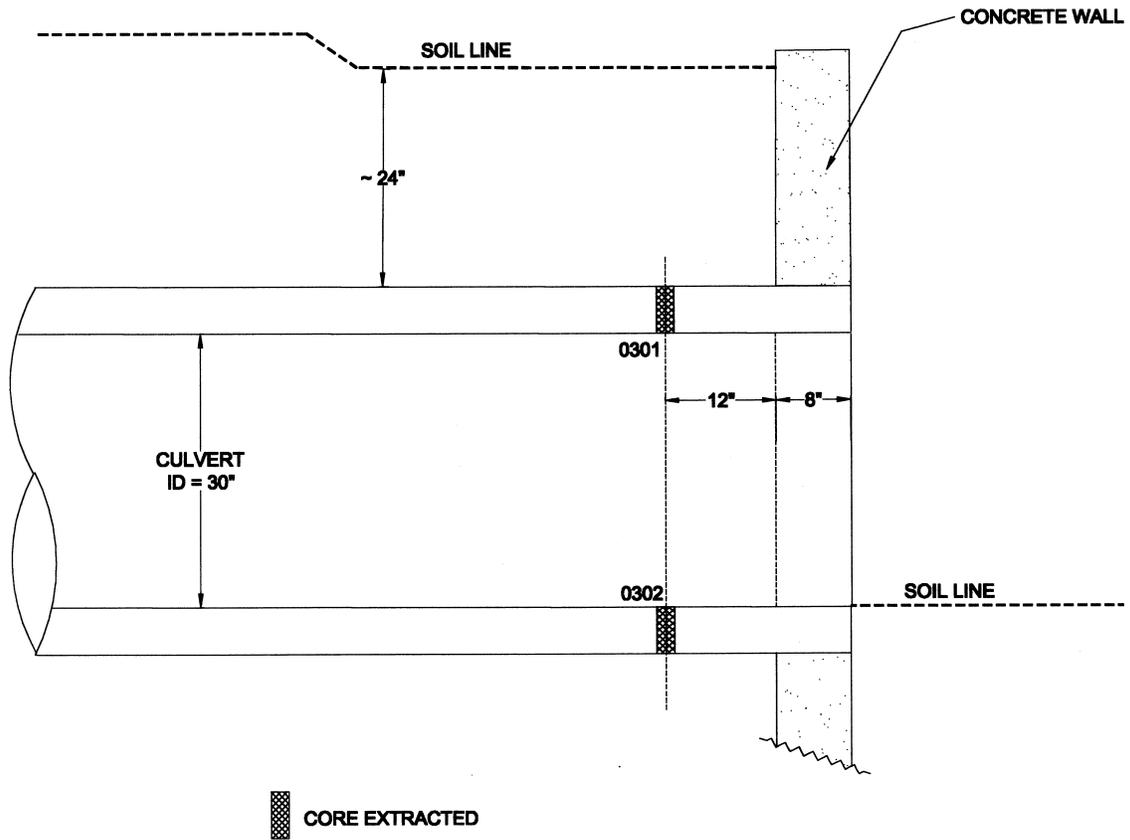
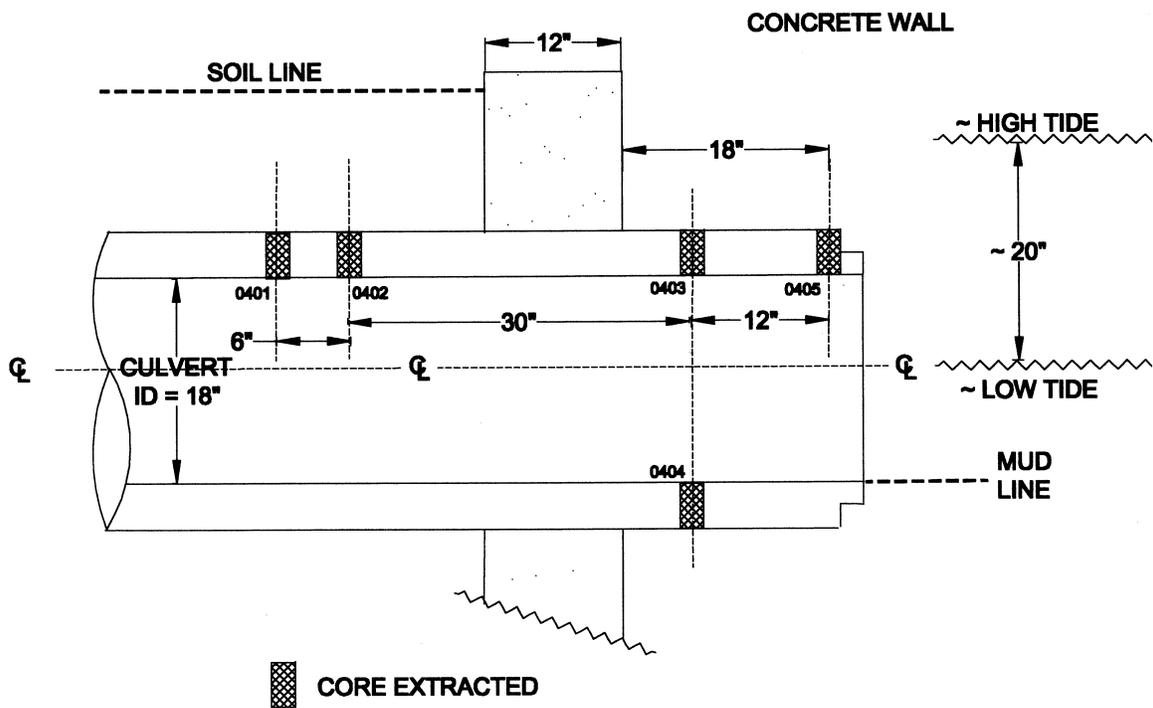
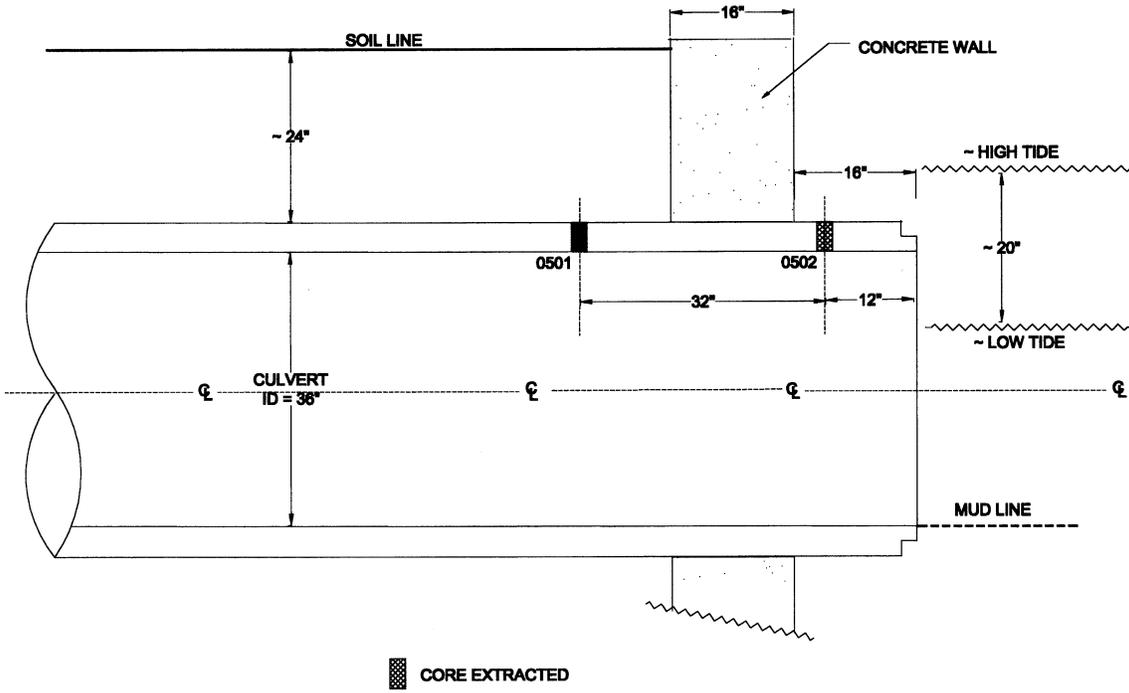
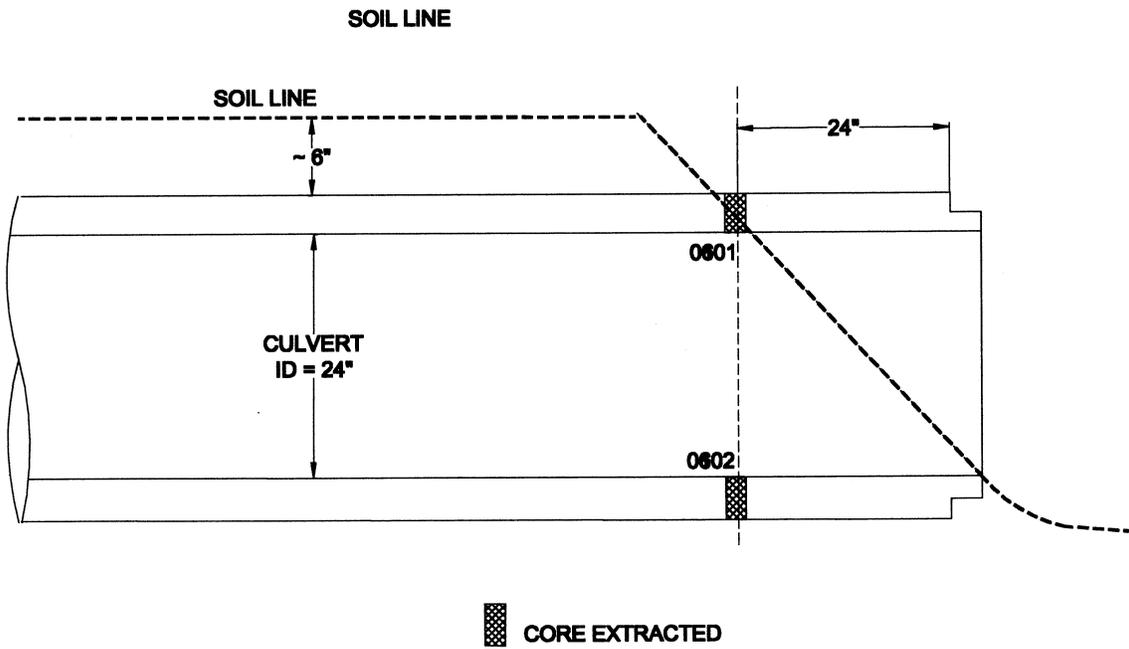
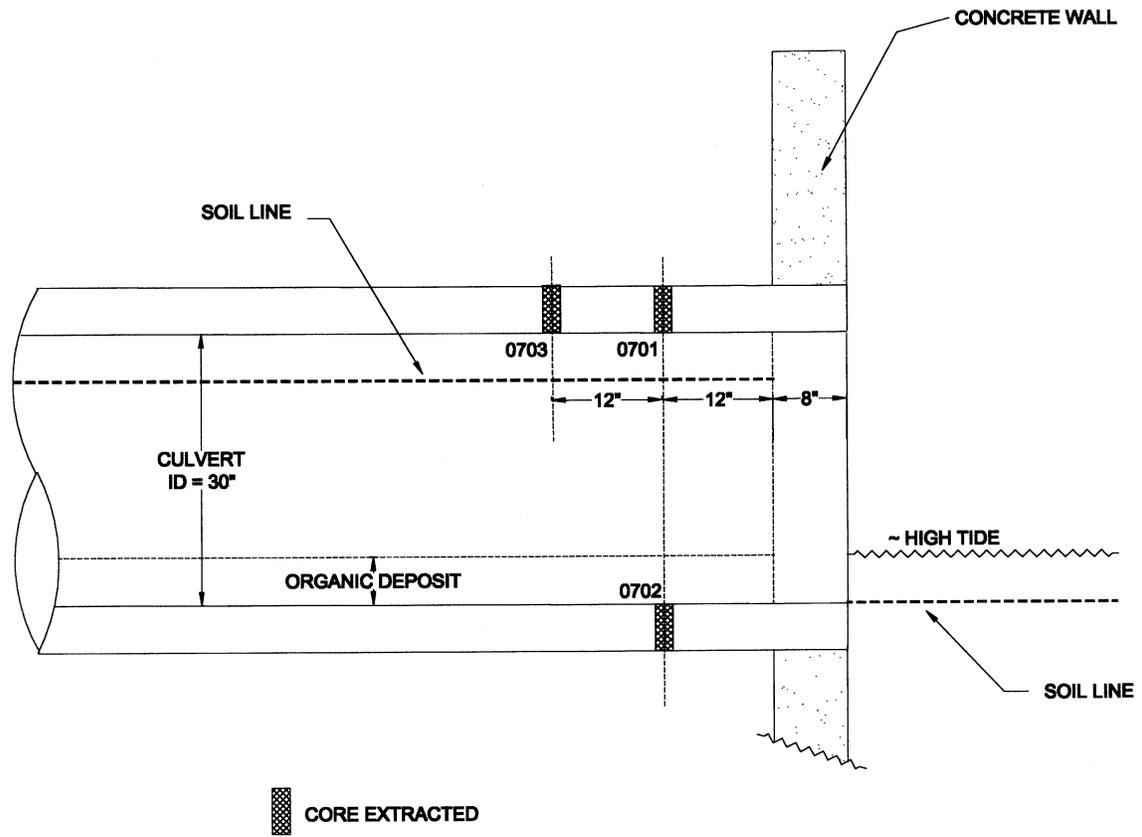
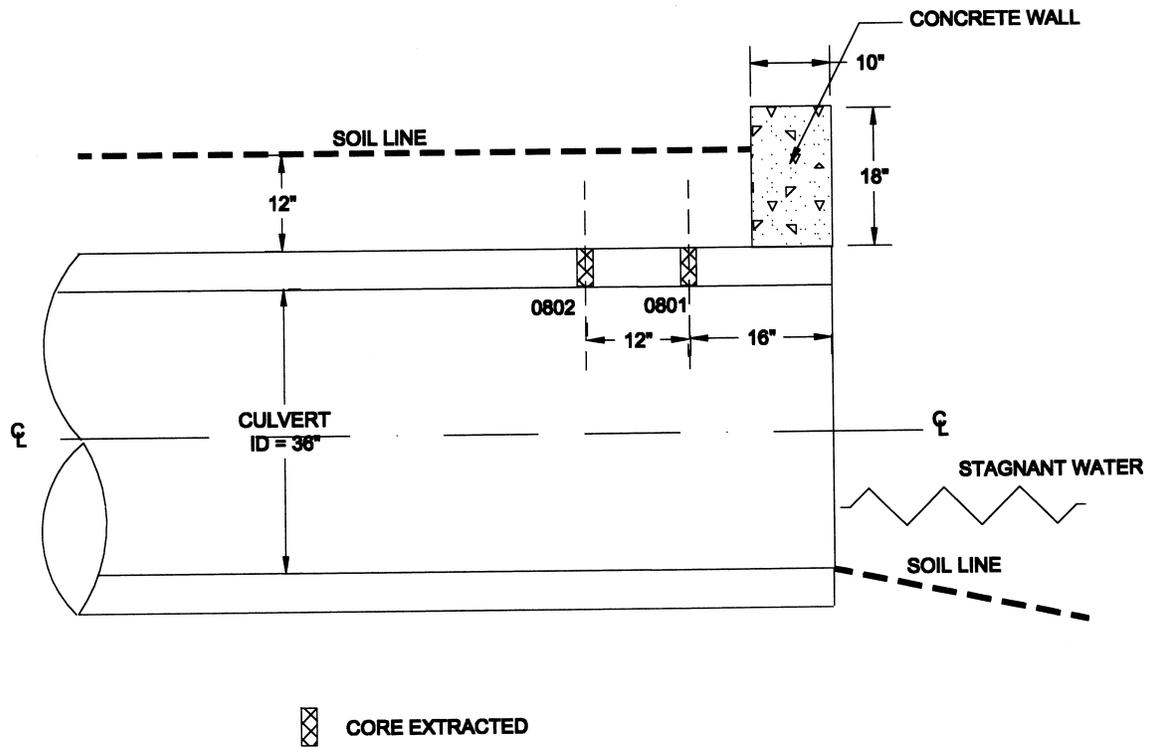
A sketch with dimensions and exposure conditions of each culvert is given in Figures 15 to 22, and a summary description of each exposure condition is given in Table 4 along with a listing of the key observations indicated in the following. Structure age was always subject to uncertainty but whenever possible it was estimated from FDOT Project number designations for the structures deemed to be associated with the culvert. The structures were visually inspected to determine overall appearance including evidence of corrosion, and the result was used to assign a rating designation ranging from "Very Good" to "Poor" to each culvert examined. Samples of soil around the culvert (usually near the crown) and water if available were analyzed for pH, Chloride and Sulfate content, and resistivity following standard procedures for soil and water analysis. Table 4 also notes the corrosion condition of steel present in cores that were extracted as indicated next.

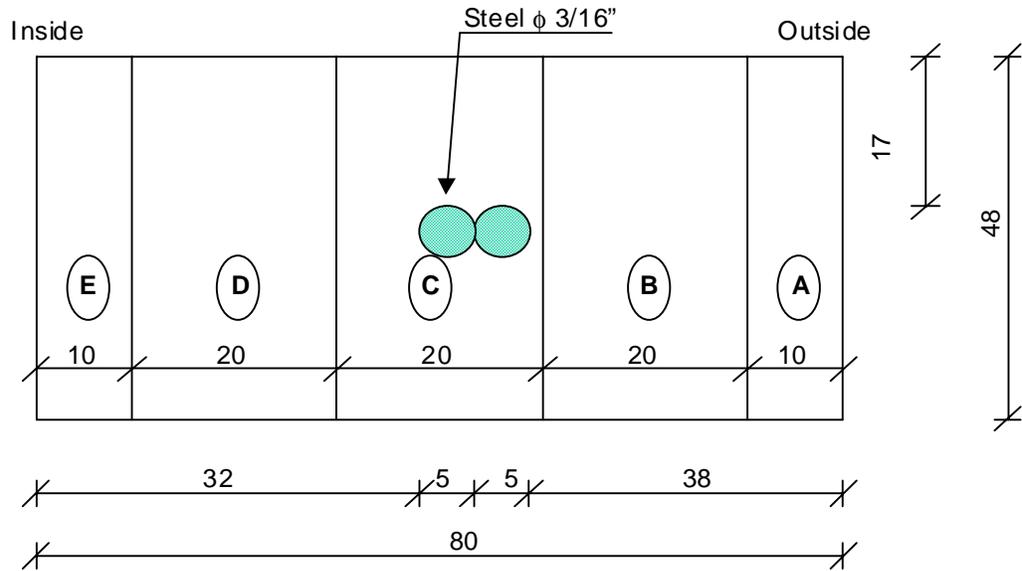
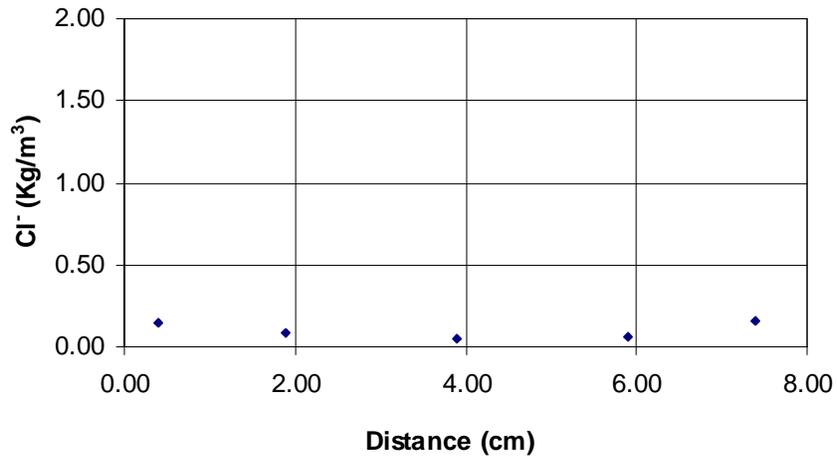
Figure 23. Core # 0102

Sample #	Sample Width (cm)	Distance x (cm)	Chloride Content (kg/m ³)
0102-E	1.0	0.4	0.14
0102-D	2.0	1.9	0.09
0102-C	2.0	3.9	0.05
0102-B	2.0	5.9	0.065
0102-A	1.0	7.4	0.16

Chloride content vs distance from inside surface

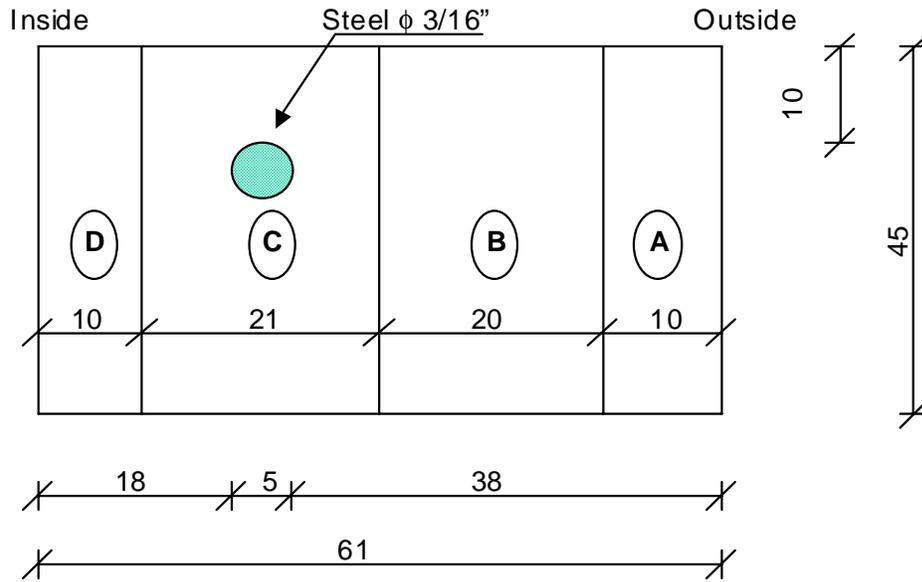
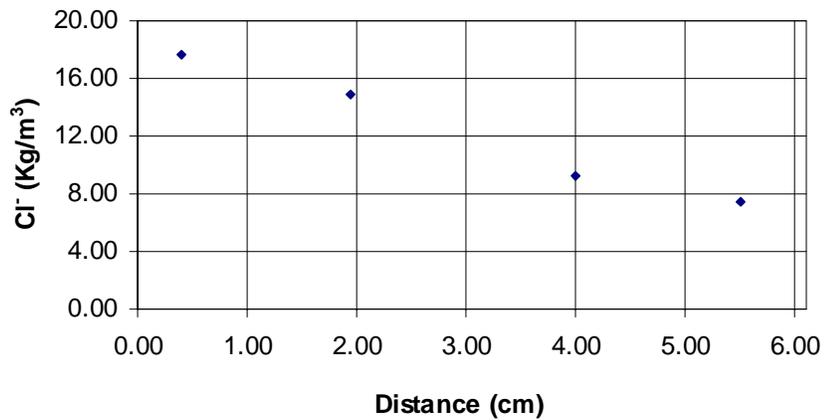
Figure 24. Core # 0401

Sample #	Sample Width (cm)	Distance x (cm)	Chloride Content (kg/m ³)
0401-D	1.0	0.4	17.71
0401-C	2.0	1.9	14.84
0401-B	2.0	4.0	9.26
0401-A	1.0	5.5	7.44

Chloride content vs distance from inside surface

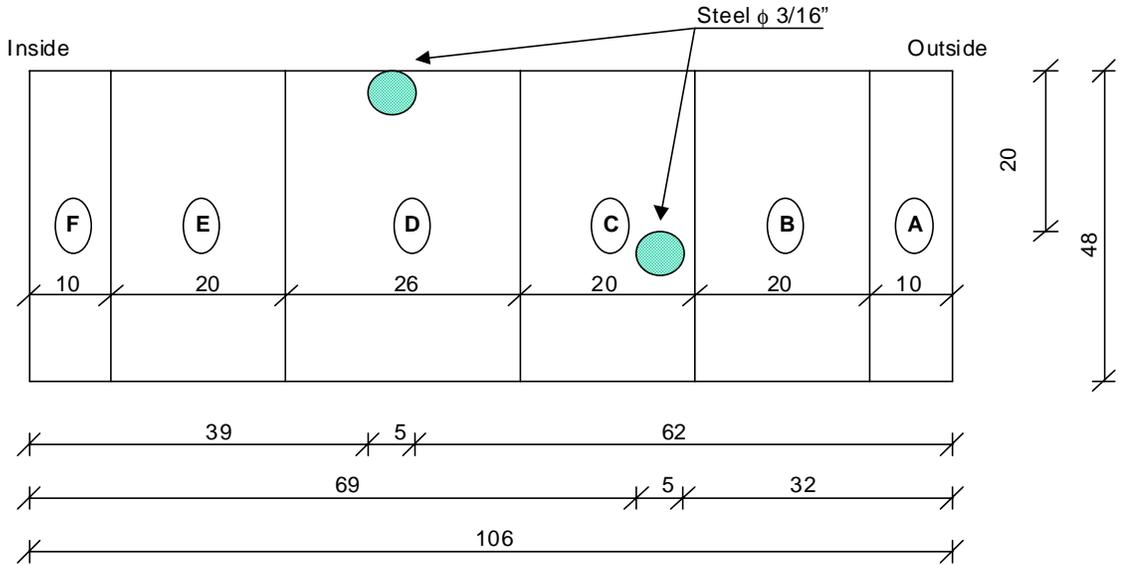
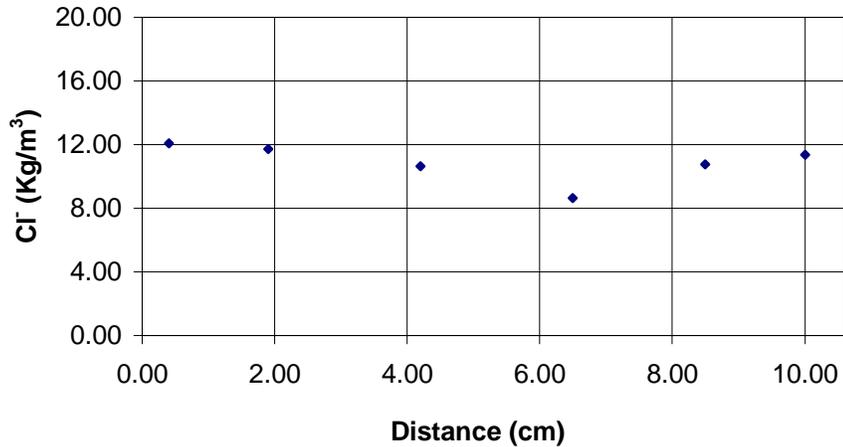
Figure 25. Core # 0502

Sample #	Sample Width (cm)	Distance x (cm)	Chloride Content (kg/m ³)
0502-F	1.0	0.4	12.1
0502-E	2.0	1.9	11.71
0502-D	2.6	4.2	10.64
0502-C	2.0	6.5	8.65
0502-B	2.0	8.5	10.76
0502-A	1.0	10.0	11.36

Chloride content vs distance from inside surface

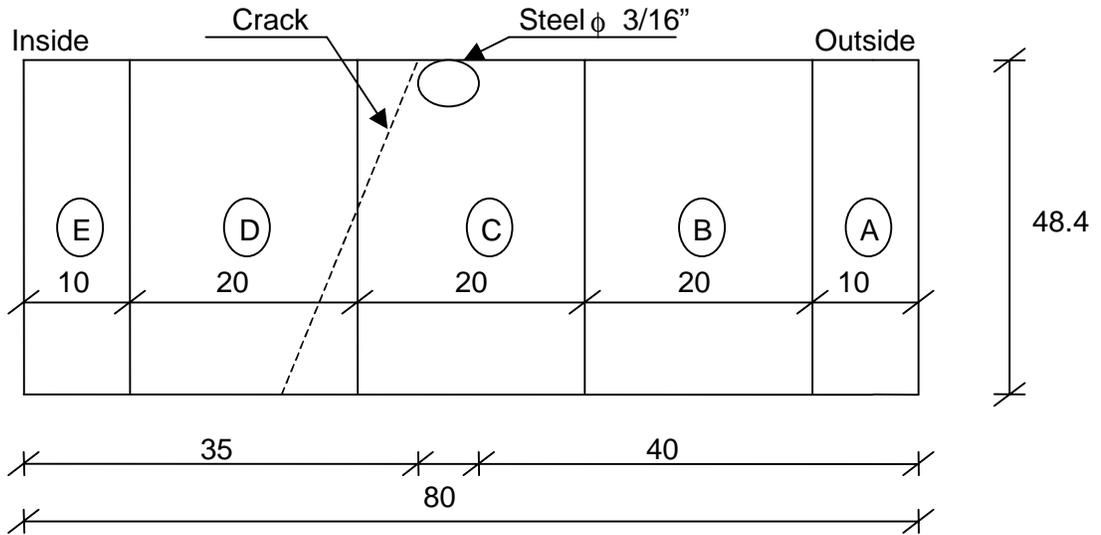
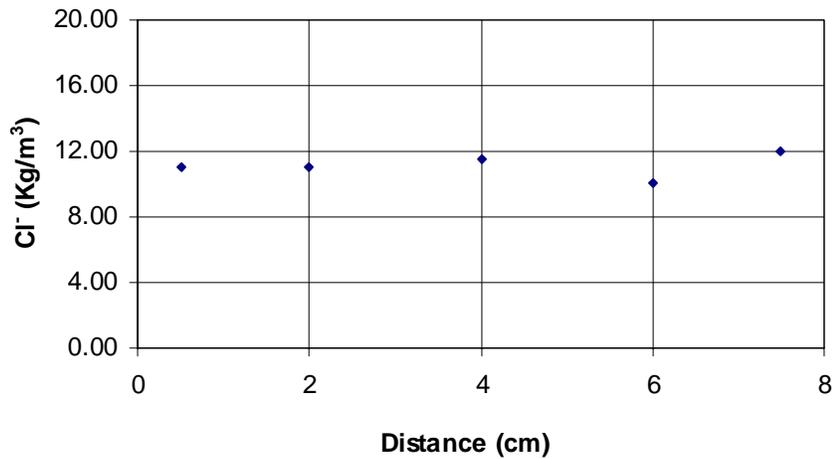
Figure 26. Core # 0602

Sample #	Distance x (cm)	Chloride Content (kg/m ³)
0602-E	0.5	11.09
0602-D	2.0	11.05
0602-C	4.0	11.55
0602-B	6.0	10.07
0602-A	7.5	11.96

Chloride content vs distance from inside surface

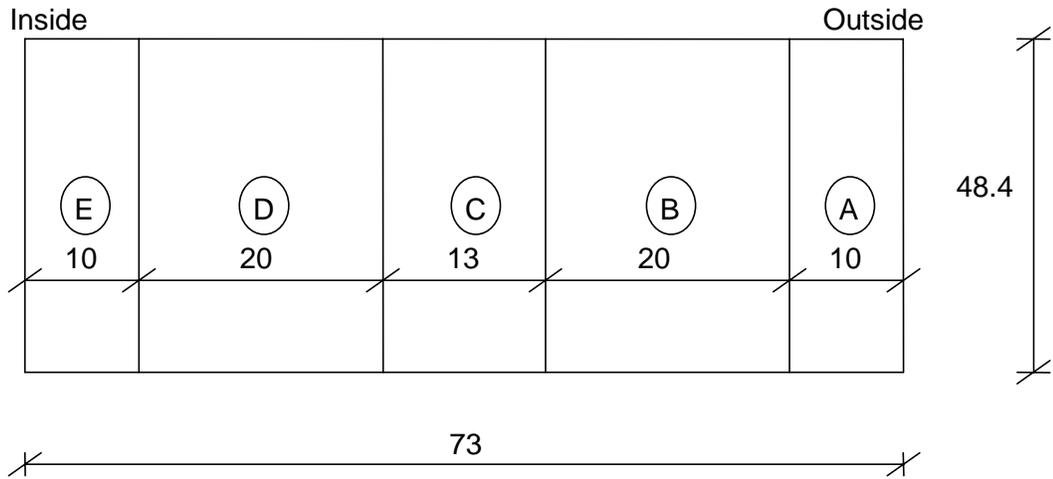
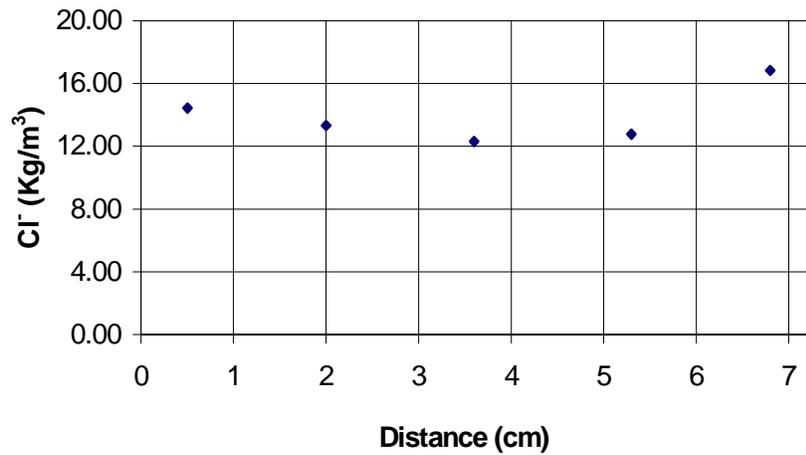
Figure 27. Core # 0702

Sample #	Distance x (cm)	Chloride Content (kg/m ³)
0702-E	0.5	14.43
0702-D	2.0	13.31
0702-C	3.6	12.30
0702-B	5.3	12.76
0702-A	6.8	16.83

Chloride content vs distance from inside surface

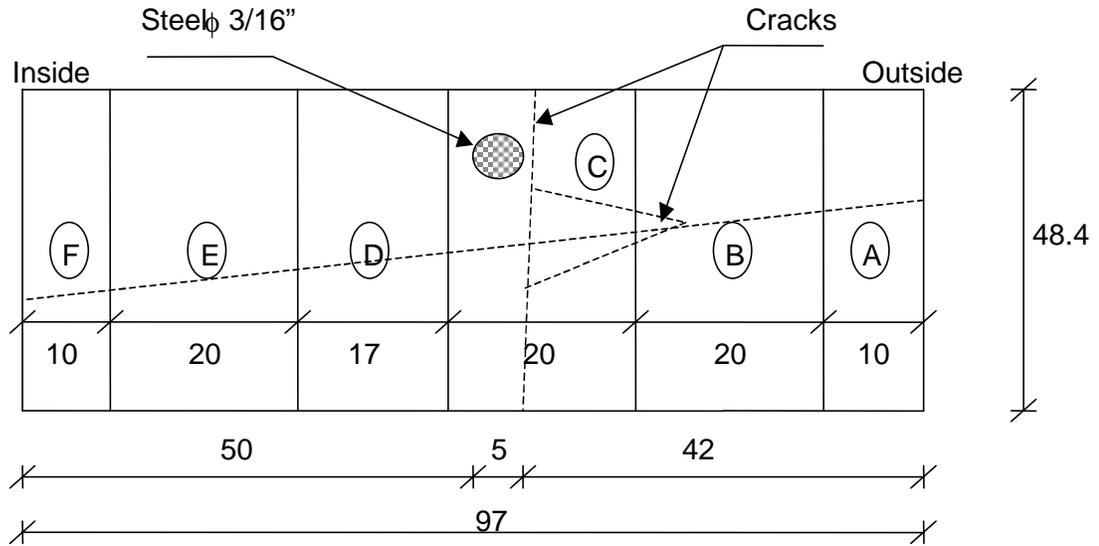
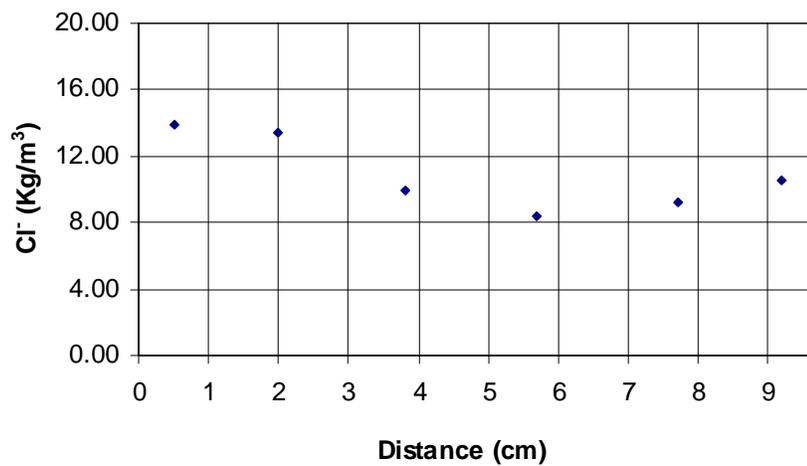
Figure 28. Core 0703

Sample #	Distance x (cm)	Chloride Content (kg/m ³)
0703-F	0.40	13.85
0703-E	2.0	13.38
0703-D	3.8	9.99
0703-C	5.7	8.39
0703-B	7.7	9.17
0703-A	9.2	10.53

Chloride content vs distance from inside surface

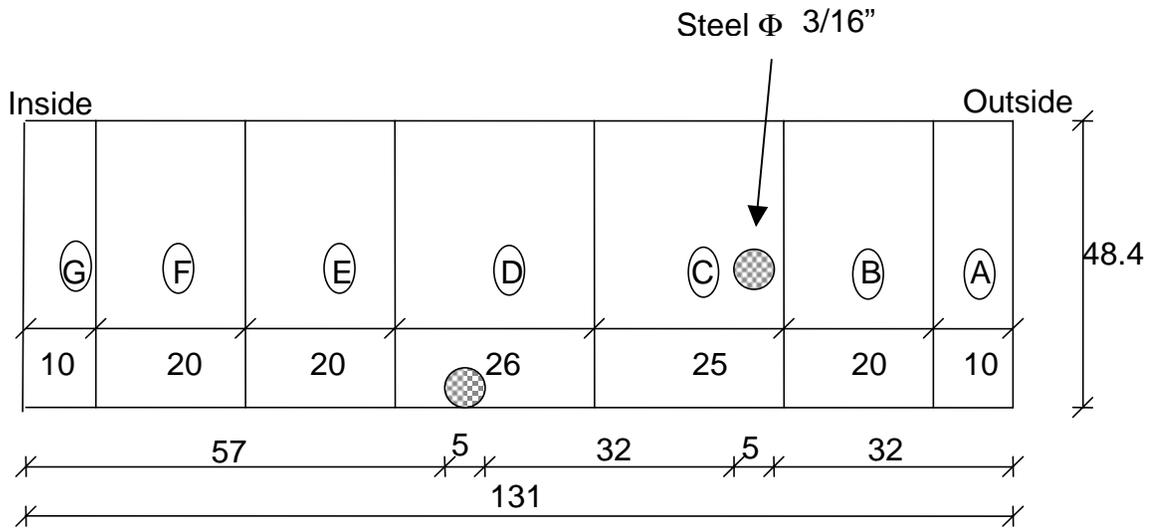
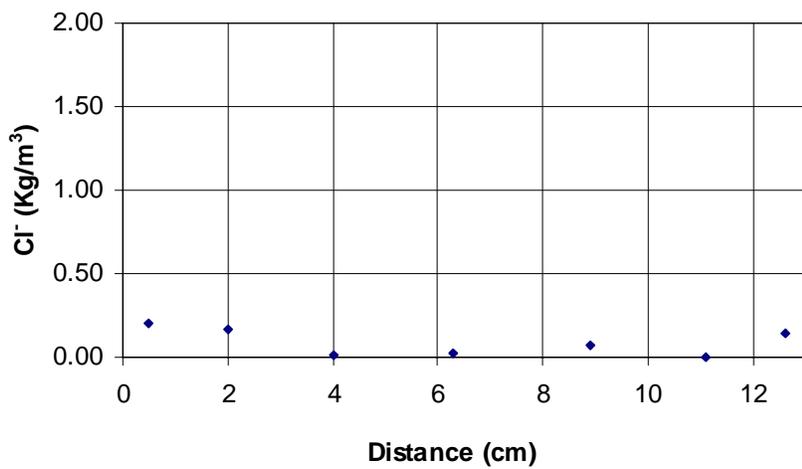
Figure 29. Core # 0801

Sample #	Distance x (cm)	Chloride Content (kg/m ³)
0801-G	0.40	0.2
0801-F	1.90	0.17
0801-E	3.90	0.015
0801-D	6.20	0.018
0801-C	8.75	0.07
0801-B	11.00	0.00
0801-A	11.50	0.14

Chloride content vs distance from inside surface

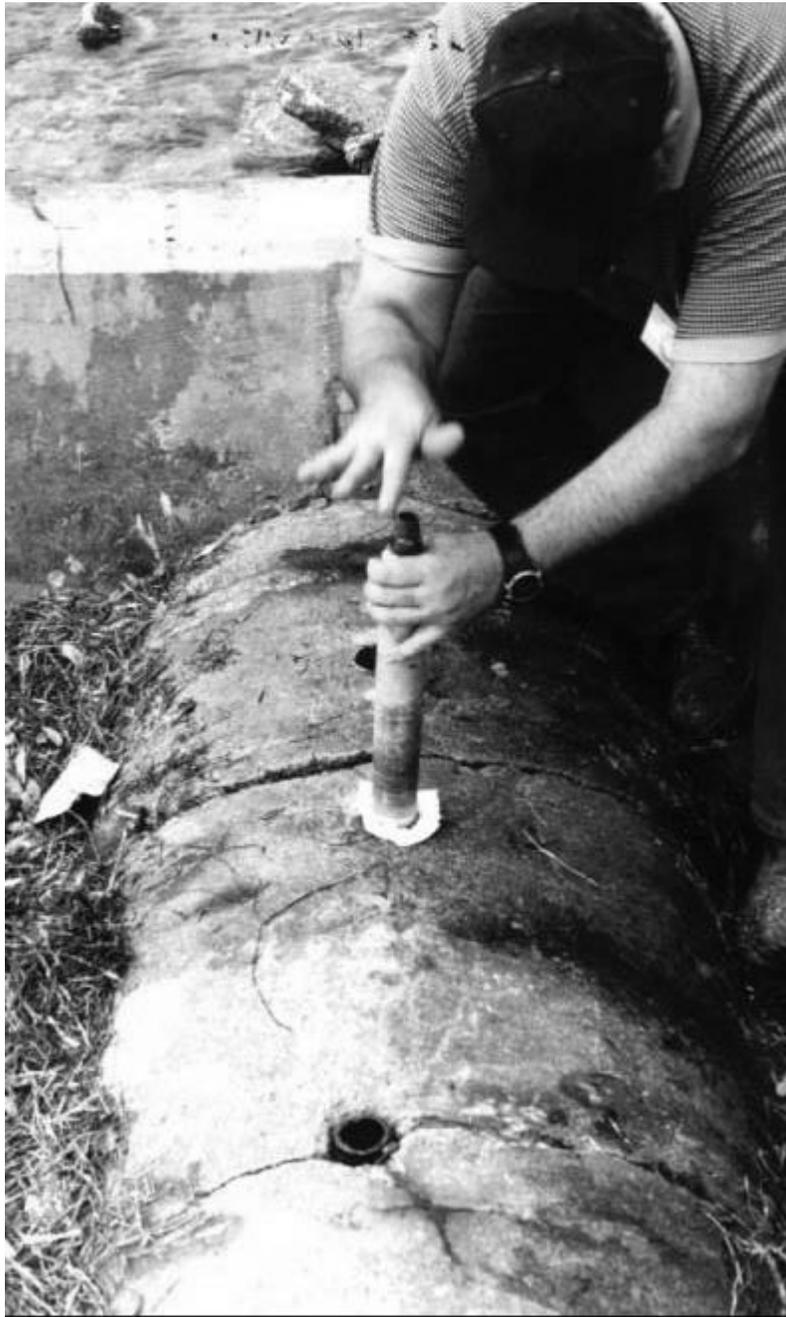
Figure 30. Site No. 7. End of San Jose Street. Low Tide. Core extraction. Evidence of pipe distress.

As shown by the chemical analysis information in Table 4, the water in locations 04 to 07 had a composition typical of seawater (with perhaps some minor dilution), and the soil next to the culvert showed significant seawater contamination in three of those locations. These extremely aggressive conditions are consistent with the evidence of pronounced corrosion seen at 3 of those sites. As expected, the sites where the Crown was below high tide (thus less likely to experience evaporative chloride concentration) have the best overall appearance and less evidence of rust in the rebar inside cores. The two sites with Crown above high tide had the most evidence of damage. Although all culverts examined appeared to be still fully functional, the condition at location 07 (estimated age 43 years) appears to be indicative of a structure approaching the end stages of its service life (See Figures 30 and 31).

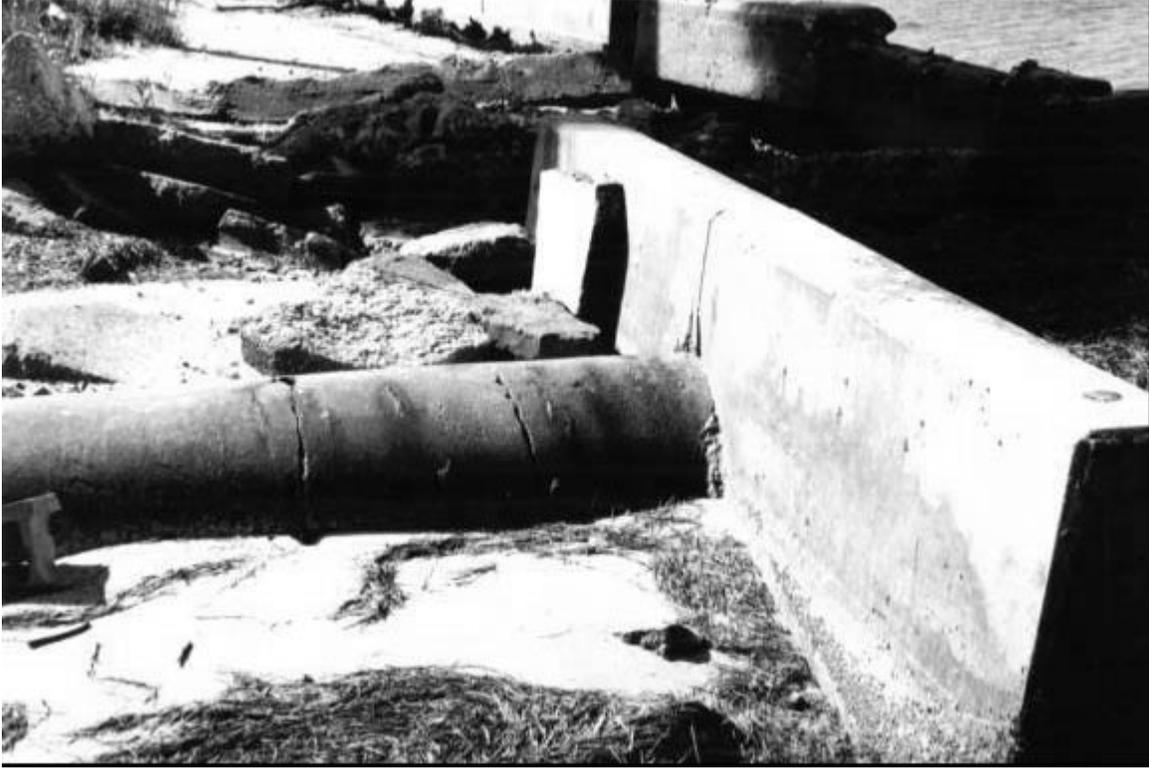
Figure 31. Site No. 7. End of San Jose Street. Low Tide. Side View.

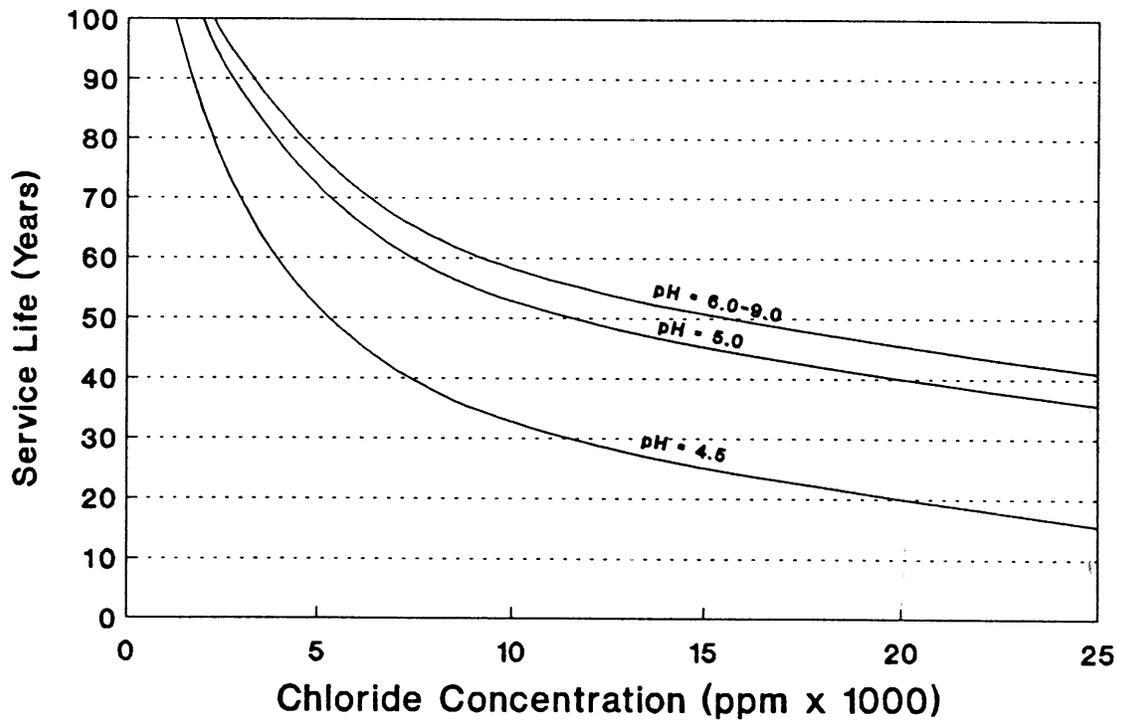
Figure 32. Estimated Service Life vs. pH and Chlorides for 36" DIA Concrete Culverts, S=1500 ppm

Report No. 93-4A illustrates that for a typical 36-inch diameter culvert pipe with concrete cover D_c = 1.05, concrete with C_c = 6 bags and W = 9%, then SL ~110 years when K and S are small (e.g. < 1,000 ppm) and pH is neutral to basic (e.g. > 6). As K or S increase the value of SL decreases smoothly, reaching values on the order of 40 years when typical seawater conditions (K ~ 20,000 ppm and S ~2,500 ppm) are reached. Figure 32 (reproduced from Figure 5-1 in Report No. 93-4A) summarizes the overall SL predictions for concrete for the case of S = 1500 ppm.
