Unexpected Corrosion of Aluminized Steel Pipes in Limestone Backfill

ABSTRACT ⁽¹⁾

Key Words: aluminum, steel, coating, corrosion, limestone, backfill, culvert pipe, high pH

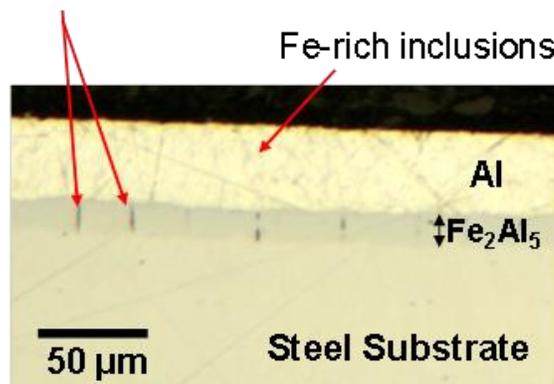
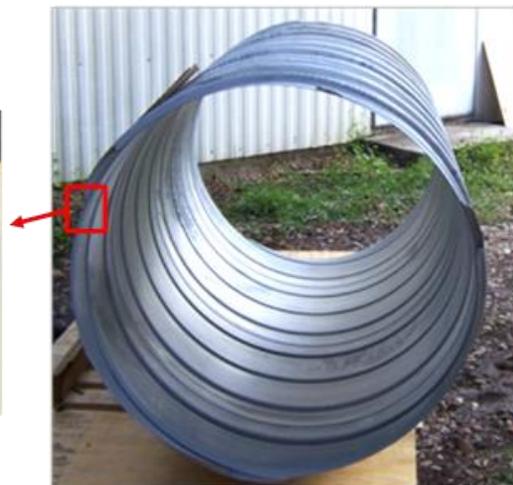
Intermetallic Breaks

Figure 1: Metallographic cross-section of AST2 on left. AST2 spiral ribbed pipe on right.

Aluminized steel Type 2 (AST2) is produced as a steel sheet hot-dip coated on both sides with commercially pure aluminum (ASTM⁽²⁾ A929 and AASHTO⁽³⁾ M274). The final coating over the carbon steel base is ~50 μm , including a 35 μm thick outer coating having a nearly pure aluminum matrix with intermetallic precipitates and a 15 μm intermetallic inner layer with frequent breaks, as shown in Figure 1. In mild environments, as those commonly found in Florida's inland waters, the aluminum outer layer naturally forms a stable passive film, which protects aluminum from further corrosion. The main composition of this film in water is reported as hydragillite, $\text{Al}_2\text{O}_3 \cdot 3\text{H}_2\text{O}$.¹⁻² Hydragillite is thermodynamically stable in the pH range of about 4 to 8.5 for solute species concentrations in the order of 10^{-4} M.³ Beyond this range, the passive film is dissolved as Al^{3+} in acidic, and AlO_2^- (aluminate ion) in basic, environments.¹⁻² Upon breakdown of the protective film the coating provides some limited galvanic protection to any exposed steel substrate.⁴

Culvert and drainage pipes made of AST2 are commonly corrugated or ribbed for greater structural stiffness, and are required to have long service life (e.g. 75 yr) in natural soil and water environments.⁵ Construction aggregates complying with ASTM C568-96 for bedding and backfill of pipes are often used to provide good structural support. Among these aggregates, crushed limestone (mostly CaCO_3) is frequently used for its availability (1.17 billion metric tons production in US in 2009) and cost effectiveness.⁶ AST2 performance has been adequate in many service conditions, but unexpected early corrosion of AST2 pipes has been recently observed in some inland Florida locations.⁷ In one particularly severe case, complete penetration of the coating and mild steel substrate, starting from the soil side, took place in only 3 years over a > 10 m long section of pipe that was placed on a limestone backfill. Metallographic cross section of a field sample indicated widespread consumption of the outer aluminum layer, a less affected intermetallic inner layer, and severe localized undercutting attack of the steel substrate. Chemical tests of water in the pipe (in contact with external water through the wall perforations) showed insignificant amount of aggressive ions such as chloride and sulfate at the site.

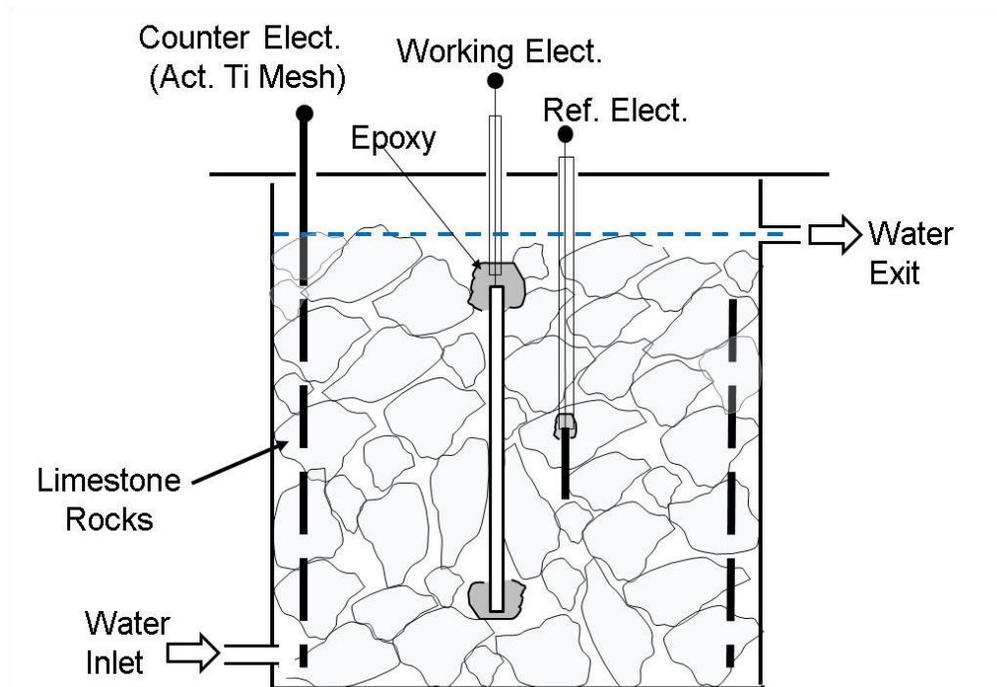
Figure 2: Limestone-cell configuration.

The immersion cells (Figure 2) were upright cylinders made of acrylic glass (10 cm internal diameter and 10 cm tall). The lower 8 cm contained ~0.8 kg of limestone crushed to a size between 1 cm and 3 cm, in which the specimen was embedded so its surface was in direct contact with multiple limestone particles. The composition of the limestone was tested in accordance with ASTM C1271 and confirmed to be ~97 wt% CaCO₃ which is comparable to commonly reported values for limestone.¹¹ Before being placed in the cells, the limestone particles were pre-washed with tap water, then DI water and were spread in a tray to dry at room temperature overnight.

The feed water was commercially supplied distilled water of resistivity > 50 kΩ-cm, representing rural rainwater.¹² The feed water was held in a tank that allowed initial equilibration with atmospheric oxygen and CO₂. Peristaltic pumps fed the water into each cell at a rate of ~2 liter per day. The water entered the cell at the lower end, ran in contact with the fully immersed specimen and the limestone, and was removed through an opening level to the top of the limestone fill. The chosen flow rate was intended to allow for dissolution of limestone while avoiding excessive introduction of additional CO₂ from air into the cell solution, approximating a post-dissolution close system condition. A total of 14 specimens were tested in these flowing conditions. The pH, conductivity, and open circuit potential (E_{OC}) measurements were taken daily.

For electrochemical measurements a titanium mesh with mixed metal oxide surface activation was placed around the inner wall of the cell to serve as a counter electrode. A similarly activated titanium rod 3 mm in diameter and 50 mm long was placed parallel to the specimen surface halfway to the counter electrode mesh, to serve as a low impedance temporary reference electrode.¹³ It was periodically calibrated against a saturated calomel electrode (SCE). All potentials reported here are in the SCE scale. Electrochemical impedance spectroscopy (EIS) measurements were periodically obtained for 8 of the specimens at the E_{OC} with a Gamry[†] Ref. 600 potentiostat in the frequency range from 100 kHz to 10 mHz using sinusoidal signals of 10 mV rms amplitude. All tests were conducted at room temperature. After exposure, the specimens were extracted and inspected for crevice corrosion. No crevice corrosion indications were observed in any of the cases. The tests and results for the first ~150 days are presented here.

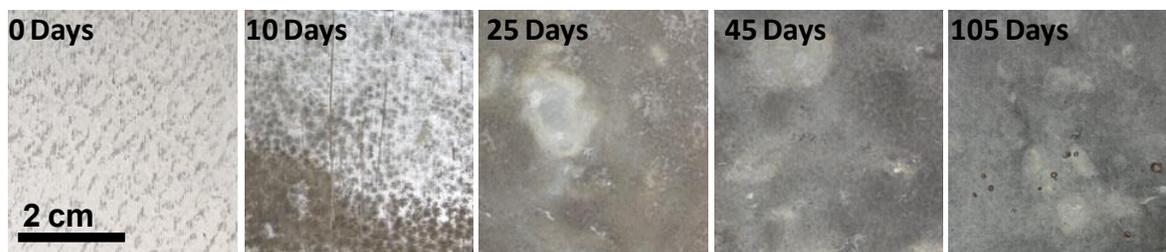
Figure 3: Surface discoloration over time; pits with rust were observed around 150 days of exposure.

Consistent with the resulting mild conditions, corrosion in the cells with no flowing water was relatively unimportant during the test period and details of those results are addressed later on. In contrast, and as expected from the high pH solution, rapid corrosion of the aluminized coating took place in the flowing water cells. Direct observation of extracted specimens revealed that severe coating damage and surface discoloration took place starting after a short (about two weeks) exposure (Figure 3). SEM observations confirmed severe loss of aluminized coating later on, as illustrated in Figure 4. As shown, the coating loss was rather generalized as opposed to sharply concentrated. The corrosion products consisted mainly of a dense, inner region that took the place of the consumed outer aluminized layer, and a usually thinner and more porous outer region. In the inner corrosion product layer, the Al-Fe intermetallic particles remained embedded and uncorroded, extending from the outer aluminized layer matrix. It noted that pits with some corrosion of the underlying steel were observed after around 150 days of exposure. This paper focuses on the precursors of those events. The subsequent development of strong localized corrosion of the steel substrate should be investigated at length in follow up work.

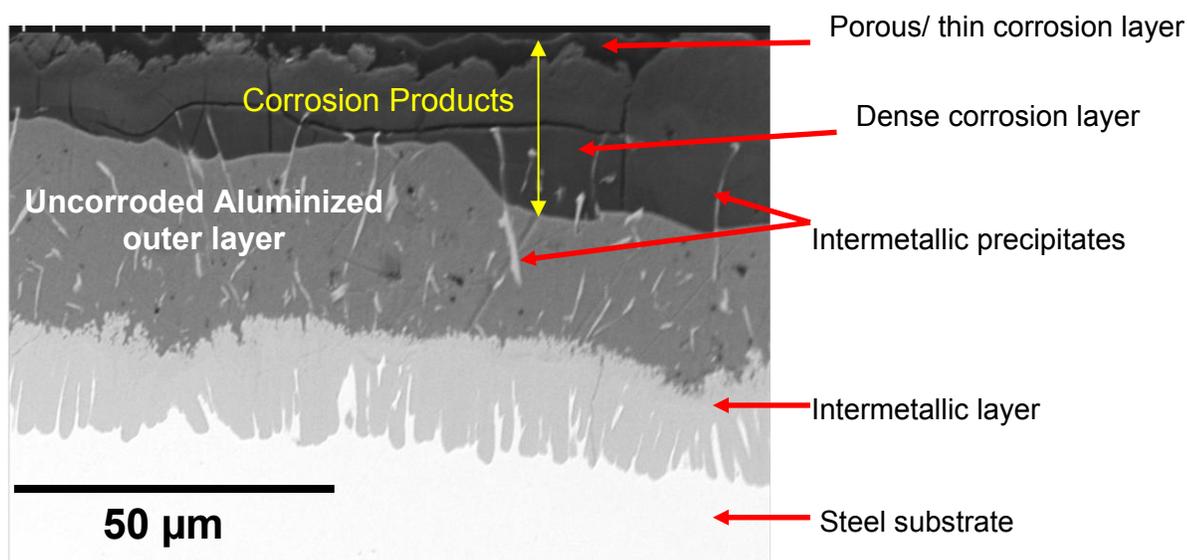
Figure 4: Coating condition after ~75 days exposure to flowing water.

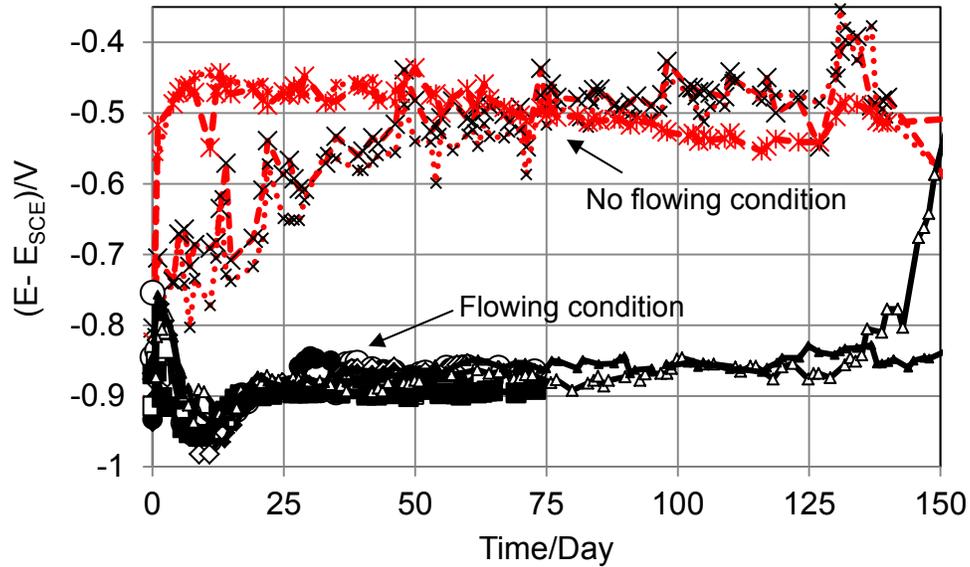
Figure 5: E_{oc} evolution; data from multiple replicate specimens. Black solid-lines represent flowing condition and red dash-lines correspond to no flowing condition.

Figure 5, shows the potential evolution for control specimens as well as for the 8 specimens for which EIS measurements were frequently performed. The potential values for no flowing water cells approached a terminal value of $\sim -500 \text{ mV}_{\text{SCE}}$. Potential values significantly more positive than $\sim -900 \text{ mV}_{\text{SCE}}$ are not uncommon for generally passive aluminum in non-aggressive waters.¹⁵ To interpret the EIS data, and estimate the corrosion rate for the Control specimens, a similar approach to Stage I, for flowing water condition, explained later, was used. Estimated corrosion rates were significantly smaller than those in the flowing water cells, as shown in comparative plots later on.

For flowing water cells, the E_{OC} initially decreased and reached a minimum ($\sim -1 \text{ V}_{\text{SCE}}$) indicative of highly active aluminum corrosion after about two weeks of exposure (Figure 5). Typical EIS behavior is shown for different exposure times in Figure 6 and Figure 7. The high frequency loop (100 Hz - 100 kHz), only shown for day 1 in Figure 6, reflects water dielectric properties apparent because of the high resistivity of the solution and was omitted in subsequent analysis. The solution resistance corresponded to the real value of the impedance at $\sim 100 \text{ Hz}$. Variations with time of the solution resistance stemmed from minor changes in feed water composition and is not of consequence to the following analysis.

The impedance behavior shown in Figures 6-7 and the E_{oc} evolution shown in Figure 5 make evident the presence of two Stages in the electrochemical evolution of the system. Stage I took place early in the exposure of the specimens (\sim first two weeks) and is characterized by rapidly decreasing values of E_{oc} and an impedance that reaches minimum values after about two weeks. During most of Stage I the impedance diagrams showed two clearly differentiated time constants (Figure 6). Stage I is followed by a subsequent Stage II where the nominal polarization resistance gradually increased, and only one time constant is observed in the impedance diagrams (Figure 7). The assumptions and the approach used to interpret the EIS results to obtain estimates of the corrosion rate prevalent in each of the stages is identified next.

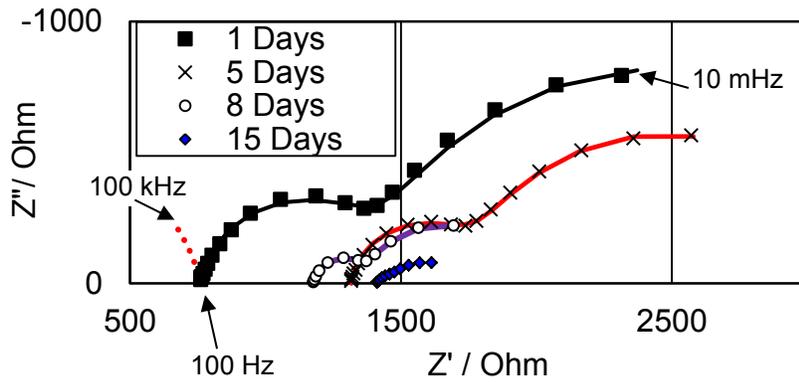
Figure 6: Typical EIS behavior of specimens exposed in limestone cells with flowing water for first two weeks (Stage I) [10 mHz (last datum) to 100Hz; 3 data/decade; Area = 77 cm²]. Solid-lines are the data fit for Stage I. No fit shown for 15 days (transition period). The high frequency loop (100 Hz - 100 kHz), only shown for day 1 (dash-line), reflects water dielectric properties.

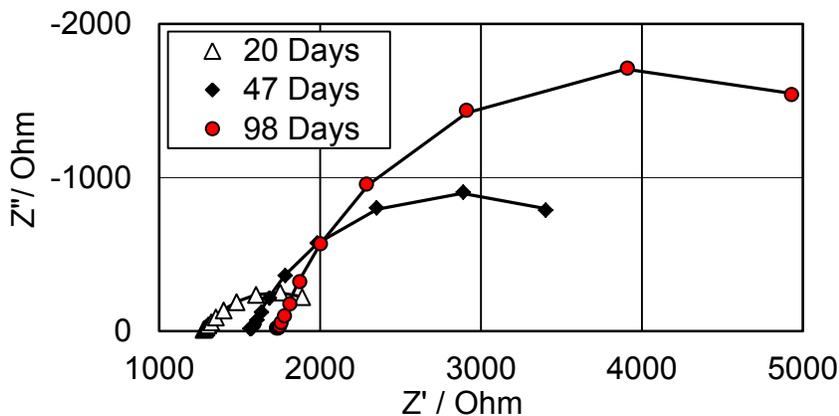
Figure 7: Typical EIS behavior of specimens exposed in limestone cells with flowing water for first two weeks (Stage II) [10 mHz (last datum) to 100Hz; 3 data/decade; Area = 77 cm²]. Lines are the data fit for Stage II.

Stage II: The impedance diagrams obtained during Stage II, (Figure 7), differed from those in Stage I. Starting shortly after the onset of Stage II and from then on there was typically only one loop, consisting of a moderately depressed semicircle. The impedance spectrum, concentrating again on frequencies below ~100 Hz for the reasons stated in the Stage I discussion, could be closely approximated by the response of a simple parallel combination of a CPE (CPE₃) and a resistor (R₃) in series with an ohmic solution resistance element (Figure 8 B).

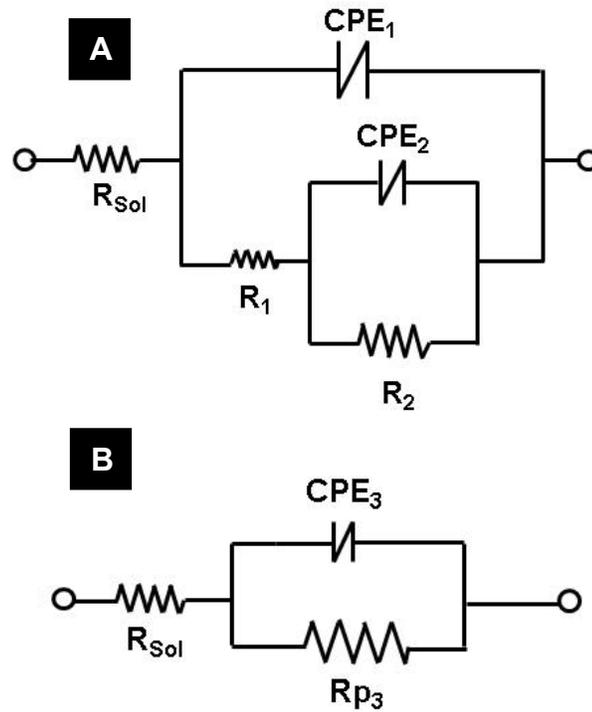
Figure 8: Final analog equivalent circuit to interpret the EIS data for Stage I (A) and Stage II (B).

Control specimens and Stage I, flowing water condition: The circuit chosen to simulate the impedance response of EIS data in Stage I for flowing water cells, as well as the entire exposure times of no flowing water cells, is shown in Figure 8 A. The circuit accounts for the impedance response of the electrolyte interface with the aluminum matrix of the outer aluminized coating layer, and of any exposed

intermetallic precipitate particles. R_{Sol} represents the ohmic solution resistance and Constant Phase Element 1 (CPE₁)⁽⁴⁾ represents the combined capacitive behavior of the passive film on the aluminum matrix and the precipitates (the latter being a minor component for the passive behavior and neglected in the following). In a more sophisticated analysis, the film capacitance could be considered to be in series with a double layer capacitance. However, the admittance of a double layer is expected to be significantly greater than that of the passive film; thus, in a series combination, the latter would dominate, and consequently the former is neglected here.⁴ The corrosion potential of the passive interfaces is assumed to be the combined mixed potential of the passive anodic dissolution processes and cathodic reactions, such as oxygen reduction, taking place primarily on the intermetallic precipitates present at the surface. Assuming a near-potential independent region (characteristic of passive dissolution) for the anodic reaction on the aluminum matrix or the precipitates, the impedance can be approximated by a resistor with a very large value.¹⁶ The contribution of that component can then be considered negligible on first approximation, given the parallel circuit configuration used.

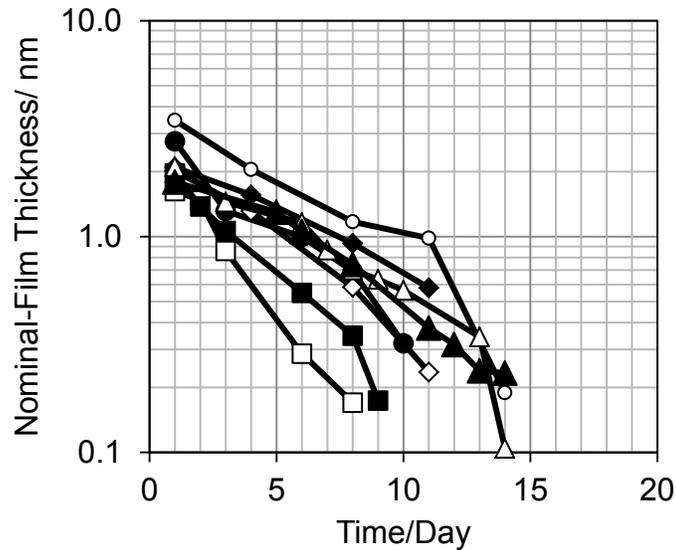
Figure 9: Nominal film thickness during Stage I. Data from multiple replicate specimens.

The nominal film thickness is plotted as a function of time in Figure 9 for multiple replicate specimens. The initial thicknesses were about 2-3 nm thick, comparable to values reported in previous studies.²¹⁻²² The values decreased with time and reached atomic dimensions (e.g. $\sim 0.2 \text{ nm}$) after about 2 weeks. That condition may be viewed as being indicative of full consumption of the film at that time. Such interpretation is consistent with the concurrent strong drop in nominal polarization values (onset of severe corrosion), lowered E_{OC} (approaching the potential of actively corroding aluminum), and the appearance of a light grey shade on the surface of the specimens at the end of Stage I.

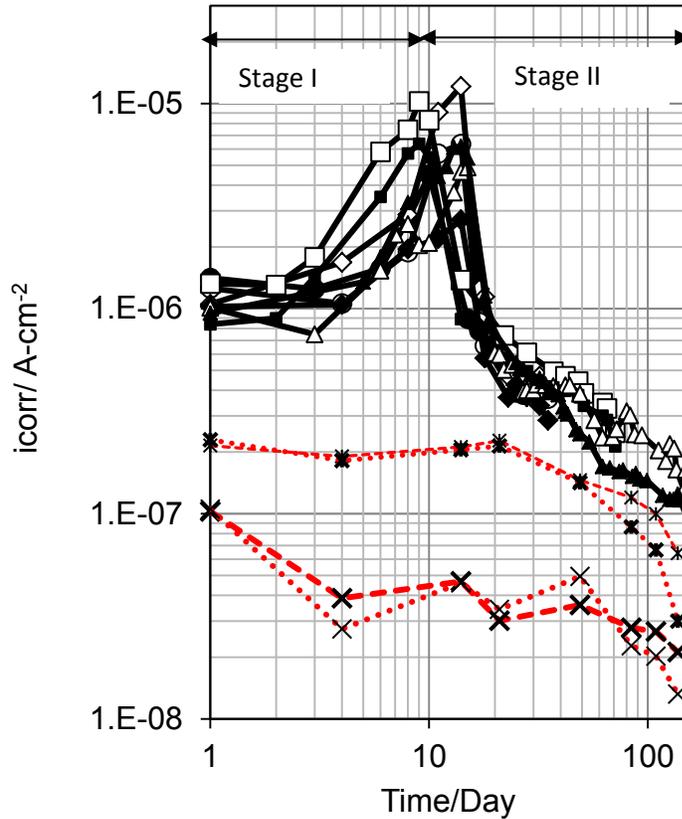
Figure 10: Estimated Corrosion current density as a function of time for flowing water Stages I and II (black solid-lines) and for no flowing water controls (red dash-lines). Data from multiple replicate specimens.

Estimated corrosion current densities for all specimens exposed to the flowing water condition as well as for control specimens are shown in Figure 10. This graph shows the increasing trend of estimated corrosion density for Stage I and decreasing trend for Stage II for flowing water cells. The results for the control specimens are shown in red dash lines; as noted earlier, these current densities are significantly lower than those estimated for the flowing water condition.

As a validation test, the corrosion current density values in Figure 10 were used to obtain H and h_i parameters, using Faradaic conversion and accounting the time step that for which these corrosion rates took place. The resulting combined graph for the data from all available specimens, up to 150 days of exposure, is presented in Figure 11. The overall slope closely approached the ideal value of 1, in support of the proposed scenario. This outcome was part of the reason for postulating earlier that one of the corrosion reactions was subject to diffusional control in interpreting the impedance data.

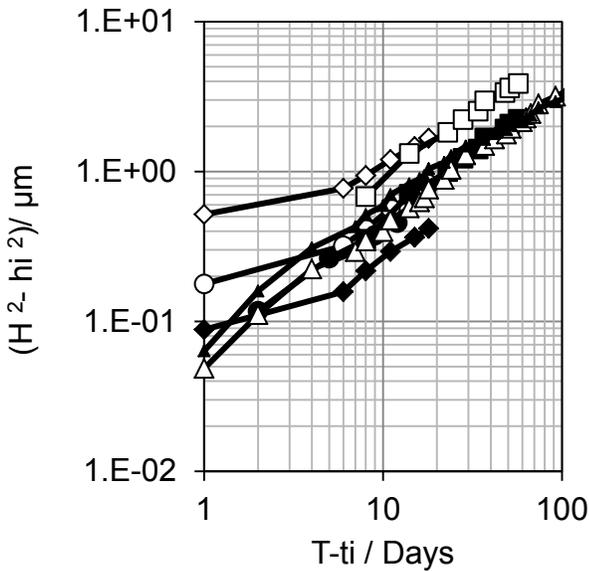
Figure 11: Accumulated thickness loss as a function of time starting at Stage II. Data from multiple replicate specimens.

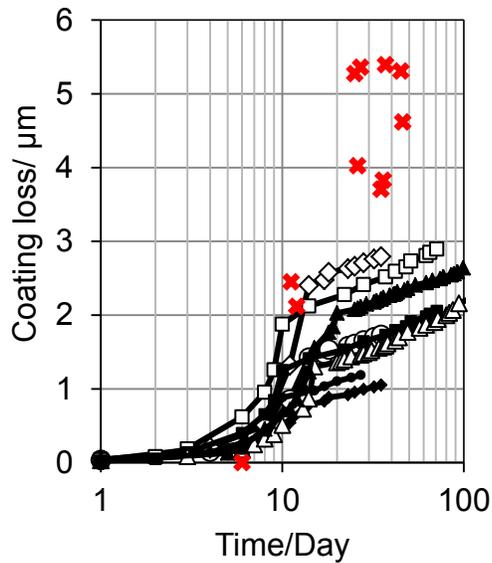
Figure 12: Total coating loss as a function of time measured by EIS data and by direct observation (X symbols). Data from multiple replicate specimens.

Metal loss determined by direct observation of metallographic cross sections of extracted specimens was subject to considerable spatial variability. To obtain a representative indication of direct metal loss, metallographic samples of 2 to 4 random cross sections of each specimen were prepared. For each cross section multiple metallographs at different spots were taken. In each photo frame the average coating loss was measured; then these values were averaged to find an overall penetration thickness for each specimen, with the result shown by red X symbols in Figure 12 where comparison with the metal loss estimated by EIS can be made as well. As can be seen, the EIS estimates and the direct observations show the same general increasing trend with time, and differ numerically on average by not much above a factor of 2 (EIS yielding the lower values). This degree of correlation between electrochemical and direct corrosion assessments is typical of similar studies and reflects both the natural scatter of both diagnostic procedures.²⁴⁻²⁵ Furthermore, there is likelihood of some corrosion rate underestimation on the part of the EIS data due to intrinsic limitations resulting from corrosion localization which may have occurred during Stage I as indicated earlier.²⁶ Consequently, both methods indicate an average loss of aluminized coating in the order of several μm after exposure times of only 1-3 months. Considering that the total outer aluminized layer is only about 35 μm thick, and that the coating loss showed large spatial variability in the cross sections examined, it is likely that penetration of the coating could take place after only a few years of service at multiple locations when a large surface area of aluminized steel (eg. many m^2 as was the case in the field) is exposed to limestone backfill. Moreover, in the case of steel substrate exposure due to occurrence of pits, after initiation of corrosion (shown in Figure 3 for 150 days), the rate of the cathodic reaction, and as a result the overall rate of corrosion, is expected to be significantly enhanced. Such phenomena may significantly increase the rate of coating loss, at least locally, and therefore reduce the service life of the pipe.

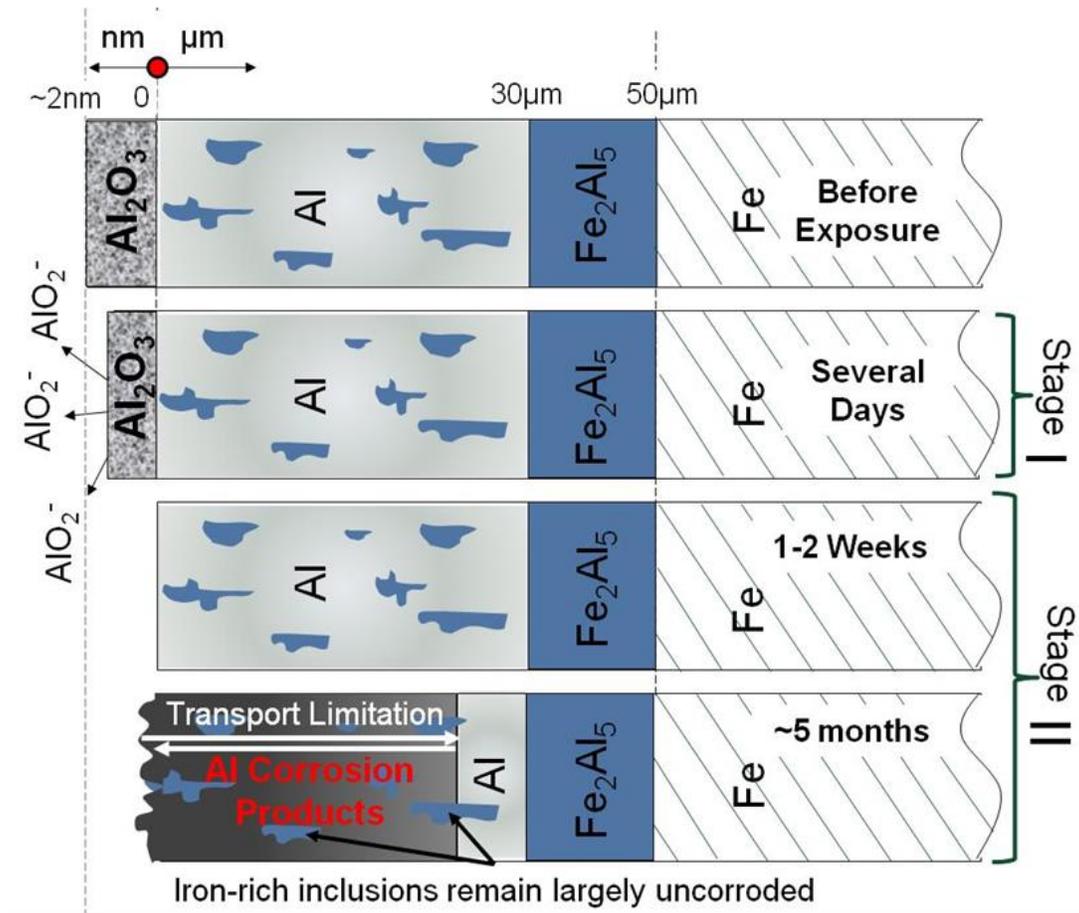
Figure 13: Scenario of corrosion progression under flowing water condition.

The findings suggest the overall corrosion progression in flowing water summarized in Figure 13. During Stage I the passive film on the outer layer of the aluminized coating is consumed by interaction with the high pH generated by dissolution of limestone under near-closed system conditions. After 1-2 weeks the film is completely consumed and active corrosion of the aluminum begins (Stage II) at a high rate. Corrosion products remain in place and transport limitation of one or more of the species responsible for the rate of corrosion ensues in an increasingly thick film. Nevertheless, after several months of exposure a significant fraction of the aluminized coating had been consumed. Aluminate inclusions, and the inner aluminized layer, are less attacked. Corrosion of the underlying carbon steel, not addressed in this paper, is expected to take place at a later age, but the observed attack of the aluminized coating in such short time portends a dramatic reduction in the life expectancy of the pipe compared to the desired performance. The results thus provide an explanation for the early damage observed in the field.
