## **MECHANISM OF CORROSION OF STEEL STRANDS IN POST TENSIONED GROUTED ASSEMBLIES**

Alberto Sagüés<sup>\*</sup>, Rodney G. Powers<sup>+</sup>, Hongbin Wang<sup>\*</sup>

### **ABSTRACT**

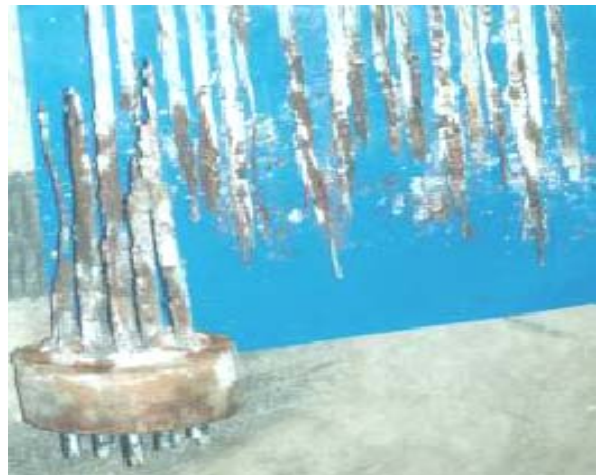
**FIGURE 2** Severe Failure of Post-Tensioning Tendons near Cap Region (Corven, 2001)  
 a) Failed tendon at Niles Channel Bridge  
 b) Failed tendon at Column 133 NB of Sunshine Skyway Bridge

The observed damage consisted, in each of the three bridges, of one completely separated tendon plus one to several partially detensioned tendons. The completely separated tendons had failed in the anchorage region following severe corrosion of many of the strands, as illustrated in Figure 2. Mechanical failure appears to be the result of simple overload due to locally reduced cross-section, usually in the form of generalized corrosion along several cm with occasional pitting. In the partially detensioned tendons severe corrosion and mechanical failure had affected some but not all of the strands. In one instance the area of severe corrosion was about 2-3 m away from the anchorage. All cases of severe corrosion were associated with large void areas that should have been filled with grout. Significant chloride contamination of the remaining grout was observed at the corroded regions. In nearly all cases the affected anchorages were at bridge expansion joints, or underneath horizontal surfaces, where salt and moisture availability was significant. Additionally, HDPE duct cracks were commonly encountered in MBB. Corrosion was not unique to any particular anchorage manufacturer.
