## **CORROSION PERFORMANCE OF CONCRETE CYLINDER PILES**

### **ABSTRACT**

Keywords: corrosion, piles, cylinder, chloride, diffusion, durability

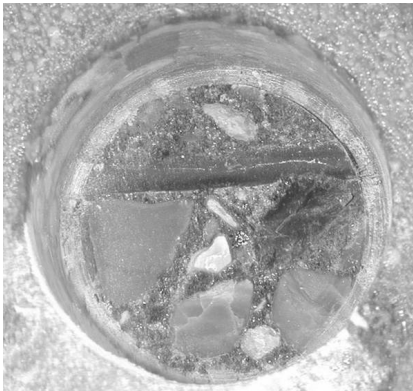
**FIGURE 1- Exposed spiral wire, no corrosion. Pile H29-3.**

Nearly always, steel reinforcement exposed by coring had a dull to lustrous gray mill scale appearance, with no discernable rust (Figure 1). At the bottom of one core (extracted 1.52 m AHT at a vertical crack location), the exposed spacing bar showed light corrosion in the form of faint rust-colored discoloration on part of the surface. Strand exposed by the same core showed small rust stringers with matching imprints on the surrounding grout. No cross-sectional steel loss of any significance was observed associated with these cases, and it was not clear whether the discoloration or rust represented corrosion that took place in service or prior to casting.

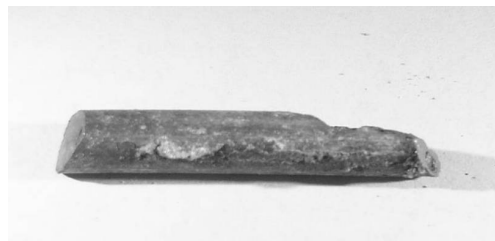
**FIGURE 3- Extracted spiral wire, severe corrosion. Spiral wire from P149-2, 0.64 cm diameter, showing appreciable localized loss of cross section at the right end of the segment cut out by coring.**

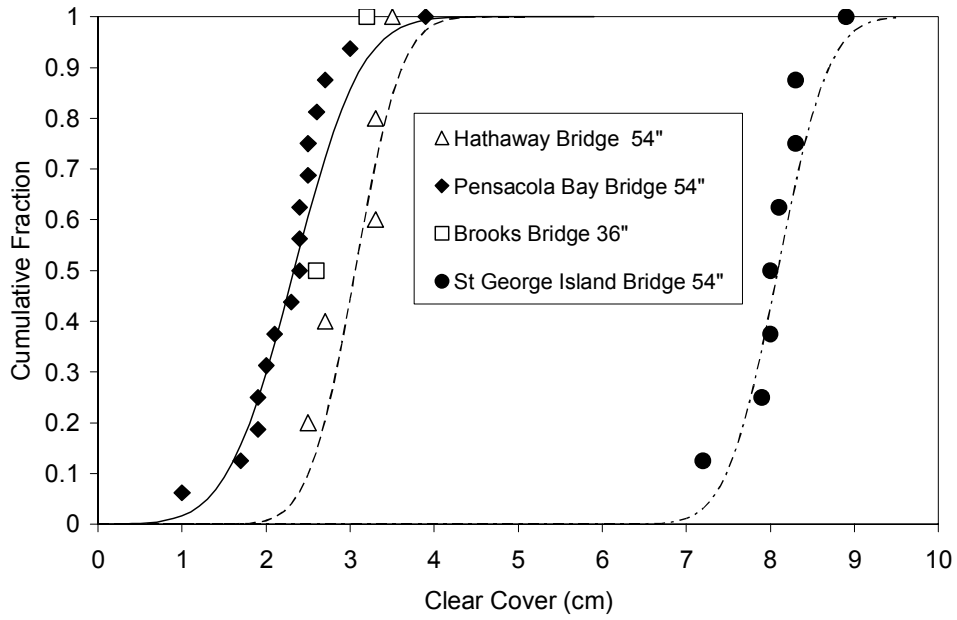
**FIGURE 4- Cumulative Fraction of Concrete Clear Cover to Spiral Wire.**

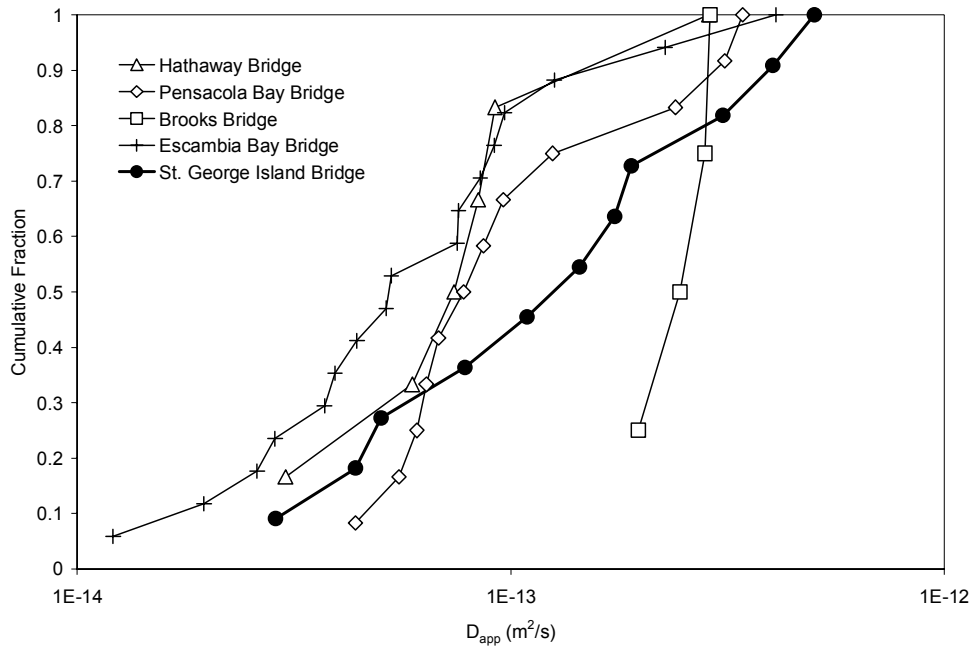
**FIGURE 7- Cumulative Fraction of  $D_{app}$  Values for Cylinder Piles in Present Investigation and Prior Escambia Bay Bridges Investigation.**

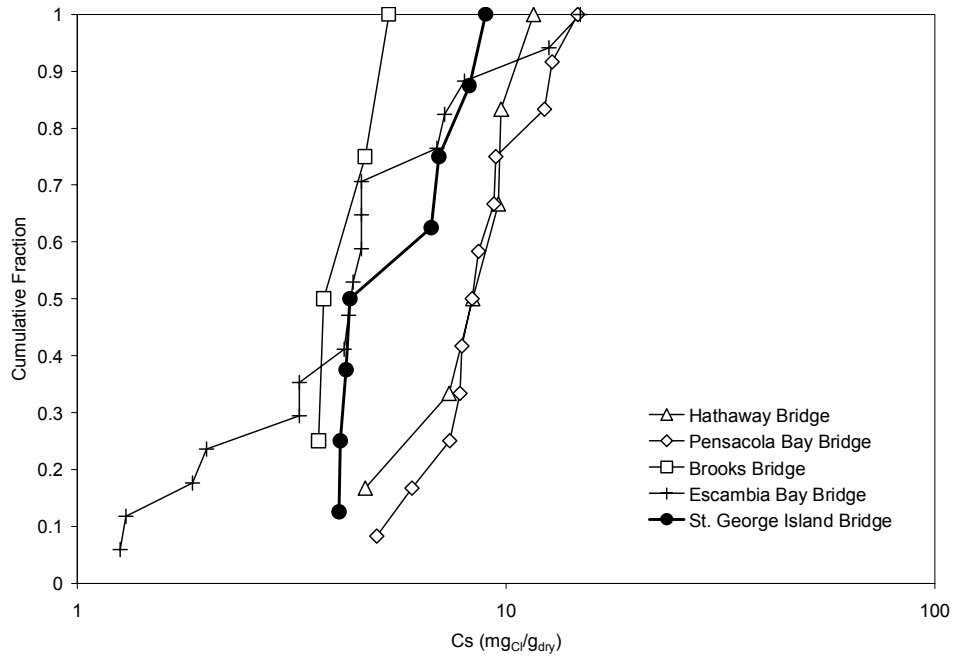
**FIGURE 8- Cumulative Fraction of  $Cs$  Values for Cylinder Piles in Present Investigation and Prior Escambia Bay Bridges Investigation.**

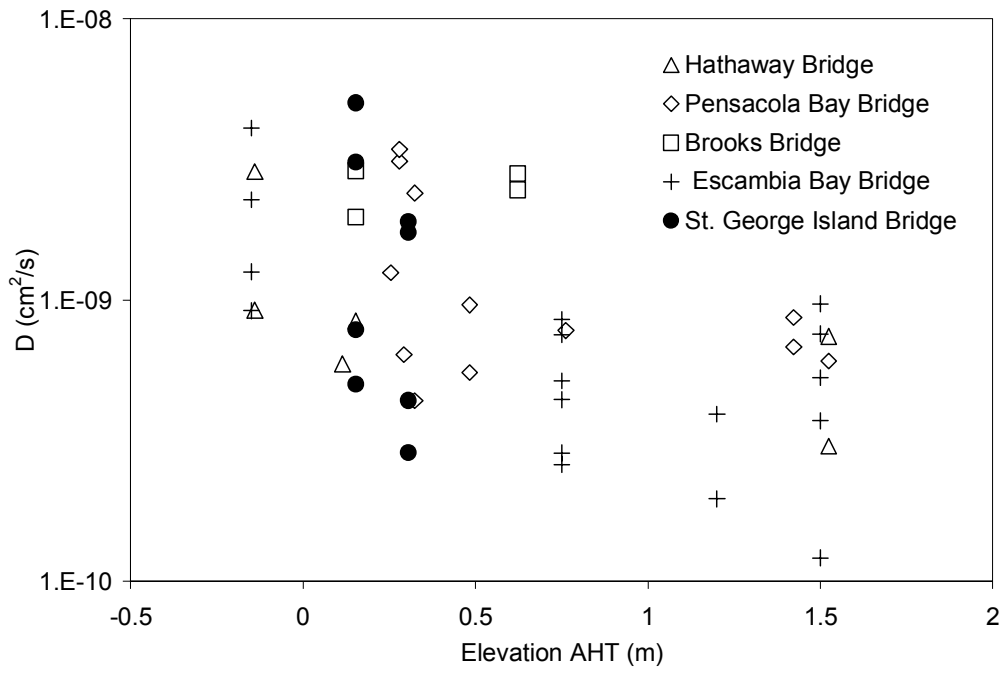
**FIGURE 9- Apparent Chloride Ion Diffusivity as Function of Core Elevation.**

In agreement with a commonly observed trend in marine substructure,  $D_{app}$  and  $C_s$  tended to decrease with increasing elevation as shown in the composite graphs in figures 9 and 10 (including the Escambia Bay Bridges data). The trend is expected as the water content of the concrete decreases with increasing elevation, with consequent reduction in the ion transport ability through the concrete.

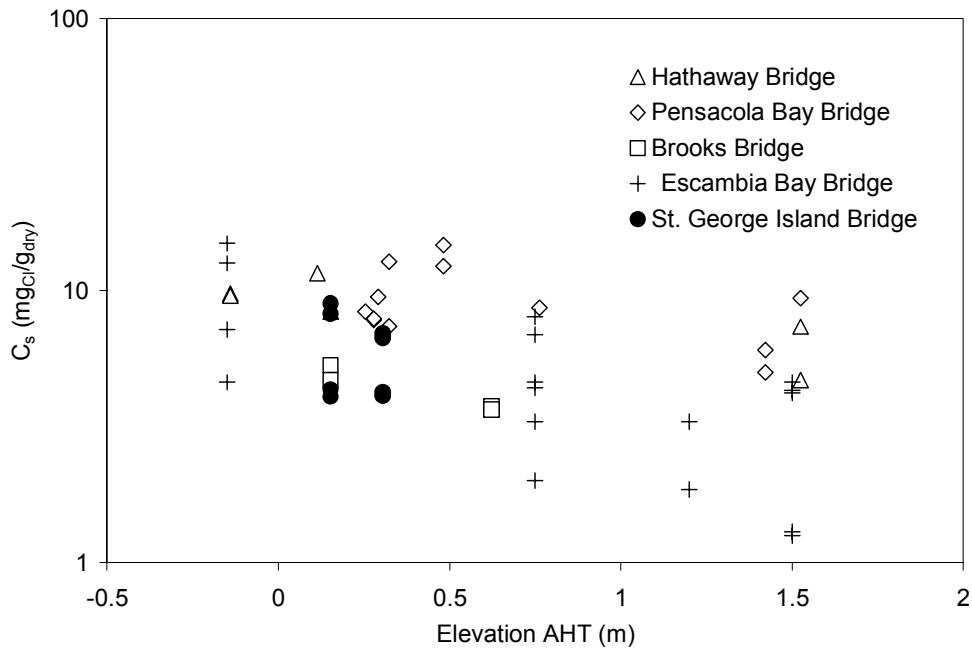
**FIGURE 10- Chloride Surface Concentration as Function of Core Elevation.**

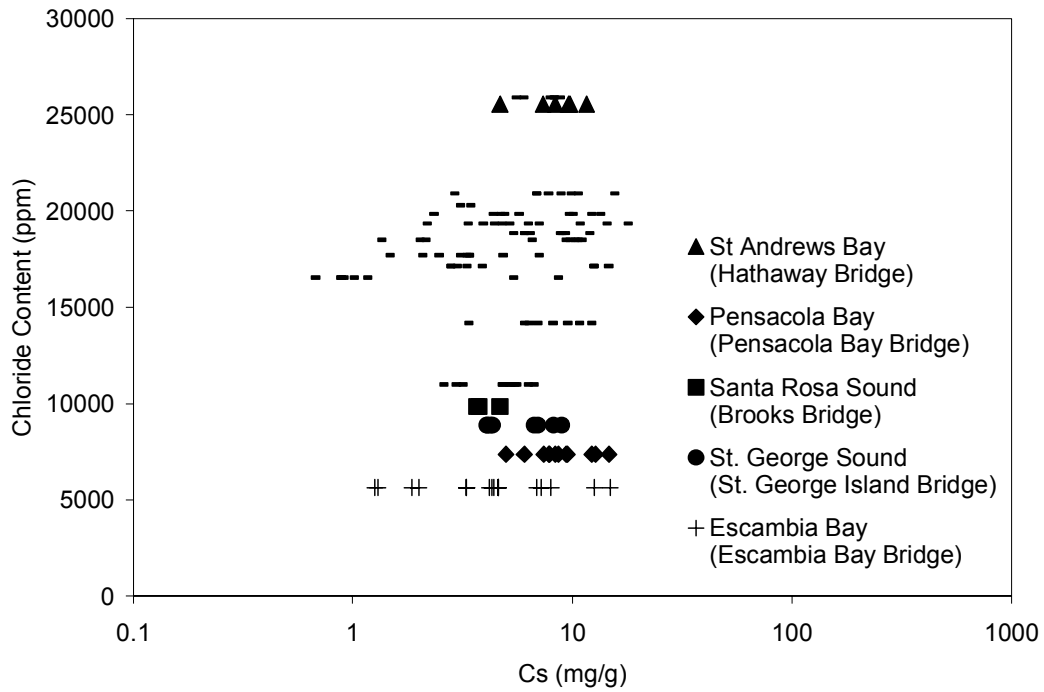
**FIGURE 11- Comparisons of Water Chloride Content and Concrete Chloride Surface Concentration  $C_s$  at Elevations -0.14 to 1.52 m AHT. Dash Symbols, Data for various bridges built with conventional modern concrete.**

The typical chloride ion concentration of the water traversed by the bridges is listed in Table 1. Figure 11 shows that the ranges of  $C_s$  values observed in the various bridges investigated are roughly independent of the chloride content of water in the span of salinity encountered. The similarly overlapping data from an additional sampling of Florida bridge substructures<sup>4</sup> made with conventional concrete is also shown. This behavior reflects the development of nearly salt-saturation conditions (and hence approximately equal concentration independent of salinity of the source) on much of the surface of the concrete by evaporative concentration of marine water.<sup>15</sup>

The range of surface chloride concentrations observed were similar to those encountered in other marine and estuarial Florida bridges built with conventional concrete (Figure 11). Thus the driving force for chloride penetration in the cylinder piles was not unusually high or low. The observed chloride diffusivities were however extremely small (median  $10^{-9}$  cm<sup>2</sup>/s) which indicate chloride penetration to be greatly retarded in the bulk of the concrete. Furthermore, in contrast to observations in conventional Florida marine substructures, rapid chloride transport through thin cracks was not strongly apparent in the older cylinder piles (Figure 5). Thus, even though thin cracks were frequently observed, inward chloride ion penetration appeared to be mainly a function of bulk parameters.

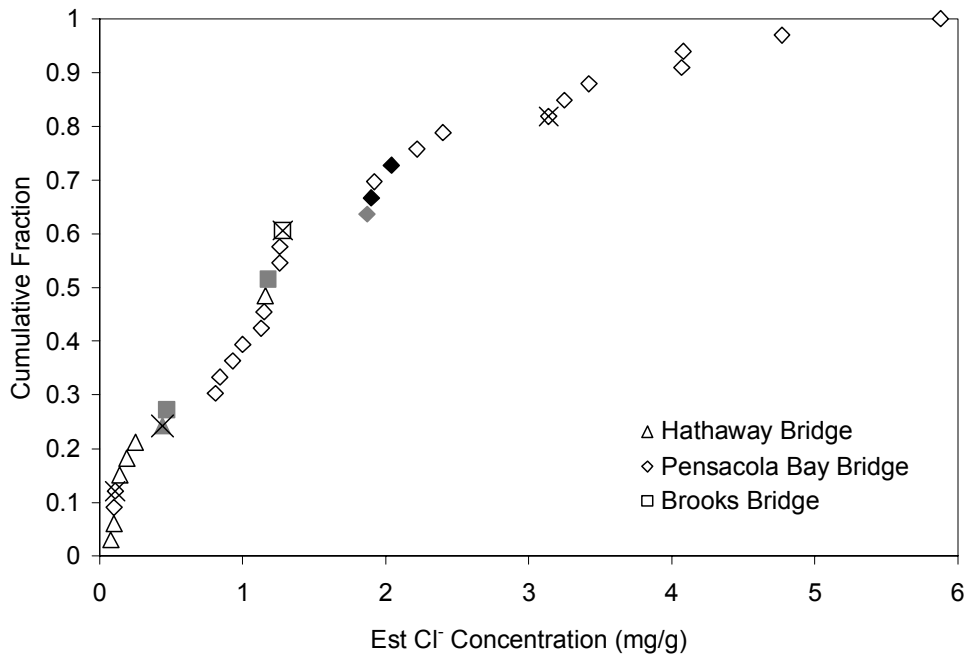
**FIGURE 12- Cumulative Fraction of Estimated Chloride Concentration at Steel Depth. Determined for locations where spiral or spacing bar steel was exposed by coring in the Hathaway, Pensacola, and Brooks bridges. Solid symbols, Severe corrosion. Grey symbols, Light corrosion. Open symbols, No corrosion. X, core drilled on crack.**

The trend in Figure 12 (although affected by large uncertainty from the many assumptions made) suggests that no corrosion initiation took place at concentrations  $<0.5$  mg/g ( $1.2$  kg/m<sup>3</sup>), but that in many instances the chloride content was higher and not even incipient signs that corrosion had taken place were observed. Thus a value of  $0.5$  mg/g may be suggested as a conservative lower bound for the critical chloride threshold of reinforcing steel in these piles, recognizing that the actual effective threshold value or range of values is likely to be significantly greater due to the stochastic nature of corrosion initiation. It is worthwhile noting that  $C_T$  values reported in the literature for steel in conventional concrete but with high cement content similar to that present in cylinder piles are in the order of  $\sim 1$  mg/g ( $2.4$  kg/m<sup>3</sup>).<sup>18</sup> Factors such as better concrete compaction in the cylinder piles may result in higher threshold values compared with that in conventional cast concrete. In any event, given the  $C_T$  values suggested by this analysis and the  $X_c$ ,  $C_s$  and  $D_{app}$  ranges obtained, it appears that at the time of the survey corrosion initiation was just beginning to affect a small fraction of the pile inventory of the older bridges.

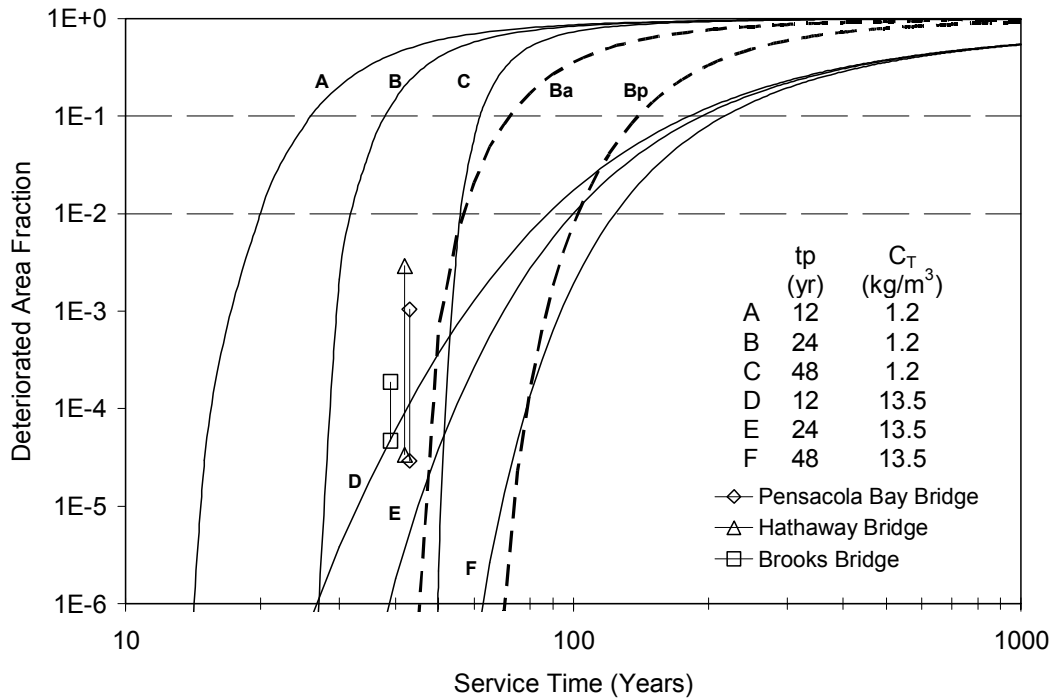
**FIGURE 13- Forecast deterioration model output. The vertical line represents the bounded range of observed damage at the time of the bridge survey. The horizontal dashed line corresponds to a 0.01 and 0.1 deterioration area fraction for nominal definitions of service life. The dashed model outputs represent the forecast deterioration of SGI Bridge piles with B input parameters for present X<sub>c</sub> (7.6 cm), B<sub>p</sub>, and for an alternative reduced X<sub>c</sub> (5.1 cm), B<sub>a</sub>.**

Figure 13 shows the resulting deterioration forecast model outputs to which are superimposed bounded ranges of values representing the actual damage in each bridge at the time of the survey. The actual damage was bounded by a conservative upper limit where each observed rust spot is

considered to represent one distressed element (although as indicated earlier many rust spots were not related to reinforcement damage). The lower bound limit is the amount of corrosion-induced damage confirmed by direct observations (not related to mechanical damage or other preexisting circumstances) in the bridge. In the case of the Brooks Bridge no damage fell in that category, so a lower limit was assigned as corresponding to at least one distressed element that may have escaped detection during the survey.

In Figure 13 the projections resulting from the various  $t_p$ - $C_T$  combinations are labeled A through F. Combination A (lowest  $t_p$  and  $C_T$  values) greatly over-projects the damage at the time of survey and is too conservative. Combination F (high extremes of  $t_p$  and  $C_T$ ) is clearly too optimistic. Thus the actual damage range was better represented by the combinations of intermediate discrete  $t_p$  and  $C_T$  values. Because of the cathodic prevention effects mentioned earlier<sup>21</sup>, lower  $C_T$  values are expected to be prevalent earlier in the life of the bridges, while higher values may exist near the end. Thus, combinations B-C (or even A) may better describe earlier behavior while D-F may apply to the later stages. If low  $C_T$  values dominate earlier behavior, then propagation times that are short or very short (e.g. 5 years, as often assumed for other marine substructure or deicing salt service cases<sup>4</sup>) do not seem likely as the resulting projected damage would greatly over-predict observations. This outcome is consistent with the expectation, from the previous discussion, that the corrosion durability of concrete cylinder piles benefited from long propagation times ( $>12$  years assuming  $1.2 \text{ kg/m}^3 < C_T < 13.5 \text{ kg/m}^3$ ).
