Corrosion of Steel in Cracked Reinforced Concrete Pipes

Ezeddin Busba and Alberto A. Sagüés
Dept. of Civil and Environmental Engineering, University of South Florida
4202 E. Fowler Ave. ENB118
Tampa, FL 33620

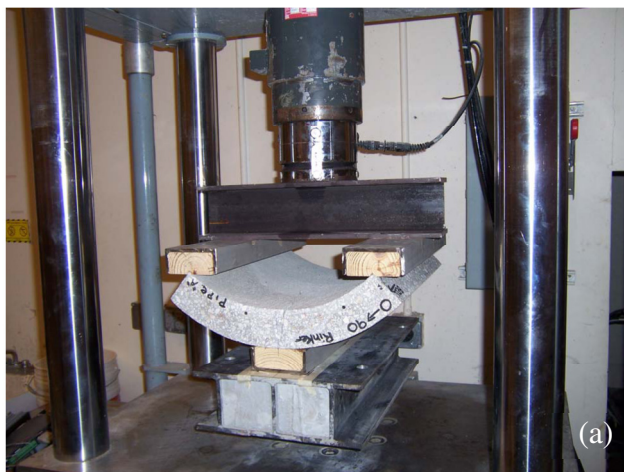
Figure 3: (a) Cracking rig used to generate cracks in RC culvert pipe specimens, (b) Top view for 0.01 in (~2.5 mm) Z-type specimen showing Crack width measurement along a crack using a crack comparator.

For the evaluations, specimens cut out of the pipes were cracked to obtain target; narrow (0.02 in) and wide (0.1 in) openings, representing a case with recognized potential for future AH and one with much poorer prognosis respectively.^{6,7} Uncracked specimens served as controls. The cracks were intended to be single with a total length of 18 in (45 cm) and extending lengthwise parallel to the direction from the bell side to the spigot side of a pipe. Figure 3a shows the cracking rig applying 3-point loading to induce the cracks. The crack width was monitored during loading. After cracking was completed, more detailed measurements of crack width, Figure 3b, and depth were performed using a crack comparator and insertion gauges at ½ in (~ 12.5 mm) intervals along the entire length of a crack. Table 2 shows the achieved crack width and depth values as well as the average measured interior concrete cover. All specimens having a 0.02 inch (~0.5 mm) crack width are referred to herein after in the text and figures as 0.02 in- crack class. Likewise all specimens having a 0.1 inch (~2.5 mm) crack width are referred to as 0.1 in-crack class.

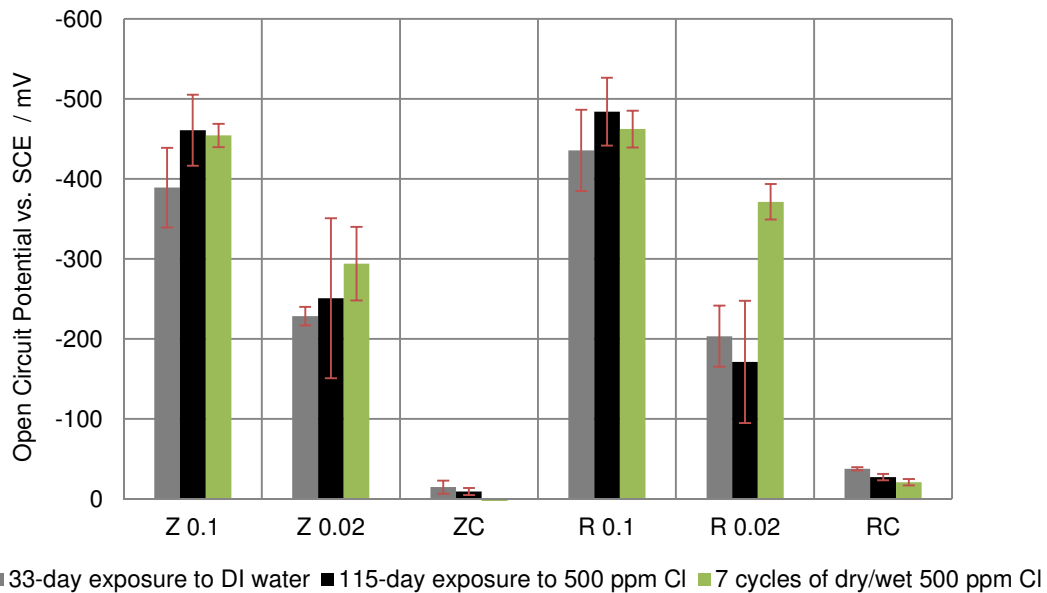
Figure 5: Average and range of open circuit potentials of duplicate specimens over the 3 exposure periods.

The OCP values for the 0.02-in-crack width-specimens were distinctly more negative than those of the uncracked controls, strongly indicating some extent of active corrosion as well even with the narrow cracks. The conditions responsible for activation are expected to be similar to that for the wider cracks. Some mitigation existed as the OCP values were not as negative as those for the wider crack specimens, likely indicating that activation at the bottom of the narrower cracks happened at fewer crack-steel wire intersection points, or that the size or the corrosion zones was smaller. Importantly, the OCP indications of corrosion were present regardless of the differences between the concrete compositions used by the suppliers.

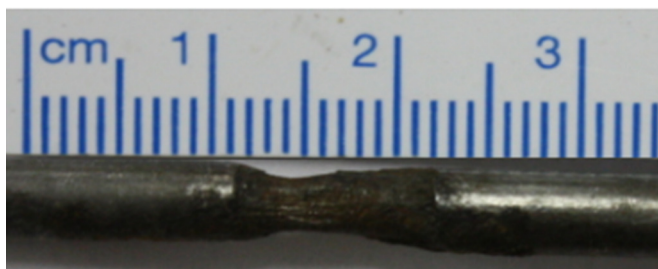
Figure 7: Corrosion influence zone at a wire-0.1 inch (2.5 mm) crack intersection of R12 after 246-day exposure to continuous and cyclic 500 ppm chloride environment

The presence of extensive accumulated corrosion was confirmed on autopsy of specimens R12, R6, Z11 and Z1. Inspection of wire-crack intersections confirmed that all intersections exhibited corrosion damage, including those outside the ponding area, for 0.1-in-crack specimens of both RCP types. Figure 7 shows the corrosion damage at one of the crack-wire intersections of R12. The Z-type specimen in the 0.02-in-wide crack class also showed corrosion at all intersections, likely due to the presence of consolidation voids along circumferential wires. The R-type specimen in the 0.02-in-wide crack class showed corrosion only within the ponding area. The corrosion influence zones on each side of those intersections, measured in terms of wire diameter (D) on each side of the crack were on

average in the order of 2D, 1D, 15D and 30 D, for R12, R6, Z11 and Z1 respectively. Approximate measurements of actual radius loss over the influence zone were performed for Z11, R12 and R6 (uncertainty in diameter change was too great for Z1 given the spread of the corrosion influence zone) and converted to a total mass loss for each specimen. The results are plotted in Figure 10.

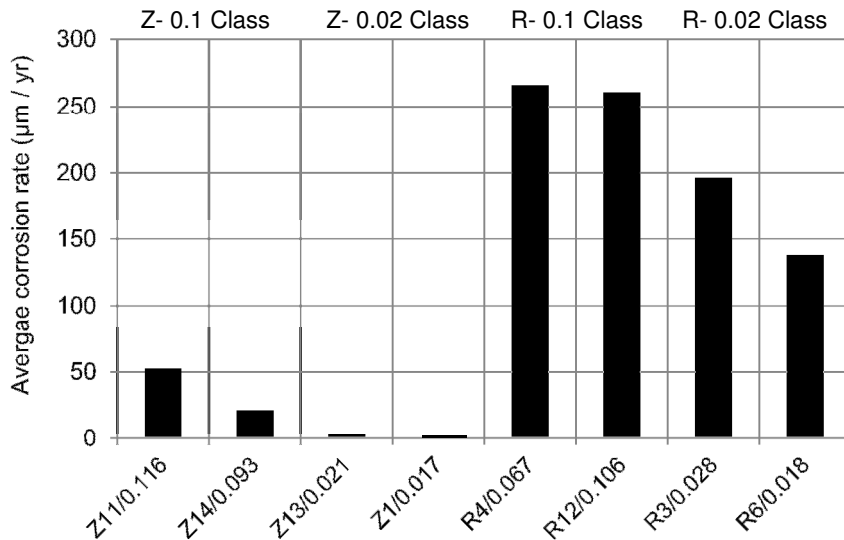
Figure 11: Corrosion rates in the corrosion influence zone (from either direct measurement or calibrated EIS data) averaged over the entire exposure of specimens to all test environments. The individual crack width in inch is shown for each specimen.

The results indicate trends in general agreement with those suggested by the OCP measurements and visual observations of rust: clear indications of ongoing corrosion for the wider crack specimens from both concrete mixtures, with greater severity occurring after the addition of chloride ions and even more so during cyclic ponding; some but significantly less corrosion present for the small crack width, and no measurable corrosion for the uncracked control specimens. The R-type specimens in the 0.02-in-wide crack class exhibited an increase in corrosion current by an order of magnitude under accelerated cyclic exposure which can also be seen from its OCP behavior. The intermittent exposure seems to have aggravated the corrosion process in the case of 0.02-in-crack class of both RCP types. The higher corrosion currents of Z-type specimens are associated with relatively large active corrosion zone leading to smaller corrosion rates as shown in Figure 11.

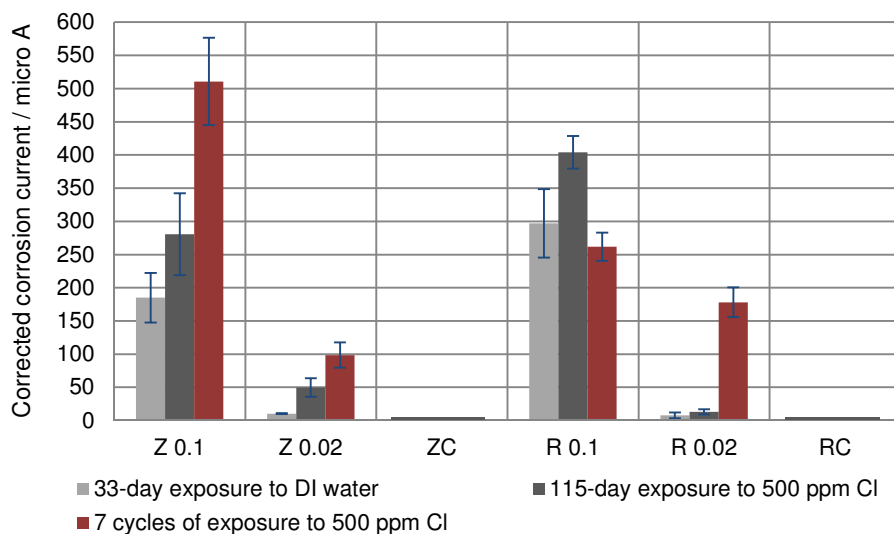
Figure 12: Corrosion currents (from calibrated EIS results) averaged over each exposure period

The time evolution of corrosion as the various exposure regimes took place can be appreciated (using again the corrosion current for the entire specimen) in the summary of results in Figure 12, compiled using EIS results calibrated as indicated above.
