# GLOBAL CASE STUDIES OF IMPROPER PLUMBING AND VENTILATION: HEALTH RISKS AND REGULATORY GAPS IN ASIA, EUROPE, AND THE UNITED STATES

Alex A. Volinsky, Ph.D

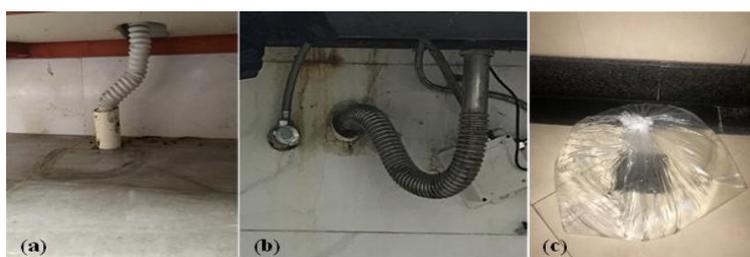
Figure 1(a) and (b) show examples of unsealed sink drainpipes, while Figure 1(c) shows a plastic bag filled with water to temporarily stop sewer gas leakage from a floor drain in a hotel room in Zhengzhou, China, installed without a water trap [3].

Figure 1. (a) Exposed sewer pipes due to the absence of a water trap and unsealed connections; (b) Exposed sewer line lacking a proper seal; (c) Plastic bag filled with water used as a temporary measure to block sewer gas escaping from a floor drain without a water trap in a hotel room in China.

A primary cause is the non-compliance with building codes, particularly the failure to install water traps and the improper installation of vertical outlet toilets. Water traps are simple devices designed to hold a small amount of water, forming a liquid barrier that prevents sewer gases from escaping into indoor spaces. Chinese national standards, such as GB 50015-2019, specify installation of floor drains and require appropriate traps for each plumbing fixture to prevent odor spread. However, these requirements are often ignored or improperly substituted.

Sewer gas leakage in China is a widespread problem, which is not being properly addressed, as newly constructed and renovated buildings have these problems. In many buildings throughout China sewer pipes and plumbing fixtures are installed in violation of Chinese national standards, allowing sewer gases to escape.

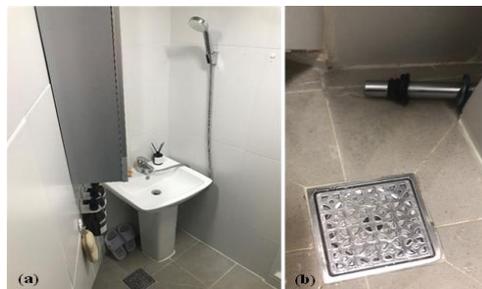
In South Korea, and Seoul specifically, it is common for bathroom sinks to drain directly onto the bathroom floor, as illustrated in Figure 2. This design reflects a broader architectural approach in South Korea, where bathrooms are often constructed as wet rooms with a central floor drain in Figure 2(a). According to housing norms and practices, especially in older or more compact apartments, the entire bathroom is designed to be water-resistant, allowing for easy cleaning and multipurpose use of space. The sink's drainage pipe typically leads to the floor in Figure 2(b), where water flows into a shared drain used by the shower and sometimes the washing machine. While this setup may seem unconventional to those accustomed to enclosed plumbing systems, it aligns with the Korean emphasis on efficient space utilization and ease of maintenance [7]. According to the Seoul Metropolitan Government Ordinance on Building and National Plumbing practices, there is no explicit requirement for a dedicated drainpipe for each fixture such as a sink.

Figure 2. (a) Bathroom sink and shower in South Korea draining directly onto the bathroom floor without a dedicated sewer line, consistent with wet-room design; (b) Exposed sink drainpipe discharging onto the bathroom floor.

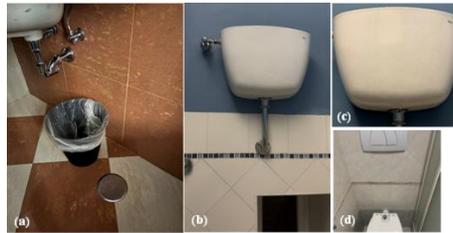
Figure 3(a) illustrates a standard bathroom installation in Rome, Italy, where the sink is properly connected to a dedicated drain line and the floor drain is sealed. However, due to elevated humidity levels in parts of Italy, condensation frequently forms on bathroom fixtures. Figures 3(b-d) show visible moisture accumulation on the surface of a toilet cistern, a phenomenon exacerbated during colder months. In many Italian installations, the toilet cistern is mounted high above the bowl, resulting in condensate dripping onto the user during winter in Figure 3(c). Figure 3(d) presents a concealed cistern installation, where condensation has visibly dampened the wall surface. Although condensation on toilet cisterns is a well-documented issue in humid environments, the Italian plumbing code does not currently mandate thermal insulation for cisterns. Scientific literature confirms that condensation occurs when warm, humid air contacts cooler surfaces, such as water tanks or pipes, especially in poorly ventilated spaces. Studies have modeled this behavior using thermodynamic and computational fluid dynamics approaches, demonstrating that condensation is intensified by high humidity, low surface temperatures, and the presence of non-condensable gases like air [8-10].

Figure 3. (a) Properly installed sink with a sealed floor drain; (b) Visible water condensation forming on the surface of a toilet cistern; (c) Magnified view of condensation droplets on the cistern; (d) Concealed toilet cistern behind a wall causing condensation and mold growth on the wall surface.

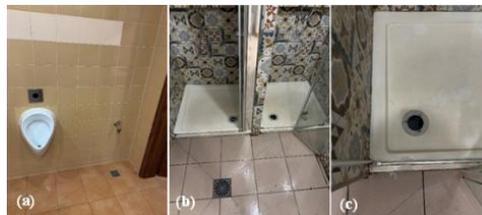
Figure 4. (a) Bathroom floor drain with a properly installed water trap to prevent sewer gas escape; (b) shower room at the New World hostel in Warsaw with missing trap inserts and exposed sewer lines; (c) magnified view of (b), clearly showing the absence of the trap insert.

Figure 4(a) shows the bathroom floor drain with a water trap, which prevents sewer gas escape. However, if the floor drain insert is removed, sewer pipes become exposed and release toxic sewer gas. Figure 4(b) shows the shower room at the New World hostel, located at Nowy Świat 27, 00-029 Warszawa, Poland, with removed inserts from the shower drains. Figure 4(c) is a magnified view clearly showing a missing insert. The hotel management refused to address this problem.

In Poland, such conditions may constitute a violation of the national Construction Law (Prawo budowlane), which mandates that buildings must be maintained in a manner that ensures safety, hygiene, and environmental protection [12]. The County Building Supervision Inspectorate (Powiatowy Inspektorat Nadzoru Budowlanego) is the primary authority responsible for enforcing compliance with these regulations. If a facility fails to maintain proper drainage systems, such as by removing trap inserts and allowing sewer gas to escape, this may be grounds for administrative intervention. Additionally, the State Sanitary Inspection (Państwowa Inspekcja Sanitarna) may become involved if the issue poses a public health risk, particularly in hospitality settings [13]. Under Article 62 of the Construction Law, building owners are required to conduct periodic inspections to assess the technical condition of installations, including plumbing and ventilation systems. Failure to comply may result in fines, mandatory repairs, or even temporary closure of the facility [14]. In cases where management refuses to act, guests or third parties may file formal complaints with the local building inspectorate or sanitary authority, triggering an official investigation and enforcement process.

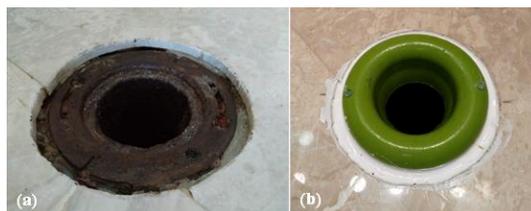
Figure 5. (a) Recessed toilet flange resulting from tile installation during renovation; (b) oversized ring used to seal the toilet above the new floor level.

However, sewer gas leakage can still happen in the U.S. When tile is installed in a bathroom, it often raises the finished floor level above the original height of the toilet flange, as shown in Figure 5(a). According to plumbing best practices, the toilet flange should ideally sit on top of the finished floor, with its top surface approximately  $\frac{1}{4}$  inch above the tile. This positioning ensures a tight, leak-free seal between the toilet and the waste pipe. If the flange ends up below the tile surface, a standard wax ring may not provide adequate compression to form a proper seal, increasing the risk of leaks and sewer gas escape.

To address this, oversized or extra-thick sealing rings are commonly used to compensate for the height difference, as shown in Figure 5(b). These rings are designed to bridge the gap between the toilet base and the recessed flange, ensuring a secure connection. In some cases, flange extenders or spacer kits may also be installed to raise the flange height to the correct level, especially when the gap exceeds what a wax ring can safely accommodate.

Importantly, the seal between the toilet and the flange cannot be visually inspected or pressure-tested once the toilet is installed, due to the concealed nature of the connection. This makes proper installation critical. A poor seal can lead to hidden leaks that damage subflooring or allow sewer gases to enter the living space.

While the International Plumbing Code (IPC) and Uniform Plumbing Code (UPC) do not specify exact flange height tolerances, they do require that all plumbing fixtures be installed to prevent leakage and ensure proper function [19]. This implicitly supports the use of appropriate flange height and sealing methods, such as oversized wax rings or flange extenders, when tile or other flooring raises the finished floor level.
