LONG-TERM CORROSION BEHAVIOR OF EPOXY COATED REBAR IN FLORIDA BRIDGES

Kingsley Lau and Alberto A. Sagüés
Dept. of Civil and Environmental Engineering, University of South Florida
4202 E. Fowler Ave. ENB118
Tampa, FL 33620

Rodney G. Powers
State Materials Office, Florida Department of Transportation
5007 NE 39th Ave.
Gainesville, FL 32609

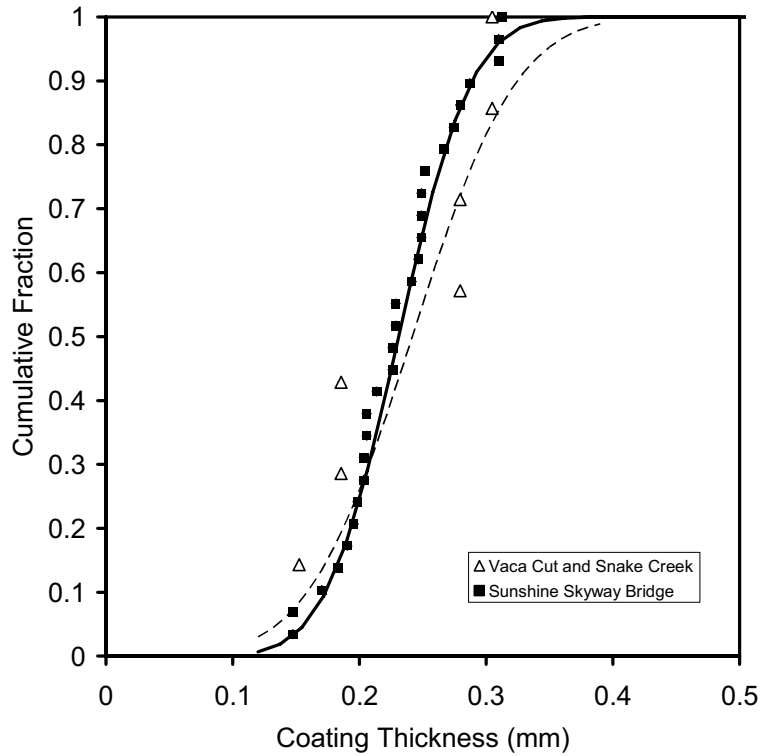
Where it could be examined, backside contamination was $\sim <1\%$. The average epoxy coating thickness was ~ 0.2 mm (Figure 2), generally consistent with product specifications.

The average epoxy coating thickness from outer mat ECR at all locations was ~0.2 mm (Figure 2), as expected from material specifications. To date, coating autopsy was completed for four ECR samples from cracked low elevation concrete and ten ECR samples extracted from the cap beams; six from cracked concrete and four from companion sound concrete cores. Figure 6 is representative of the metal and coating underside appearance of samples with disbonded coating as described below.

Figure 2. Cumulative Fraction of Coating Thickness

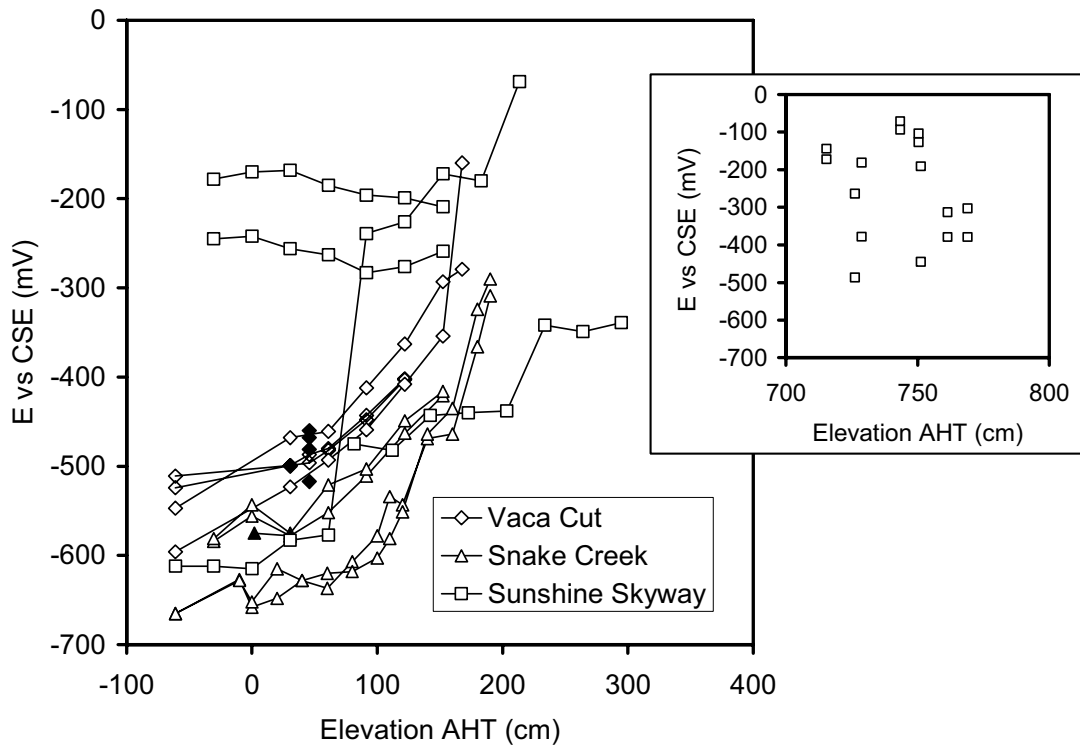
Vertical and horizontal ECR exposed by coring in the same column were mostly found to be electrically continuous. Half-cell potential mapping of the ECR generally showed potential values (more negative than -300 mV CSE), traditionally indicative of corrosion activity for plain rebar in atmospherically exposed concrete (Figure 3). Although potential may not be a reliable indicator of active corrosion of ECR in marine concrete, it is noted that all the rebar which had showed visual signs of corrosion were similarly negative. Concrete resistivity reached <5 k Ω -cm, indicative of highly permeable concrete (Figure 4). A general trend of lower resistivity at low elevations was consistent with expectations of near water saturation there.

Figure 3. Half-cell potentials as function of elevation.

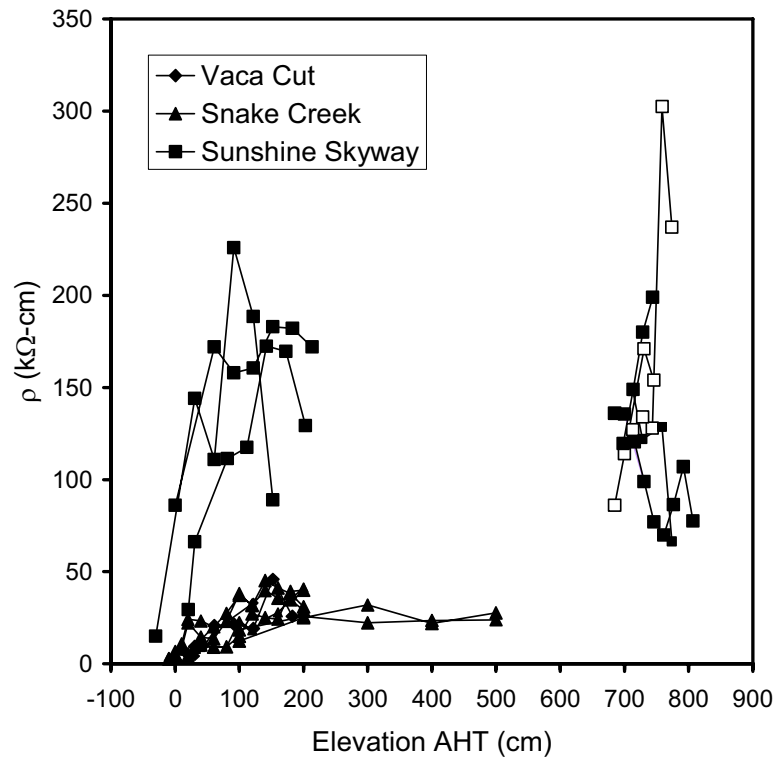
Figure 4. Concrete resistivity as function of elevation.

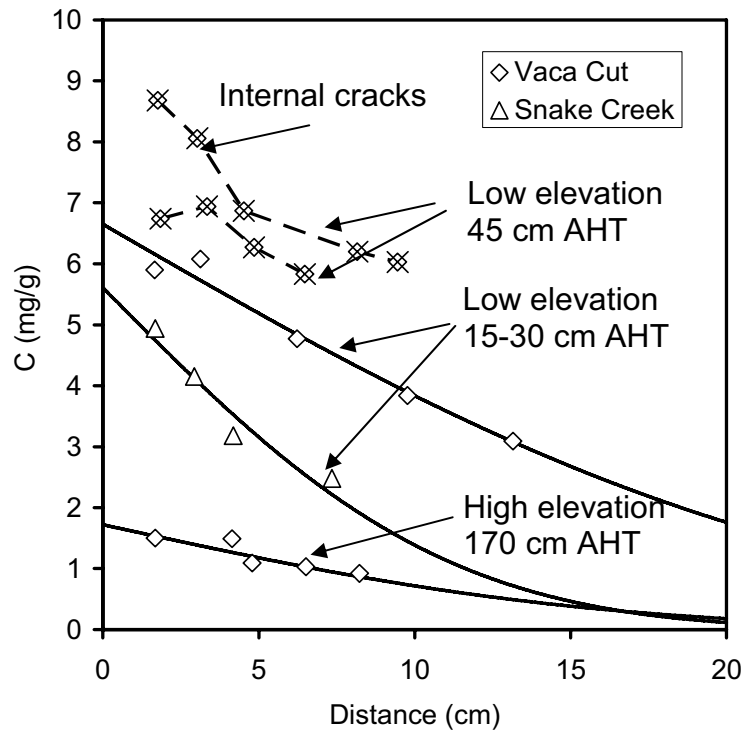
The chloride penetration profiles are shown in Figure 5. The D values for Vaca Cut were very high ($1e-7$ to $2.76e-7$ cm²/s) and less but still indicative of high permeability for Snake Creek ($4.73e-8$ cm²/s). The average C_s value was similar to those measured in other Florida marine bridges (~ 7 mg/g, ~ 17 kg/m³).⁹ The chloride content of the cracked concrete samples were higher than in the sound concrete within the area of the drilled shaft susceptible to sea splash (<46 cm AHT) which gives indication of preferential chloride penetration through the cracks. The volumetric porosity of the concrete from both bridges were high ($\sim 20\%$), consistent with the high permeability observed.

Figure 5. Chloride concentration as function of depth. X: cracked concrete. Solid line: fitted trends to obtain diffusional parameters.
