EFFECT OF CONCRETE ENVIRONMENT ON THE CORROSION PERFORMANCE OF EPOXY-COATED REINFORCING STEEL

A.A. Sagiúes
Department of Civil Engineering and Mechanics
University of South Florida
Tampa, Florida 33620

R.G. Powers
Materials Office
Florida Department of Transportation
Gainesville, Florida 32602

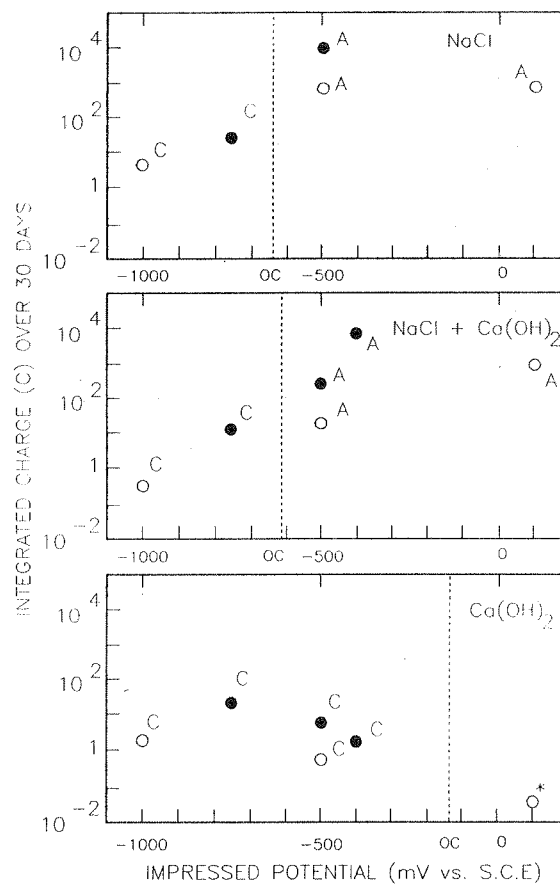
A summary of the tests conducted and their exposure parameters is given in Table II. Highlights of results for each test environment are given below. All electrode potentials in the following text are versus SCE. The amount of disbondment observed in each case, expressed as a fraction of the area of bar in contact with the liquid, is presented graphically in Figure 5. Integrated current demand for potentiostated specimens is presented in Figure 6.

FIGURE 5 - Average percentage of coating that could be removed by sliding a knife between the coating and substrate after the one-month exposure to the chloride-containing environments. The results are given as a function of the impressed potential (open circuit condition shown by dashed line). Open symbols (○): as-received material. Closed symbols (●): intentional surface damage. The calcium hydroxide-only solution resulted in negligible disbondment.
