CORROSION OF POST-TENSIONED TENDONS IN FLORIDA BRIDGES

Abstract

Severe corrosion distress and failures in post-tensioned tendons has been found in two major bridges in the State of Florida. Corrosion distress and complete tendon failure has been identified in horizontally oriented tendons that support pre-cast bridge superstructure box segments. In virtually all instances, the observed corrosion has been associated with the presence of grout voids and visual evidence of grout bleed water having been present for indeterminate periods of time. With few exceptions, corrosion induced strand failures have occurred in the immediate vicinity of the anchorage. The anchorage systems in both bridges utilize a proprietary multi-plane anchorage (housing) comprised of ductile cast iron and forged steel wedge plate. The presence of these metals coupled with high strength strands gives rise to concerns relative to galvanic corrosion thus prompting this preliminary investigation focusing on dissimilar metals corrosion. The investigation involves laboratory tests that examine the corrosion aspects of grout bleed water and re-charge water in contact with dissimilar metals comprising the tendon and

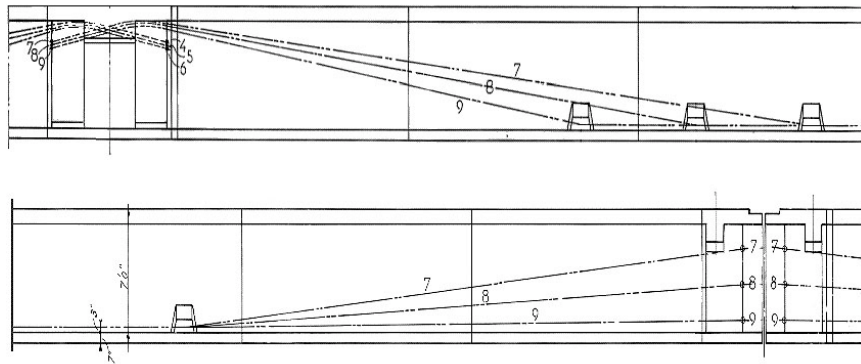
Figure 1 – Typical tendon configuration in the superstructure of the affected bridges.

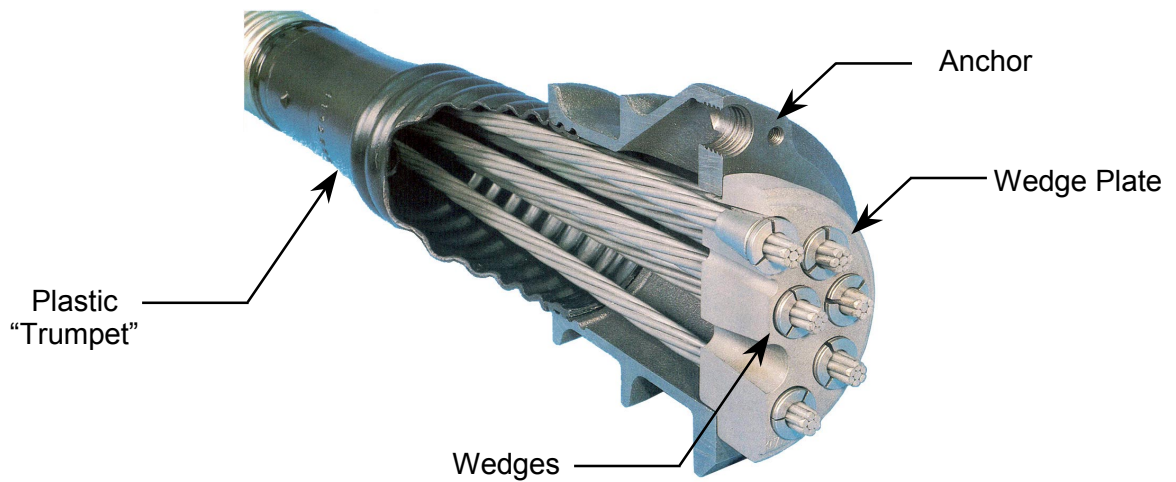
Anchorage Mock-up Details: The mock-up utilized a proprietary anchorage system (Figure 2) of the same type and from the same manufacturer as that used at MBB. The system consists of a ductile iron, multi-plane anchor manufactured to ASTM A27, Grade 65-45-12 specifications and a forged steel wedge plate manufactured to ASTM A688 specifications. The post-tensioning strands were seven-wire, 14.3mm nominal strand diameter, Grade 1860 manufactured to AASHTO M 203 specifications. Composition of the components was verified via metallographic examination and spectrographic analysis. The wedge plate in this experiment was represented by a cut-off piece of plate cast into the anchorage grout. The wedge plate section measured 5.5cm wide (the thickness of the plate) by 12.7cm in length. Since this specimen was cut from the edge of the wedge plate, one side of the test specimen had a sawn edge while one side was in the “as-manufactured condition”. The total surface area of the portion of the specimen in contact with grout was approximately 81cm². This metal-to-grout surface contact area is proportionate to the contact area that would exist with a horizontally positioned anchor approximately 50% filled with grout. The surface area of the anchor in contact with the grout was 856cm². All of the metal components used in the experiment were “as-new” and showed no signs of deterioration or contamination. The strands were gray in color, free of grease and oils and had a mill finish.

Figure 2 – Details of the anchorage system used in the Niles Channel and Mid Bay Bridges.

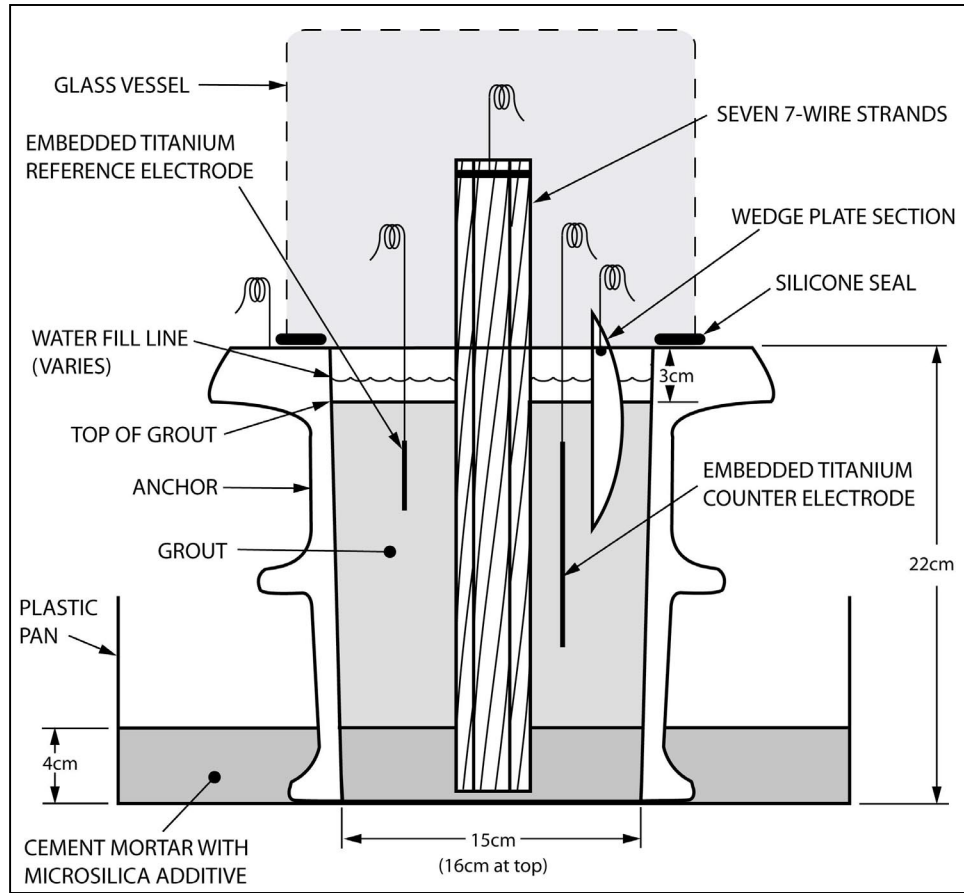
The mock-up (Figures 5 and 6) consisted of seven bundled, seven-wire strands and a cut-off section of the wedge plate cast into the anchorage in a vertical position. A thick grout made up of cement and micro-silica was used to seal the bottom 4cm of the anchorage. Care was used to ensure that none of the metal components were in contact with one another. The grout used in this experiment was as previously described using 1 percent (by weight) aluminum based expanding admixture. Approximately 3.3L of grout was placed into the anchor. The grout filled the anchor to a point 3cm from the top (outer end). During grout placement, the strands and wedge plate section were suspended in place using cloth tie-wires. Following introduction of the grout, the specimen was vibrated (as indicated earlier) continuously for four hours. Subsequently, measurements were made for grout shrinkage and bleed-water. Each of the metallic components was equipped with securely attached and sealed electrical connections to facilitate testing and establishing electrical continuity between the anchorage components. Two activated titanium rods (3.2mm diameter) were imbedded into the grout. One rod was 10cm in length; the other was 4cm in length. These served as counter and reference electrodes in the polarization resistance tests. The open end of the anchor was fitted with a suitably sized glass vessel to minimize evaporation during the laboratory evaluation. A silicone seal approximately 2mm thick by 25mm wide was used between the glass vessel and anchor. A section measuring 10mm wide was cut out of the silicone seal to replicate a defect in construction that would be of sufficient size to allow water re-charge and aeration similar to that which might be experienced in actual field conditions.

Figure 5 – Schematic of the experimental anchorage mock-up.

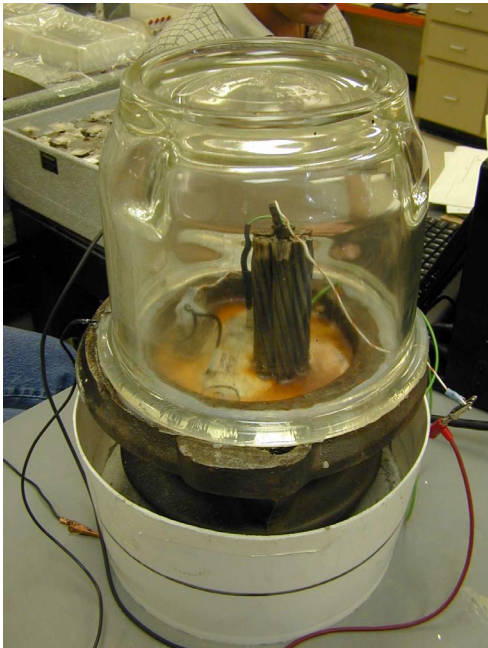
Figure 6 – Photograph of the experimental anchorage mock-up.

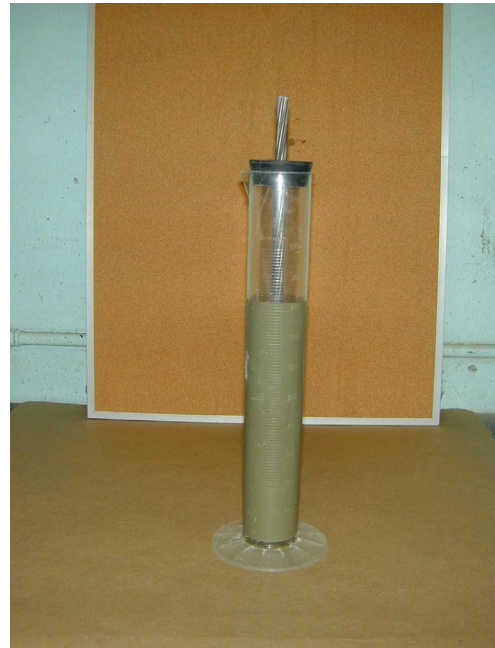
Standard Grout Tests: In these standard tests (Figure 7) grout shrinkage is characterized by the loss of grout volume due to water loss (grout bleed-water) during the plastic phase. Results of these tests showed grout shrinkage and bleed-water volumes to be within expected parameters for the aluminum admixed specimen, and the non-admixed control specimen. However, when these materials were exposed to low amplitude vibration as previously described, the volume of bleed water increased dramatically. The non-vibrated control specimen developed 1.81% bleed-water, and the vibrated specimen developed 6.2% bleed-water. Comparatively, the aluminum admixed specimens developed 1.94% bleed-water (non-vibrated) and 10.2% bleed-water (vibrated) with a correspondingly equal loss of grout volume. Visual examination of the test specimens (except for the vibrated, aluminum-admixed specimen) showed the grout to be of relatively uniform consolidation and coloration throughout. Comparatively, the aluminum admixed specimen showed wide variations in coloration (Figure 8) along its length. The lower portion of the specimen was dark and dense in appearance but with increasing height, the grout was increasingly lighter in coloration until finally at the uppermost portion of the specimen (~1cm) the grout was near white in color and chalky in texture (Figure 9). The pH of the grout at the top of the specimen was determined to be 8.7 (+/- 0.5). The pH of the grout near the bottom of the specimen was $> \sim 12$.

Figure 7 – Photograph of the test apparatus for measuring grout bleed-water and grout volume change.

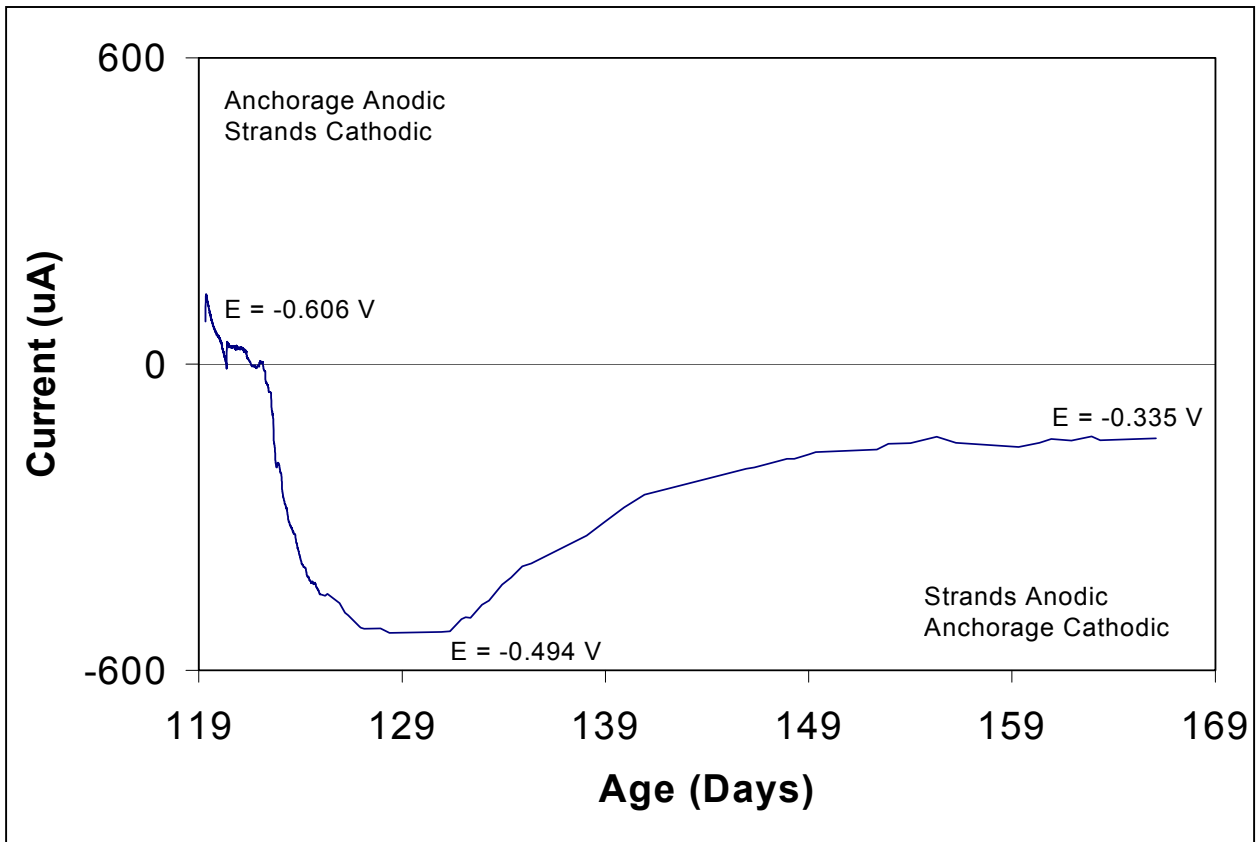
Figure 10 – Macro-cell current and half-cell potentials for the fifth water re-charge event.
