Engineering Failure Analysis

Failure analysis of the oil transport spiral welded pipe

The spiral welded pipe for oil transport failed catastrophically fracturing along the spiral welding line. The failure was in the base metal close to the heat-affected zone. Passive inclusions in the rolled metal are responsible for the pipe failure. Microstructure examination and Charpy-V notch tests reveal that the crack follows the oxide inclusions and is associated with their distribution, since the base metal toughness is insufficient to retard cracking. Improvement of the steel purity is suggested to prevent future pipe failures. Improving the welding technique to reduce the residual stress acting on the base metal also decreases the risk of pipe failure.

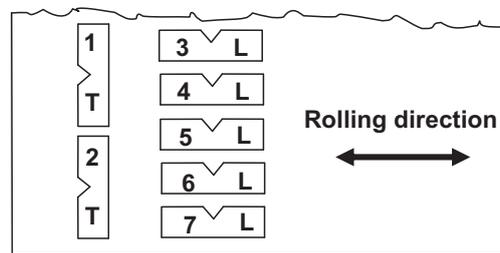
Fig. 2. Specimens for the Charpy V-notch impact test prepared in longitudinal (L) and transverse (T) orientations.

The Charpy V-notch (CVN) impact test [3] was conducted to evaluate the notch sensitivity and impact toughness of the spiral welded pipe (base metal). Specimens (5 × 10 × and 55 mm long) were cut parallel and perpendicular to the rolling direction in order to compare the toughness in different orientations; their corresponding positions are presented in Fig. 2.

In order to prove that alignment of passive inclusions resulted in mechanical resistance anisotropy leading to pipe failure, the Charpy V-notch impact test (CVN, ASTM E23) was conducted. The CVN specimens were prepared with the notch in the sheet plane either parallel or perpendicular to the rolling direction (Fig. 2). The corresponding experimental data of the CVN
