Hydrogen redistribution under stress-induced diffusion and corresponding fracture behaviour of a structural steel

Hydrogen redistribution under stress-induced hydrogen diffusion and corresponding fracture behaviour of a 960 MPa grade martensitic steel were studied. Slow strain rate tensile (SSRT) tests after hydrogen pre-charging were performed and the fracture surface was observed and analysed. The strain rate ranged from 10^{-6} to 10^{-4} s⁻¹. In the pre-charged sample with a certain hydrogen content of 0.62 ppm, hydrogen distribution was homogeneous before the SSRT test. After tensile testing, brittle fracture features appeared in the centre of the fracture surface, while ductile features appeared in the surrounding area. Brittle region size increased with the strain rate slowing down in the range from 10^{-4} to 5×10^{-6} s⁻¹, while it stabilised at the strain rate slower than 5×10^{-6} s⁻¹. Relationship between the strain rate and the brittle region size was established and discussed based on the present data of hydrogen content in the material.

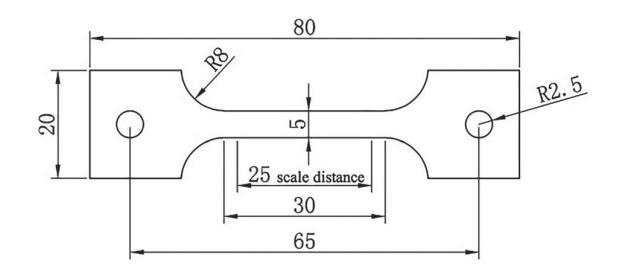
Figure 1. Tensile specimen schematics, and the thickness is 1.5 mm.

The specimen of slow strain rate tensile (SSRT) used in this study is shown in Figure 1. The tensile specimens

were 1.5 mm thick, and their surfaces were wet-ground with SiC paper up to 2000 grit, and then ultrasonically cleaned in acetone and ethanol. The strain was recorded from the cross-head displacement. Hydrogen charging was implemented in $0.2 \text{ mol } L^{-1}$ sulphuric acid (H_2SO_4) solution at a current density of 1 mA cm⁻² for 15 min at room temperature. Only the gauge region of the tensile specimen was charged. After pre-charging, the sample was washed with deionised water, dried, and then cadmium was plated on the sample surface for about 45 min. Then the sample was cleaned and dried again followed by installation onto the tensile machine to immediately start the SSRT. The above procedure took about 15 min. Three tensile strain rates of 5×10^{-5} , 10^{-5} and 5×10^{-6} s⁻¹ were mainly studied in this work. The other two strain rate of 10^{-4} and 10^{-6} s⁻¹ were used to verify the result. Each major strain rate was tested three times.

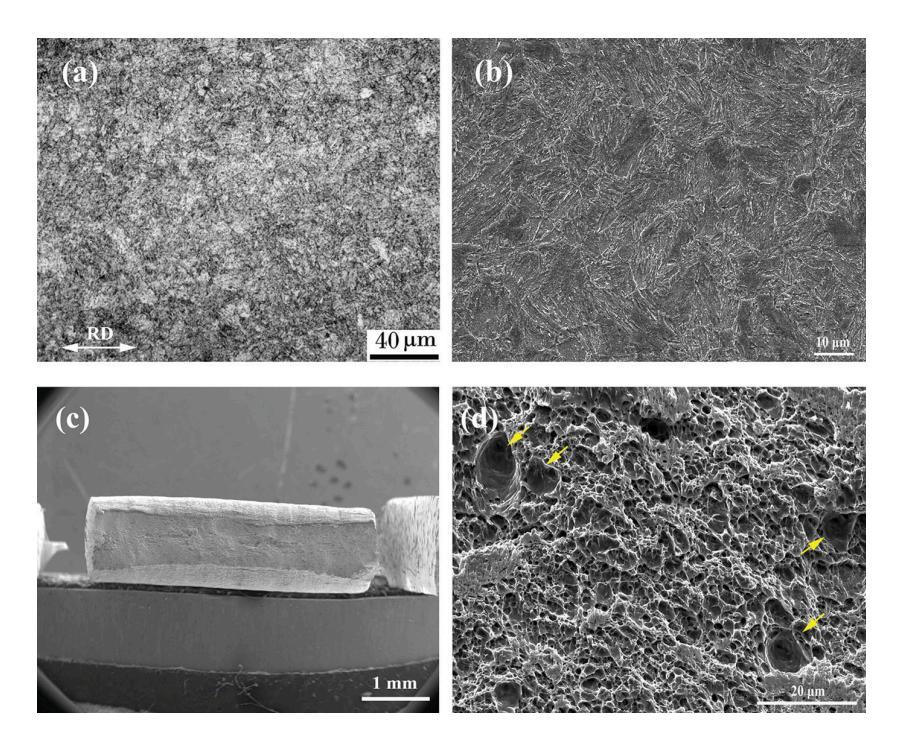
Figure 2. Microstructure of the 960 MPa grade high-strength steel: (a) light micrograph; (b) SEM image; (c) and (d) are fracture morphology of hydrogen-free sample.

Figure 2 exhibits the 960 MPa grade high-strength steel microstructure and fracture surface of hydrogen-free sample, and the horizontal direction is the rolling direction in the light micrograph, which was marked by white arrow in Figure 2(a). The microstructure of the steel is full lath martensite and almost isotropy, which is more easily distinguished in the SEM image as Figure 2(b). The fracture surface of hydrogen-free sample has mainly dimples and a few small regions of brittle features, as indicated by yellow arrows in Figure 2(d).

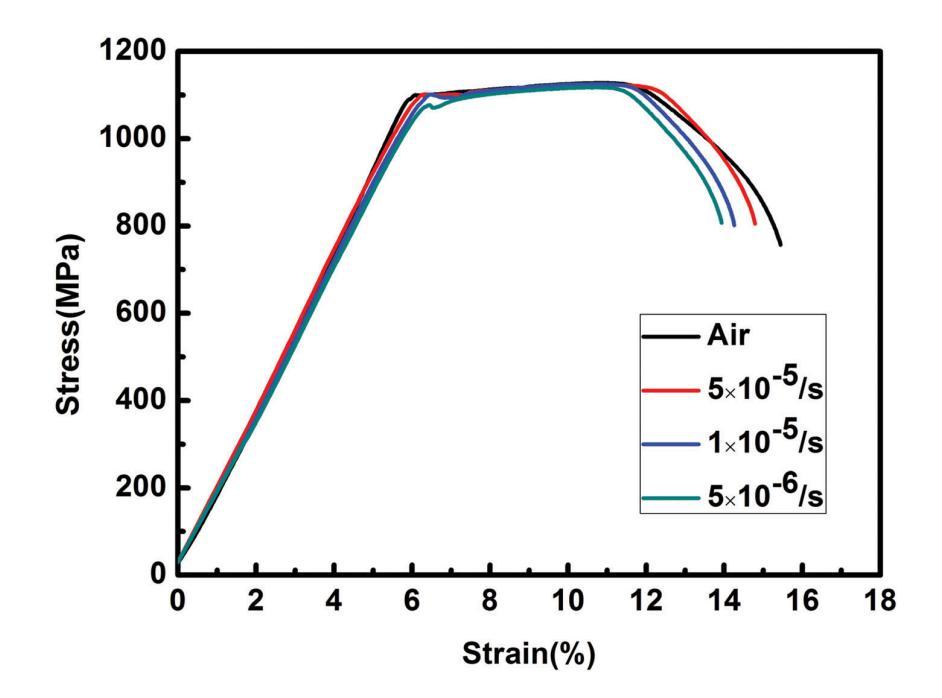
Figure 3. The nominal stress-nominal strain curves of the hydrogen pre-charged specimens.

The nominal stress-nominal strain curves of SSRT after hydrogen pre-charging are shown in Figure 3. The strain is not measured with a local extensometer but from the cross-head displacement. Therefore, the slope of the linear part of the curve does not correspond to the elastic modulus of the steel. Overall, the elongation decreased with the strain rate slowing. The duration time is about 3 min for the stretching of the hydrogen-free sample, 51 min at $5 \times 10^{-5} \text{ s}^{-1}$, 237 min at $1 \times 10^{-5} \text{ s}^{-1}$, and 460 min at $5 \times 10^{-6} \text{ s}^{-1}$ for the pre-charged samples. When the tensile rate is quick enough, the effect of diffusible hydrogen in the lattice could be ignorable, because the duration time of tensile test is short and not enough for hydrogen diffusion and enrichment to cause the change of mechanical property [17]. However, when the strain rate was slow, such as 10^{-5} and $5 \times 10^{-6} \text{ s}^{-1}$, there is long enough time for hydrogen enrichment. Thus, the total elongation was affected. Moreover, an average and the standard deviation of hydrogen concentration in this work was 0.62 ± 0.1 ppm. So, the small elongation loss is mainly because of the low hydrogen concentration of the precharging specimen.

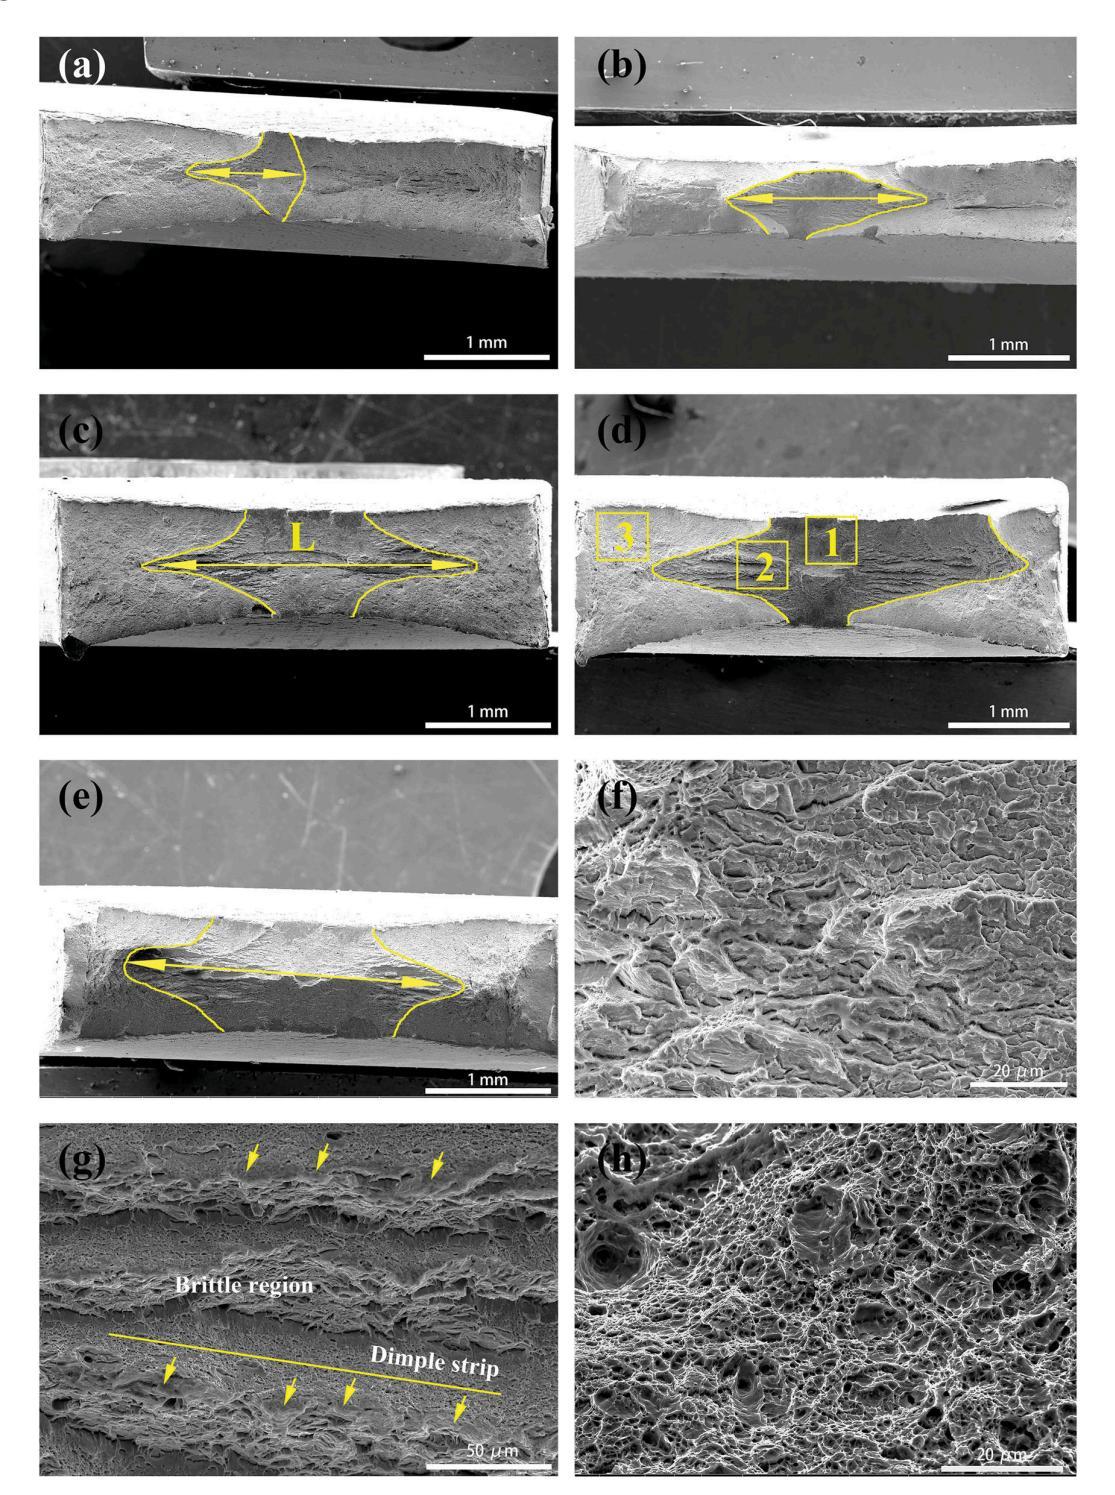
Figure 4. SEM images obtained after pre-charging at different strain rates: (a) 10^{-4} s^{-1} ; (b) $5 \times 10^{-5} \text{ s}^{-1}$; (c) 10^{-5} s^{-1} ; (d) $5 \times 10^{-6} \text{ s}^{-1}$; (e) 10^{-6} s^{-1} ; (f, g and h) enlarge regions labelled as 1, 2 and 3 in (d).

After SSRT, SEM was used to observe the fracture morphology. Figure 4 shows the fracture surface of the pre-charged specimen. Figure 4(a-e) show the overall morphology of the fracture surface at five strain rates, and Figure 4(f-h) show enlarged view of Figure 4(d). It is clear that entirely brittle fracture occurred in the centre of the fracture surface, as shown in Figure 4(f), and the fracture behaviour changed to mixed mode of shallow dimples and brittle crack, as indicated by

yellow arrows in Figure 4(g), then completely ductile fracture at the edge of the fracture surface, as shown in Figure 4(h). As mentioned above, three samples were tested at each mainly studied strain rate, and the average size of the brittle region was calculated. L is defined as the size of the brittle region. It was found that L becomes larger with the strain rate decrease, as indicated by the yellow lines in Figure 4(a–c), which is 1.62 ± 0.12 mm,

2.55 ± 0.11 mm and 2.97 ± 0.07 mm corresponding to the strain rate of 5×10^{-5} s⁻¹, 1×10^{-6} s⁻¹ and 5×10^{-6} s⁻¹. Thus, the fracture morphology of SSRT for the pre-charged sample here is absolutely different from the situation of dynamic charging during SSRT. For example, Wang's work [18] showed that hydrogeninduced cracking occurred in the surrounding of the specimen under dynamic hydrogen charging of SSRT,

Figure 4(g) shows that brittle region is also accompanied with dimples. Previous work [21–23] indicated that hydrogen promoted cracking propagation by promoting void growth in front of crack tip. Abbassi's [20] research showed that largest strain occurred at the centre of the fracture surface for the plate tensile specimen. Local strain decreases from the centre to the edge of specimen. When the stress gradient and hydrogen concentration gradient existed in the specimen, Fick's first law can be changed as [2]

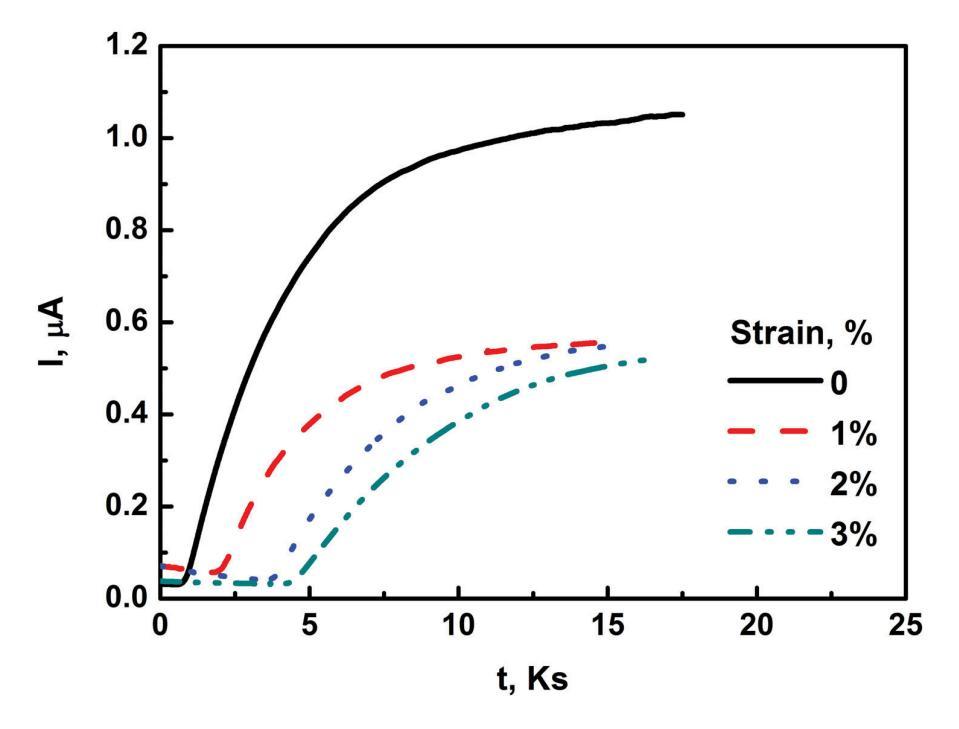
Figure 5. Hydrogen permeation curves for the specimen as-received and after pre-strained of 1, 2 and 3%.

Hydrogen permeation test under different plastic strain was studied. Figure 5 shows the hydrogen permeation curves for the samples with different pre-strain of 0 (asreceived), 1, 2 and 3%. After testing, apparent hydrogen

The details of *D* and $t_{0.63}$ for the four different prestrain are listed in Table 1. When the strain increases, *D* decreases. The value of *D* is the largest at the conditions without any plastic deformation. For example, comparing the *D* values of 0 and 3%, the *D* value decreased from 6.8×10^{-7} to 1.8×10^{-7} cm² s⁻¹.

Kim and Kim [19] showed that D did not change with elastic deformation. However, when the specimen was plastically deformed in tension, apparent hydrogen diffusion coefficient decreased. Thus, D is not a constant in the plastic range, and decreases with plastic strain increasing. This is mainly because the as-received material is hot-rolled and tempered at 600°C, and the dislocation density in the material is low. So the saturation current value of the hydrogen permeation curve is high. After plastic deformation, the dislocation density

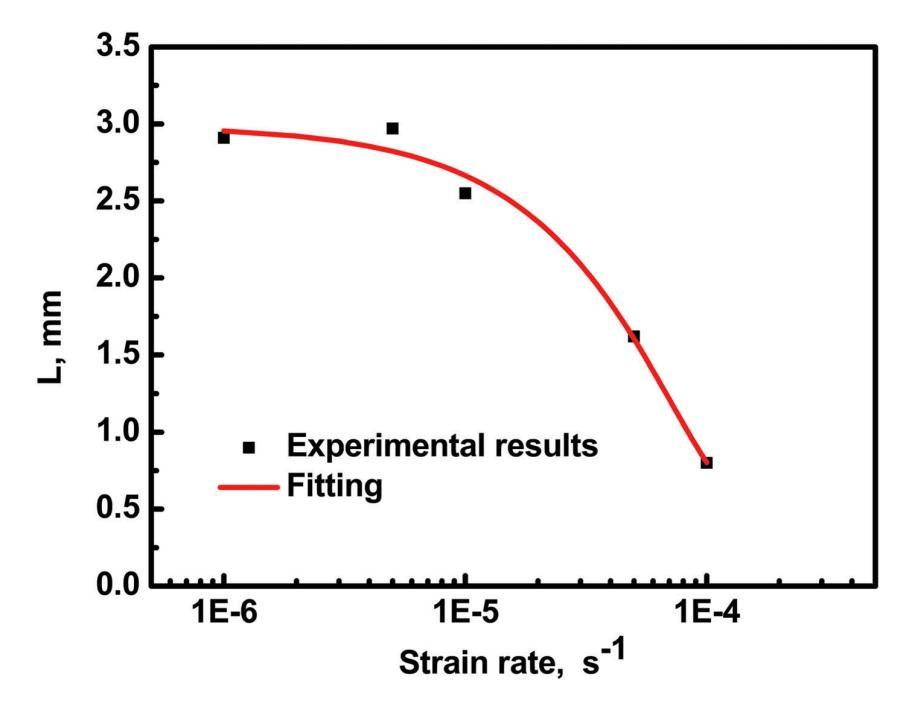
Figure 6. Relationship between the size of brittle region and the strain rate.

Detailed information of the size of brittle region Land strain rate $\dot{\varepsilon}$ are listed in Table 2. Relationship between L and $\dot{\varepsilon}$ can be fitted as shown in Figure 6, where the size of the brittle region increases with the tensile rate decrease. However, when the strain rate is slow enough, the value of L tends to be stable. This means that the value of L might become a constant. It should be mentioned that the hydrogen content in the present work is a constant, i.e. 0.62 ppm. It is believed that the brittle region size will be related to hydrogen content. For a sample with hydrogen content higher than 0.62 ppm, L would properly increase. According to Abbassi's [20] work, the exponential relationship between the size of nucleation of microvoid and $\dot{\varepsilon}$ was observed. According to Figure 6, here, the relationship between *L* (mm) and $\dot{\varepsilon}$ (s⁻¹) in the present situation was exponentially fitted as follows:

$$L = 3.02e^{-13167\dot{\varepsilon}}$$
(2)

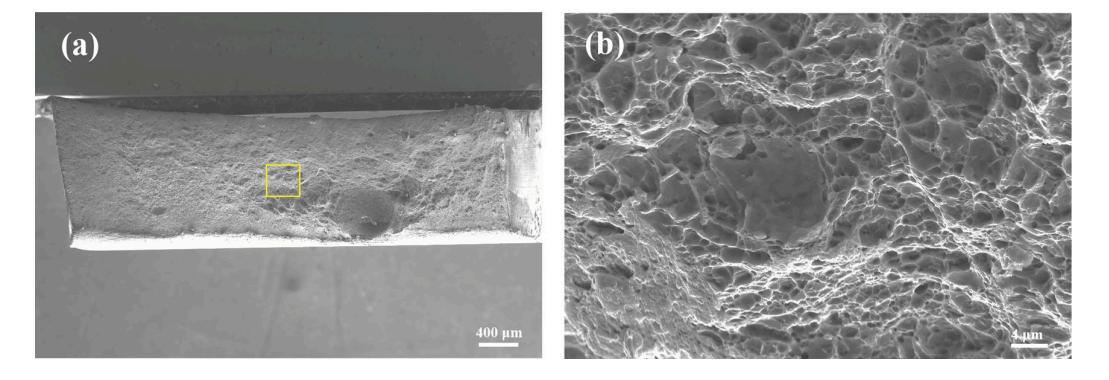
Figure 7. Fracture surface obtained at 6×10^{-3} s⁻¹ strain rate: (a) the whole fracture surface; (b) zoomed in boxed area marked in (a).

To verify this formula, $\dot{\varepsilon}$ of $6 \times 10^{-3} \text{ s}^{-1}$ was carried out to a same pre-charged sample. According to equation (2), when $\dot{\varepsilon} = 6 \times 10^{-3} \text{ s}^{-1}$, $L \approx 0 \text{ mm}$, which means that there is no brittle area on the fracture surface. The corresponding fracture surface is shown in Figure 7. It exhibited dimples feature either in the centre or in the edge on the fracture surface. There is exactly not brittle area. The tensile test lasted only about 3 min. During the short time, hydrogen accumulation degree is too small to cause the change in mechanical properties [17], including the fracture mode. Thus the hydrogeninduced brittle cracking would not occur.

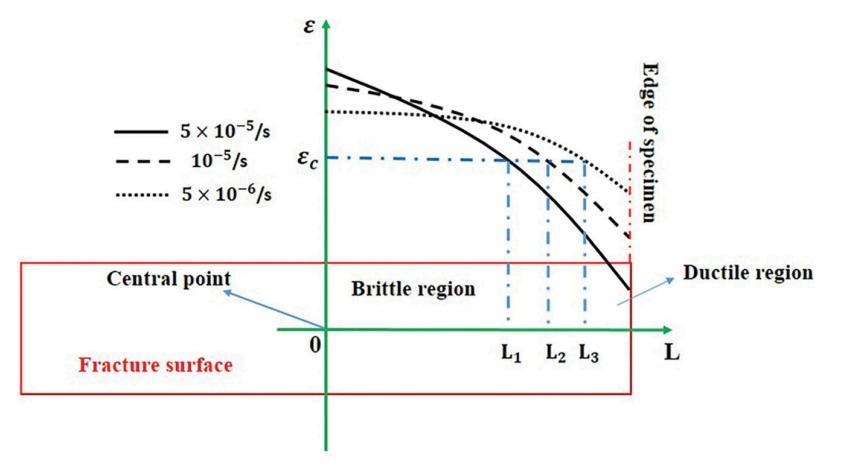
Figure 8. Schematics of the relationship between L and ε for the three tensile test rates.

On the other hand, hydrogen-induced cracking is related to the hydrogen concentration. According to the relationship (4), when the local strain is high enough, hydrogen concentration might reach higher than the critical value and cause HE. The corresponding schematic is shown in Figure 8. Here, ε_c is the critical strain of causing HE. Brittle region formed at the region with strain higher than ε_c . For a certain material and a certain hydrogen content (0.62 ppm, in this work), ε_c is a constant [2]. With the tensile rate decrease, the size of the brittle region increased. It is worth reminding that the combination of the size of the brittle region and hydrogen concentration is not clear. Thus, further research will focus on finding this relationship among the brittle region size, hydrogen content and strain rate.
